Technical product information

Topic	Headlamp operation issues
Market area	Bentley: worldwide (2WBE),Hongkong-Macau (5HK)
Brand	Bentley
Transaction No.	2054599/5
Level	EH
Status	Approval
Release date

New Continental GT and New Continental GTC

Headlamp operation issues

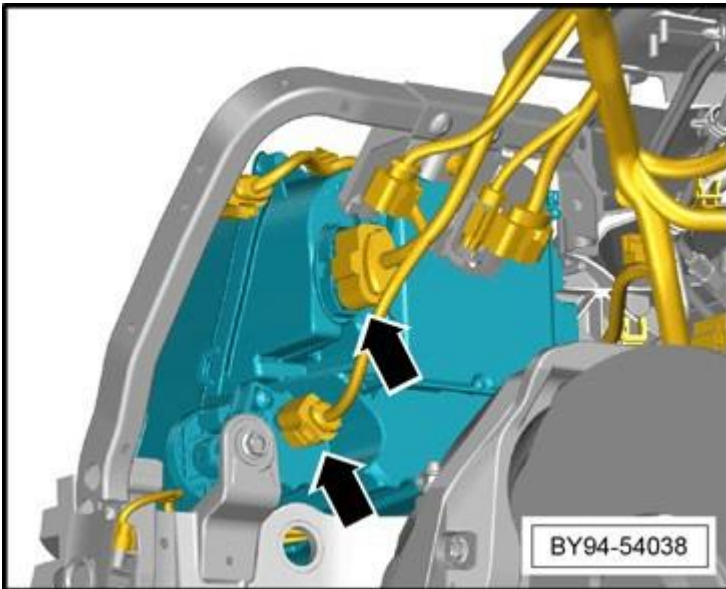
Figure 1

Disconnect the applicable headlamp plugs (right and/or left hand side) - During disconnection look out for any abnormalities for example a plug which is loose/broken or is easily disconnected
