# Technical product information

| <b>Topic</b> | New Continental GT / GTC - Exhaust Flap - Diagnostic Trouble Code |
| <b>Brand</b> | Bentley |
| <b>Transaction No.</b> | 2060432/1 |

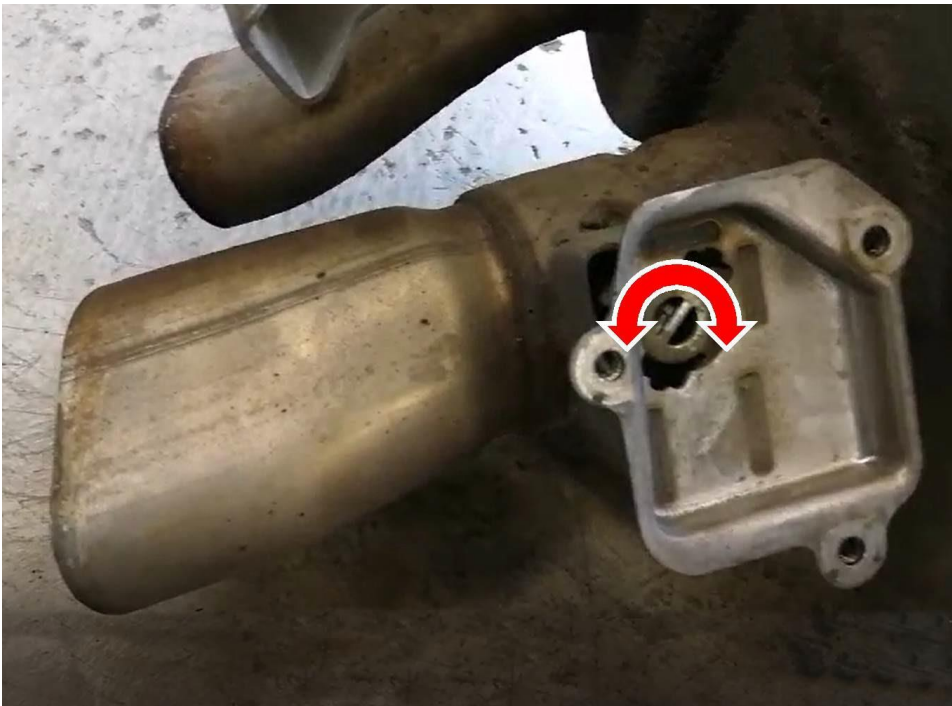
Check and confirm the Exhaust Flap spindle is free to open and close by hand - Figure 2.

If no issue is evident and the Exhaust Flap oscillates freely by hand - replace the defective Exhaust Flap Control Unit, refer to *Repair Group. 26 Exhaust system – Exhaust flap control units (J883, 945) – To remove and fit.*
