Technical product information

Topic	New Continental GT and New Continental GTC - Driver/Passenger door power latch creak on close
Market area	Bentley: worldwide (2WBE),Hongkong-Macau (5HK)
Brand	Bentley
Transaction No.	2052394/7
Level	EH
Status	Approval
Release date

New Continental GT and New Continental GTC

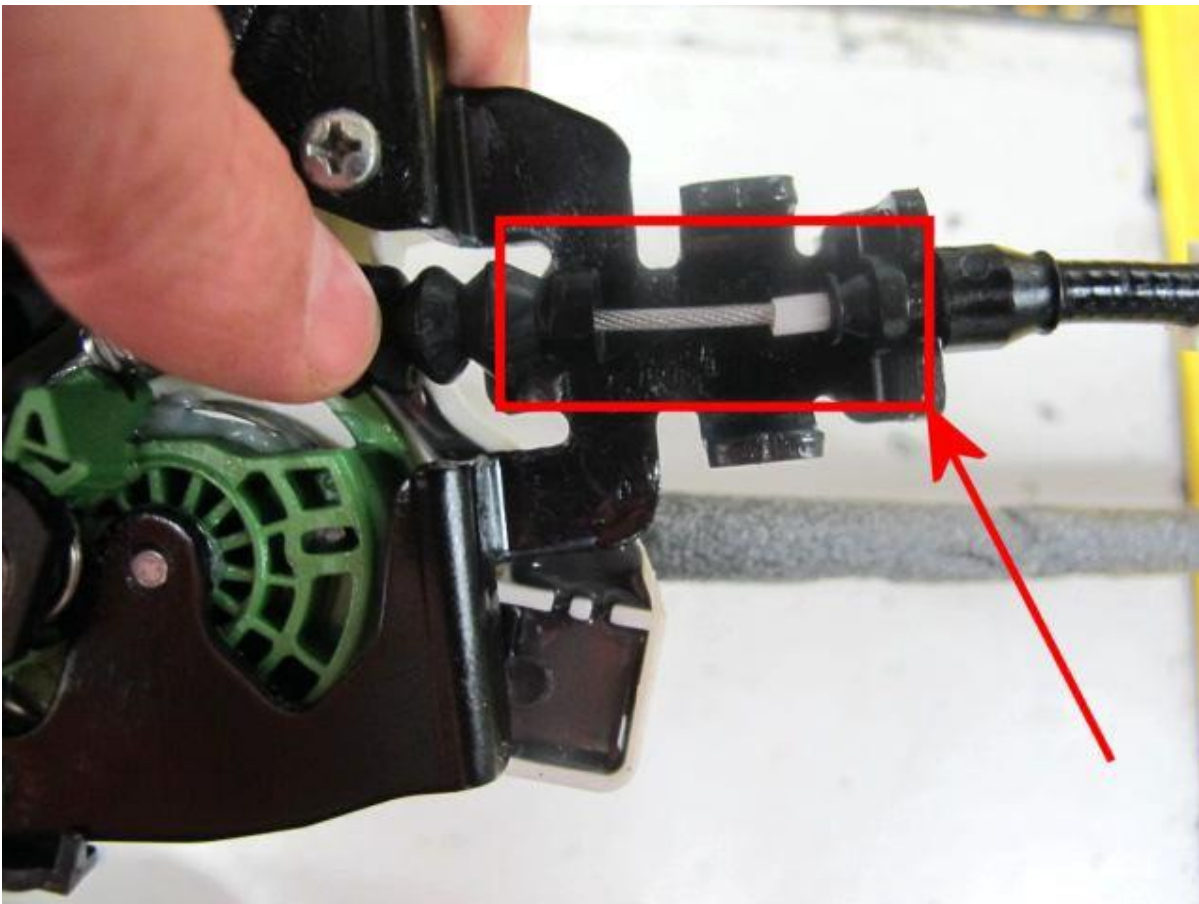
Figure 1

Driver or Passenger door creak during the power latch "Close" function

- 1) Obtain a clear video recording of the issue (save the video as it may be required for analysis)
- 2) Remove the applicable front door trim - Refer to Repair manual Rep.Gr 70
 - Remove the front door inner closing panel -Rep.57
 - Remove the door latch -Rep.Gr57
- 3) Referring to Figure 1, Remove the rubber boot - Apply Dow Corning Molycote 33 extreme - Low temperature bearing grease to the inner cable
 - Refit the rubber boot

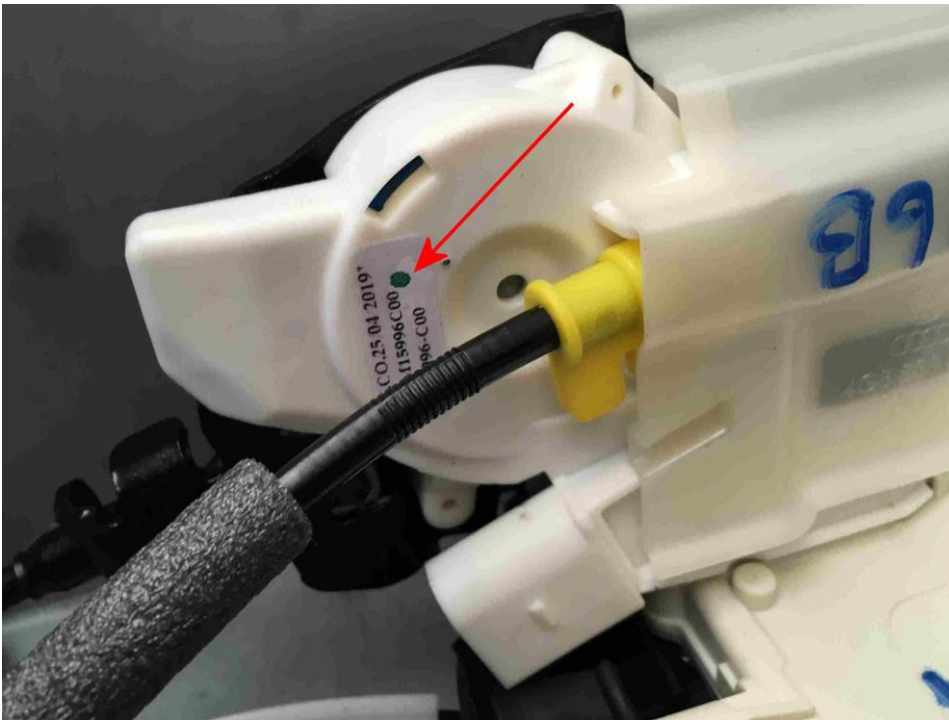
IMPORTANT: If a green paint dot is evident on the label, please ensure the dot is clearly visible within the photograph

- 4) Open a Non technical/For information only DISS query - Attach a photo of the door latch label as shown in Figure 2

- Should the green dot not be evident a photograph of the latch label is still required
- Attach the previously recorded video to the open query, the query can now be submitted
