CAMPAIGN LAUNCH STATUS

DEFENDER SERVICE ACTION N472

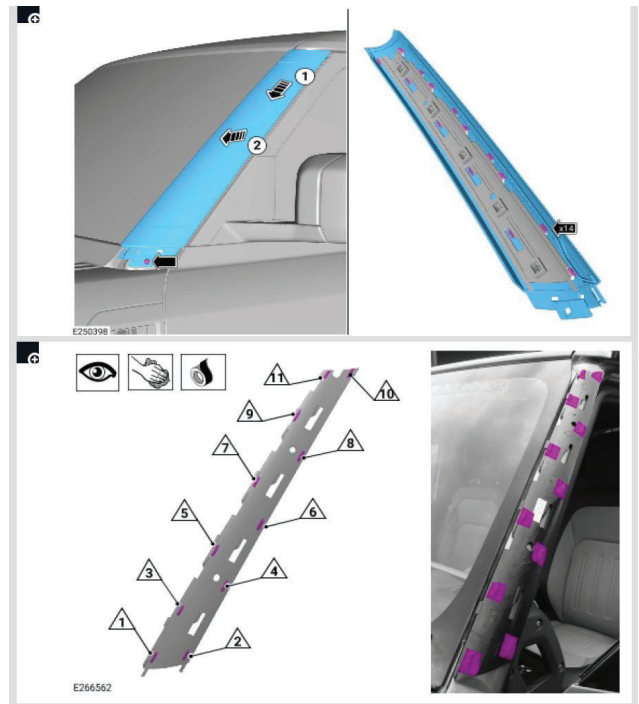
SERVICE ACTION N472 – A POST WIND NOISE	
AFFECTED MODELS	20MY DEFENDER
VOLUME AFFECTED	1125 USA
REPAIR	Fix is required to remove risk of a 'tapping' type of wind noise at the A post. The A post trim to be removed and felt tape applied to the trim mounting clips to increase clearance to the body.
REPAIR TIME	0.2hrs + drive in/out
TARGET CAMPAIGN LAUNCH	August 3 rd 2020
Notes	*Care required in removing lower bolt covers as replacement parts are not yet available. Also requires locally sourced felt tape.
