# CAMPAIGN LAUNCH STATUS

## DEFENDER SERVICE ACTION - N472

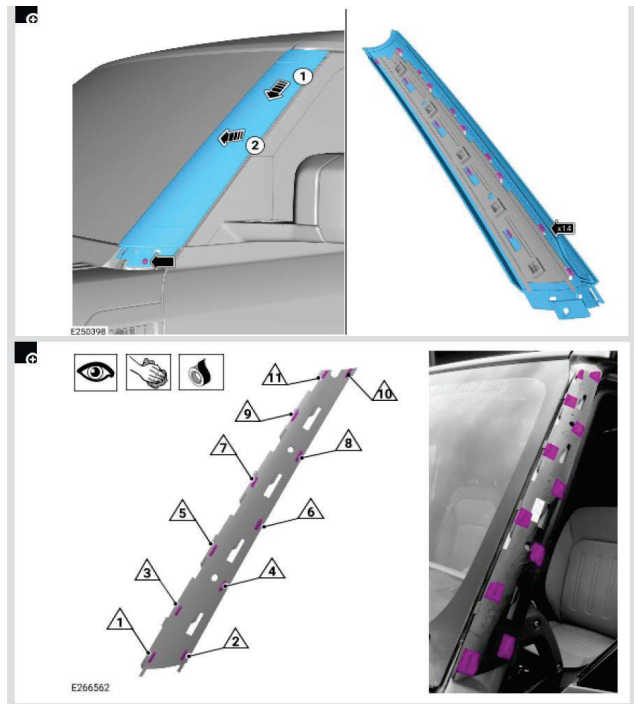
SERVICE ACTION N472 – A POST WIND NOISE	
AFFECTED MODELS	20MY DEFENDER
VOLUME AFFECTED	1125 USA 217 CANADA
REPAIR	Fix is required to remove risk of a 'tapping' type of wind noise at the A post. The A post trim to be removed and felt tape applied to the trim mounting clips to increase clearance to the body.
REPAIR TIME	0.2hrs + drive in/out
CAMPAIGN LAUNCHED	August 4 <sup>th</sup> 2020
Notes	*Care required in removing lower bolt covers as replacement parts are not yet available. Also requires locally sourced felt tape.
