TECHNICAL TOPICS POWERTRAIN

<p>PCM Setting P050E-00</p>	<p>16-20MY Range Rover, RR Sport, Discovery equipped with 3.0L TDV6</p>
<p><u>Customer Voice:</u></p> <ul style="list-style-type: none"> The Check Engine Lamp is illuminated. <p><u>Technical Description:</u></p> <ul style="list-style-type: none"> PCM may have P050E-00 Stored for engine exhaust temperature too low. Upon further inspection the SCR Cat is found to have shifted and been damaged inside the DPF causing damage to temperature sensors as well. <p><u>Status:</u></p> <ul style="list-style-type: none"> Under Investigation. Perform all test as outlined by TOPIx. Check for exhaust leaks and cracks in hoses, and PM sensor operation. Remove both exhaust sensors and check if either of the sensors are bent. If the sensor is found bent measure the distance inside where the sensor would normally fit into the DPF. Notate if the distance is more than 6mm. Replace components as required and raise an EPQR. Include pictures of measurements, damaged sensors and pictures inside the brick if applicable.

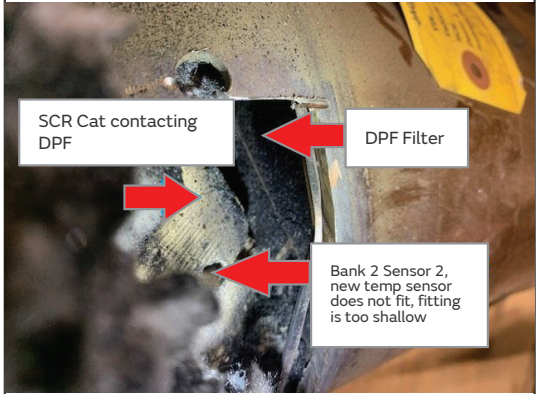
<p>SCR Cat contacting DPF</p> <p>DPF Filter</p> <p>Bank 2 Sensor 2, new temp sensor does not fit, fitting is too shallow</p>
