## TECHNICAL TOPICS POWERTRAIN

### Tip-in Hesitation

19/20 MY Range Rover, RR Sport, Defender equipped with AJ20P6

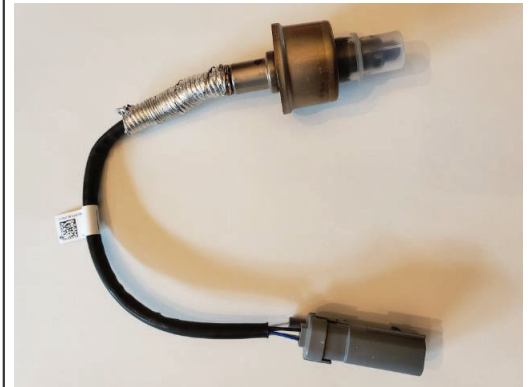
- There is a delay when accelerating.

- A tip-in hesitation is identified and resolved with replacement of the upstream (B1S1) oxygen sensor.
- It is possible no DTCs are stored.

- Raise an EPQR if replacement of the O2 sensor resolves the customer complaint.
- Include a session file (even if no DTC is stored) and contact information (name, email address, phone number) for someone at the retailer who can serve as the point of contact for PRR.
