Tapping from A-Pillar Trim

20MY Defender

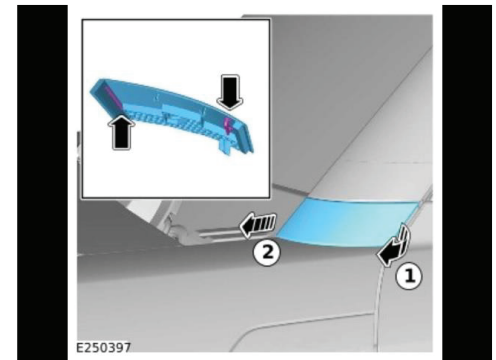
- A limited number of New Defender vehicles may present a tapping noise concern from the exterior A-Pillar finisher contact points on the inner bracket at speeds between 37 – 75 mph (60 – 120 km/h).

- Service Action N472 is being published to proactively address this concern, by installing felt tape between the A-Pillar finisher and the finisher retaining bracket.
- Please note care must be used when removing the finisher retaining screw cover to avoid damage. A video has been provided within the bulletin procedure to aid in the removal and installation of the cover.

View the video and then remove the left windshield molding bolt cover.
