Rear Roof Blind Aperture Seal Adrift

17 – 20MY Discovery

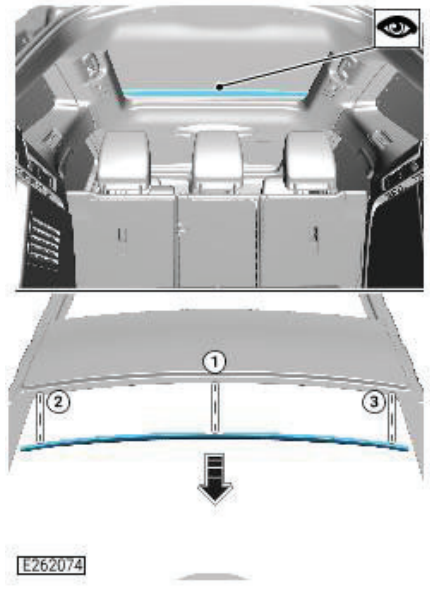
- A customer may report that the rear roof blind seal is coming loose or that the power rear roof blind is not operating properly.

- On certain Discovery model variants the rear roof blind seal may be coming loose due to poor retention.

- New retaining clips have been developed to address this concern.
- Service Action N444 is being published to proactively address this concern by removing the blind seal and installing new retaining clips to keep the seal in place.
