Rear Doors Difficult To Open

20MY Defender

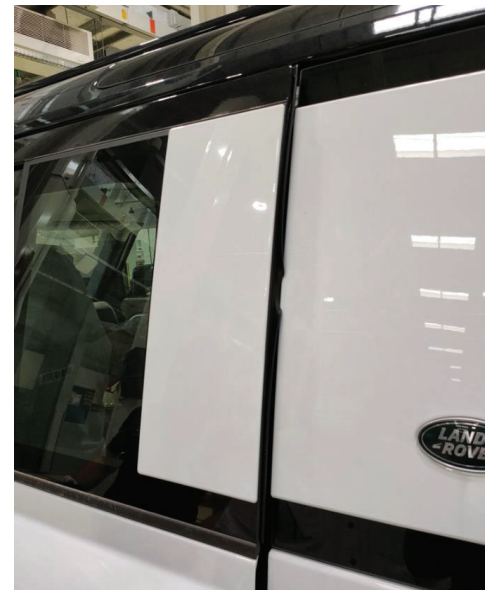
- A customer may report the rear door is difficult to open.

- The rear door seal may catch and drag on the quarter glass due to an incorrect C-Pillar exterior trim finisher alignment.

- SSM74962 was published July 29, 2020 to initially address this concern.
- TSB JLRTB02052NAS1 is being published to replace SSM74962.
- Should a customer express a concern, please refer to this TSB for repair guidance.
