TECHNICAL TOPICS

BODY

Tailgate Mounted Tail Lamp Condensation / Water Ingress	20-21 MY RR Evoque
<p><u>Customer Voice:</u></p> <ul style="list-style-type: none">• A customer may report that the rear tailgate tail lamp has moisture in it. <p><u>Technical Description:</u></p> <ul style="list-style-type: none">• A tailgate mounted tail lamp may develop condensation or standing water in the lamp housing. <p><u>Status:</u></p> <ul style="list-style-type: none">• Engineering is currently investigating this concern.• Please submit an EPQR with pictures for any tailgate tail lamps you find with this concern.• A request for return of any failed parts will be raised to support the investigation.

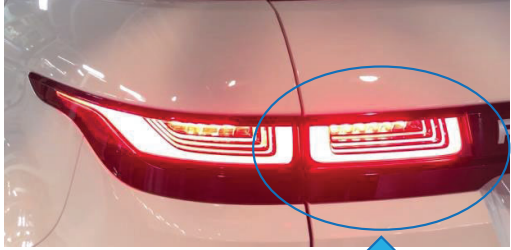
<p>The tailgate tail lamp as shown.</p>
