N472NAS1

TECHNICAL BULLETIN

Service Action: Windshield Molding Tapping Noise

| MODEL: | MODEL YEAR: | VIN: |
|---|---|---|
| Defender (LE) | 2020 | 000584-008252 |

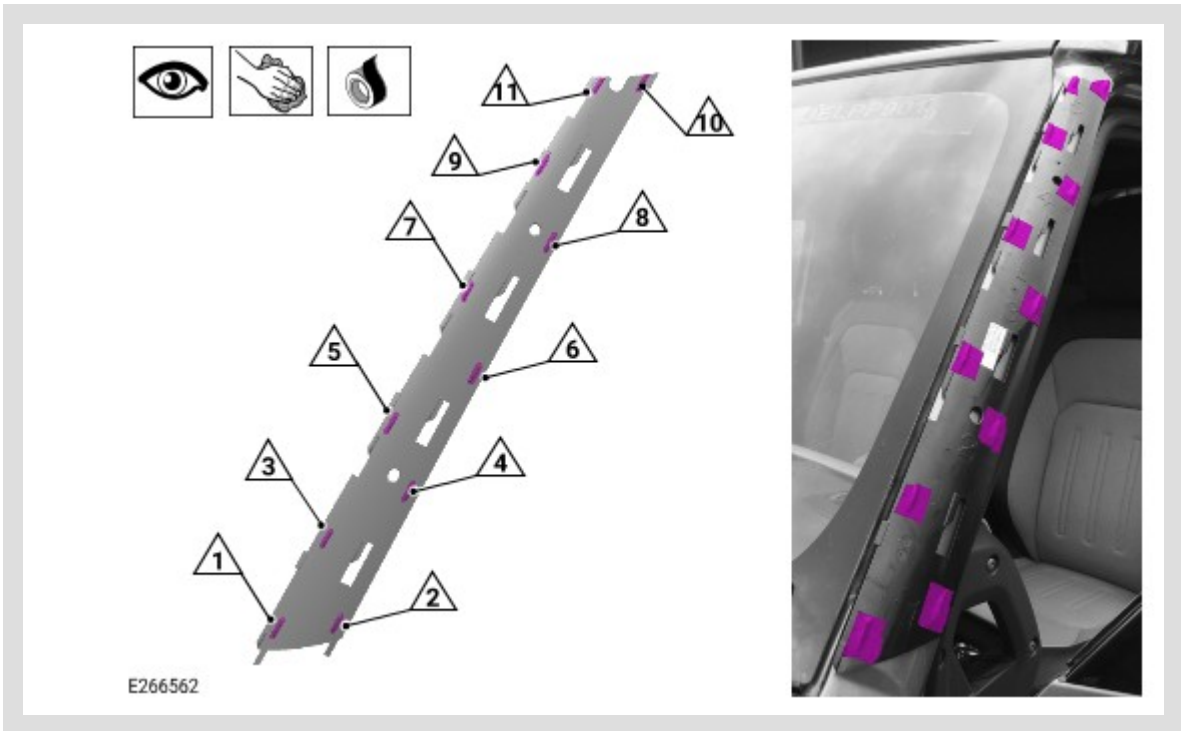
4.

Locate the 11 windshield molding retaining ribs as shown highlighted.

- Clean the area around each windshield molding retaining rib.
- Apply felt tape to cover each of the 11 windshield molding retaining ribs as shown.

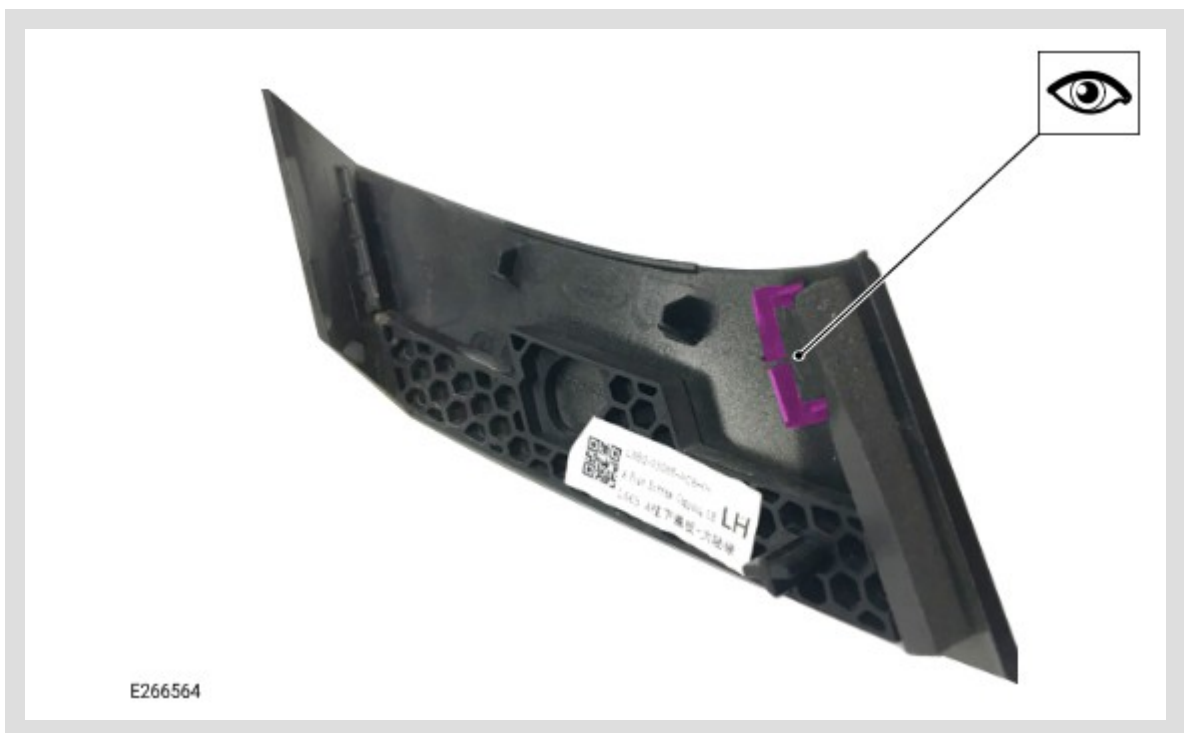
Inspect the retaining clip on the left windshield molding bolt cover.

- If the retaining clip **is** broken (as shown highlighted), **install a new left windshield molding bolt cover during the next step.**
- If the retaining clip **is not** broken, **install the original left windshield molding bolt cover during the next step.**
