JLRTB02012NAS3  
**TECHNICAL BULLETIN**  
14 AUG 2020

'Gearbox Fault Detected' Displayed On The Instrument Panel Cluster (IPC)

MODEL:	MODEL YEAR:	VIN:	ASSEMBLY PLANT:
I-PACE (X590)	2019-2020	F60094-F80069	Graz (Austria)

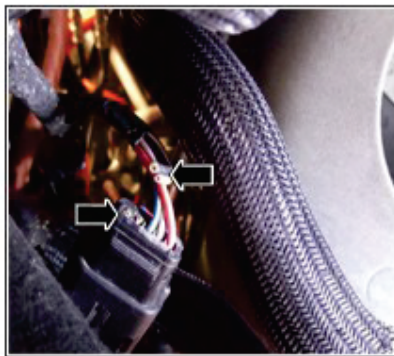
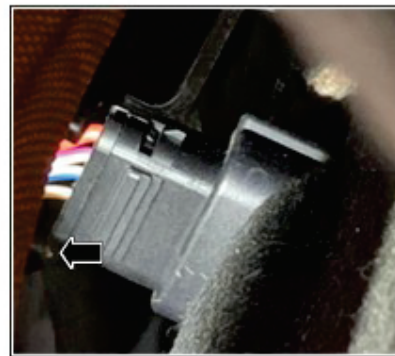
E256857

No retention to the front Electric Drive Unit (EDU) causing strain on the wiring going to the EDU parking lock actuator connector (C1YE113A).

- ■ If the EDU parking lock actuator connector (C1YE113A) wiring is found to be damaged as per the illustration, **continue to step 2.**
- ■ If no related repairs were identified **and** the customer concern is still present, **continue to step 2.**
- ■ If any related repairs were identified **and** have been rectified **and** the customer concern is still present, **continue to step 2.**
- ■ If any related repairs were identified **and** have been rectified **but** the customer concern is **not** present, **do not continue with this technical bulletin.**

2. Remove the front compartment wiring harness (see TOPIx Workshop Manual section 418-02: Wiring Harnesses - Removal and Installation - Front Compartment Wiring Harness).

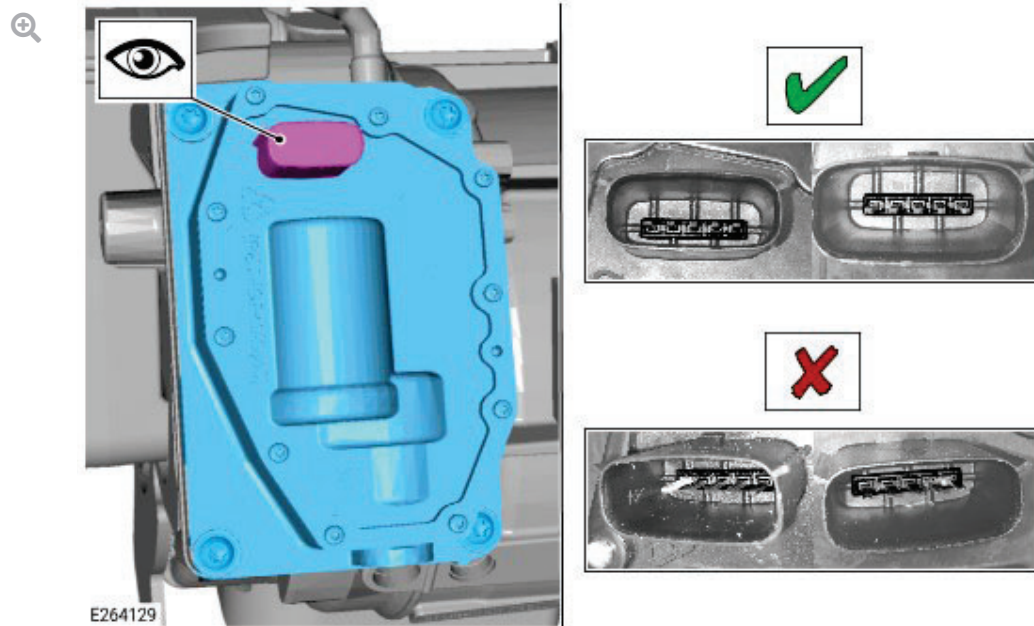
Inspect the electrical connector pins of the EDU parking lock actuator for signs of water ingress or corrosion.

- ■ If signs of water ingress or corrosion **are not** present on the electrical connector pins of the EDU parking lock actuator, as shown in the image with a **GREEN '✓'**, **continue to step 5.**
    - ■ If signs of water ingress or corrosion **are** present on the electrical connector pins of the EDU parking lock actuator, as shown in the images with a **RED 'X'**, **continue to step 4.**
4. Renew the EDU parking lock actuator (see TOPIx Workshop Manual section 601-01: Electrical Drive Unit - Removal and Installation - Electric Drive Unit Parking Lock Actuator).
