N472NAS2

# TECHNICAL BULLETIN

Service Action: Windshield Molding Tapping Noise

MODEL:	MODEL YEAR:	VIN:
Defender (LE)	2020	000584-008252

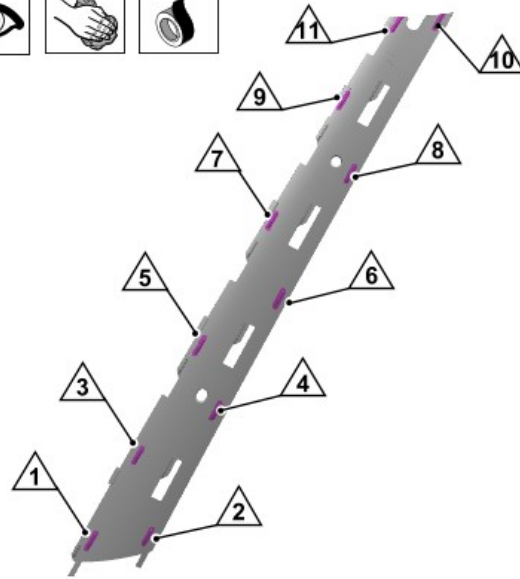
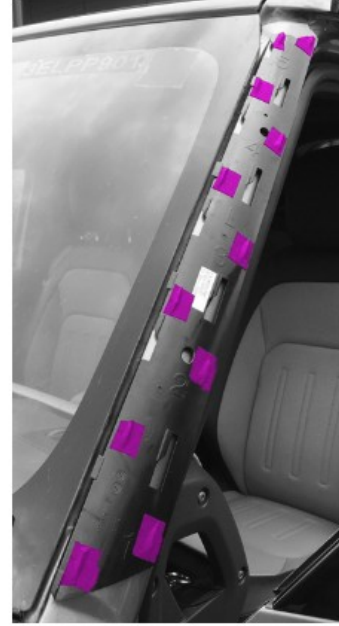
E266562

Locate the 11 windshield molding retaining ribs as shown highlighted.

- Clean the area around each windshield molding retaining rib.
- Apply felt tape to cover each of the 11 windshield molding retaining ribs as shown.

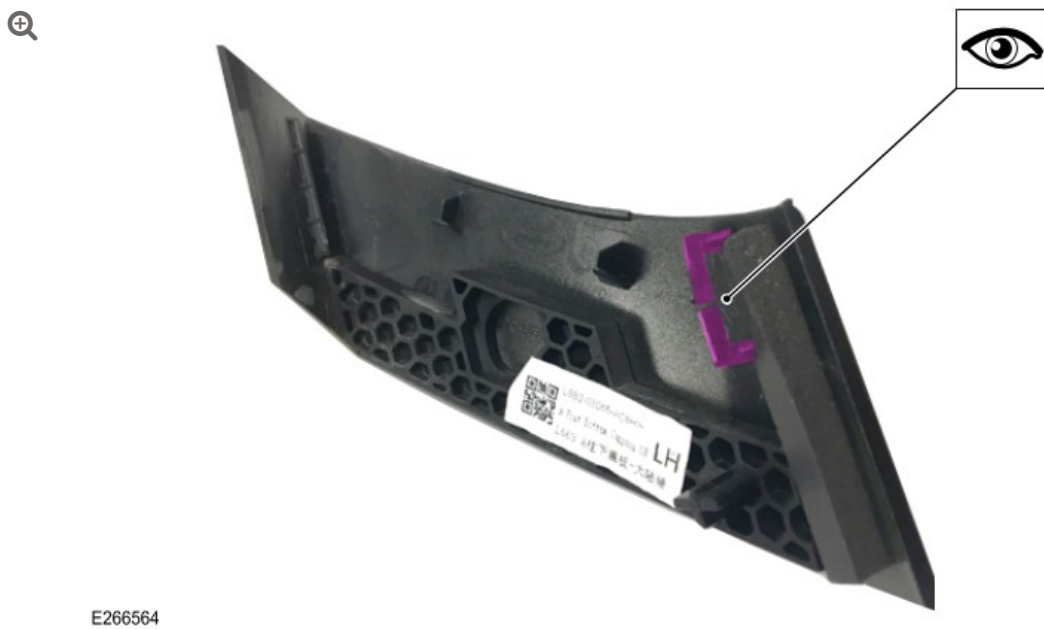
Inspect the retaining clip on the left windshield molding bolt cover.

- If the retaining clip **is** broken (as shown highlighted), **install a new left windshield molding bolt cover during the next step.**
- If the retaining clip **is not** broken, **install the original left windshield molding bolt cover during the next step.**
