SERVICE BULLETIN

BT20-012 ITB20-020 August 13, 2020

RATTLE FROM HEAT SHIELD

APPLIED VEHICLES: 2018-2020 QX80 (Z62)

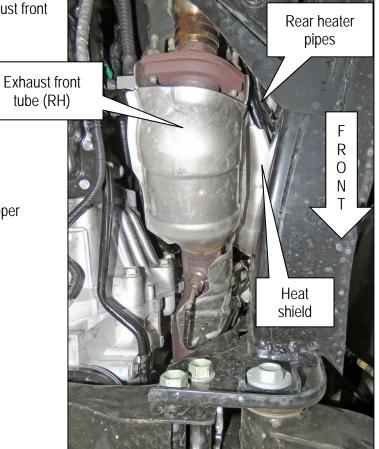
Figure 1

1. Locate the heat shield above the exhaust front tube (RH).

Locate the rear heater pipes on the upper **inboard** side of the frame.
