Title: Base Line 1020 update

Applicability: MY20 Revero GT

CC-20-00-02

Type: Baseline Release

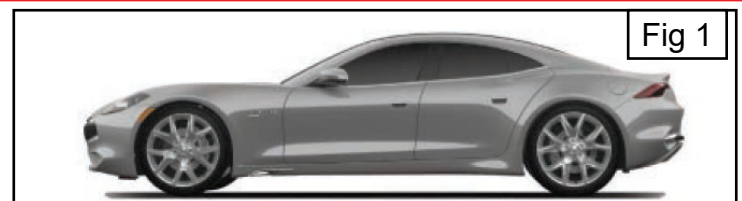
Keep the hood closed when doing a Baseline update for all Revero GT (Fig 1).

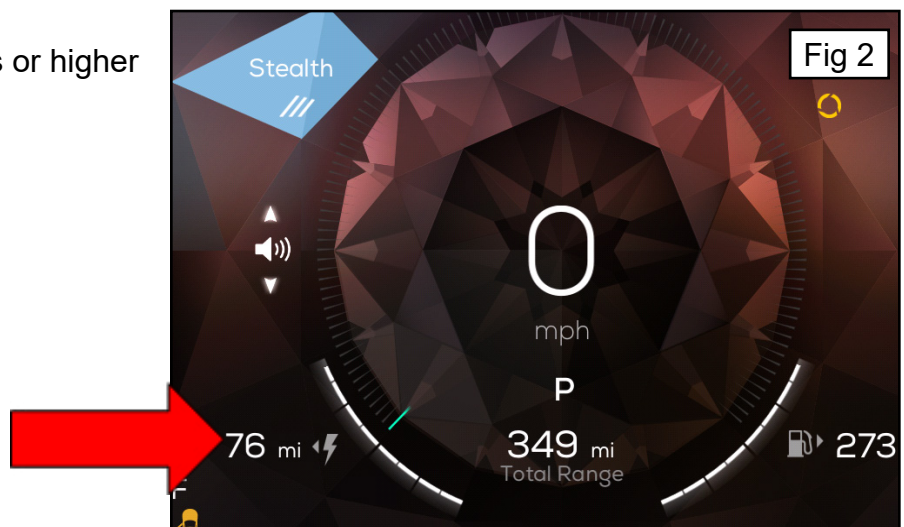
Ensure the electric range is at 25 miles or higher in the displayed range gauge (Fig 2).

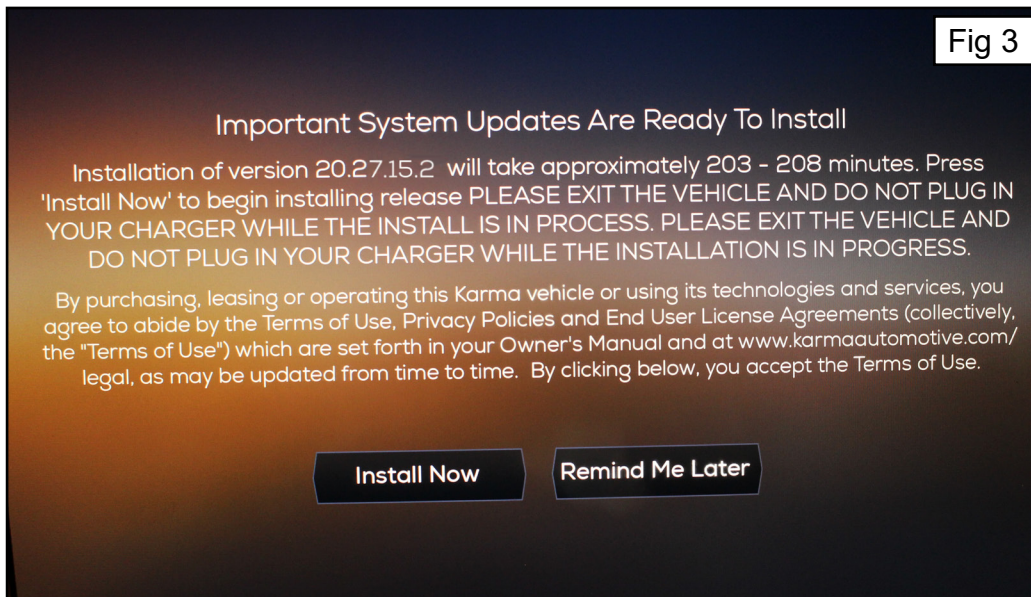
Fig 3

Accept the prompt to perform the OTA, install, do not allow the vehicle to “sleep”. Leave a door open, this is a easy way to prevent this (Fig. 3).

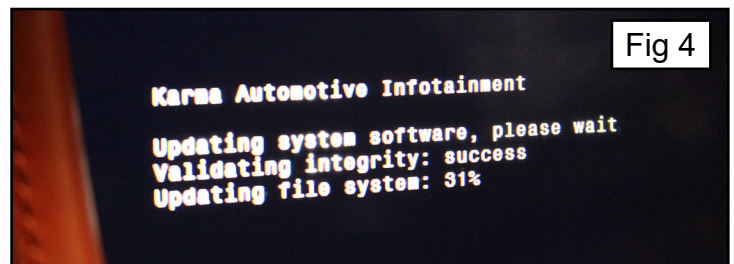
Fig 4

The Touch Panel screen will display the step it is involved in from downloading to install. the vehicle will reboot when complete (Fig 4).

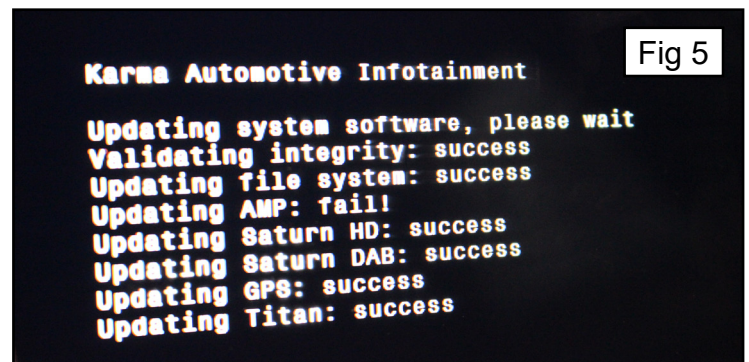
Fig 5

The amp will not be updated, observing a “fail” remark is normal (Fig 5).

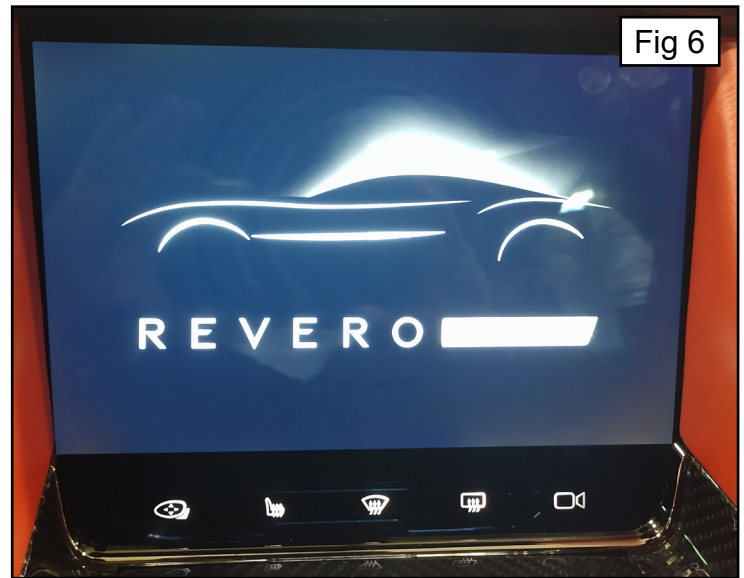
The TPI and Vehicle will reboot when complete, you should see the welcome screen (Fig 6).

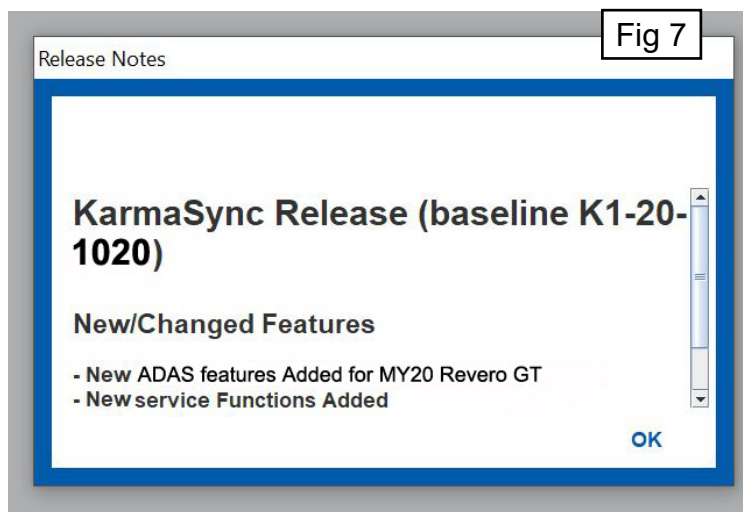
The Karma Sync should be updated to the latest deliverable, this message will be displayed when the initial session is launched (Fig 7).

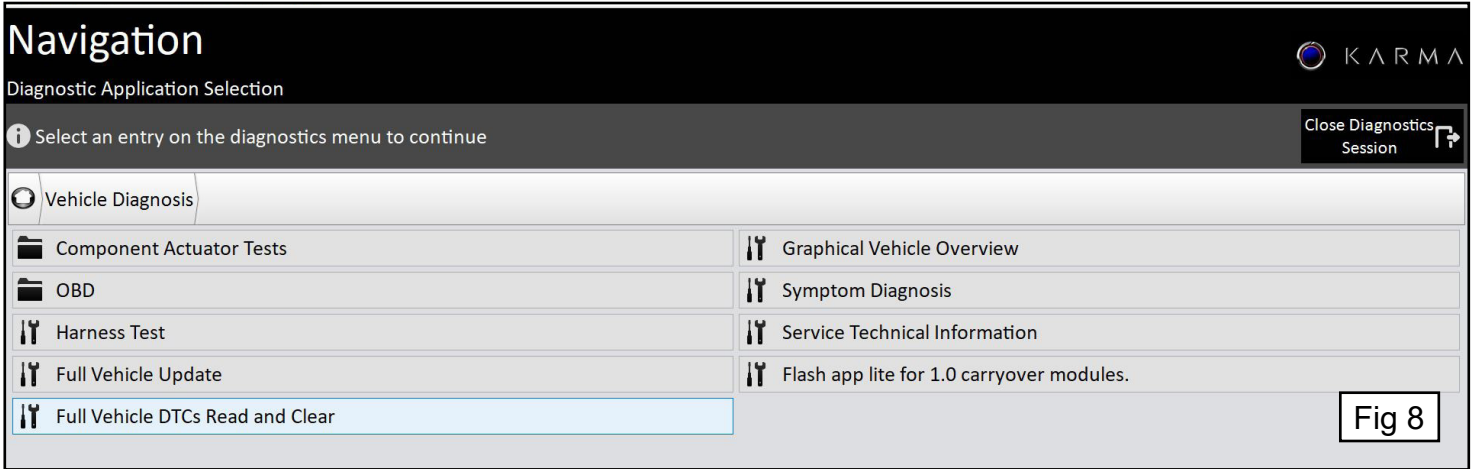
Begin a diagnostic session, and clear any DTC's (Fig 8).

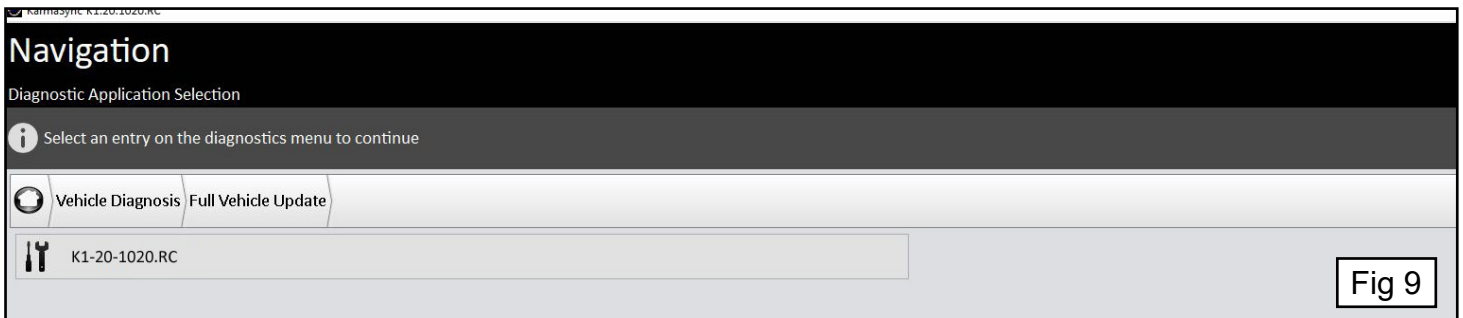
Enter full vehicle update and select K1-20-1020 (Fig 9)

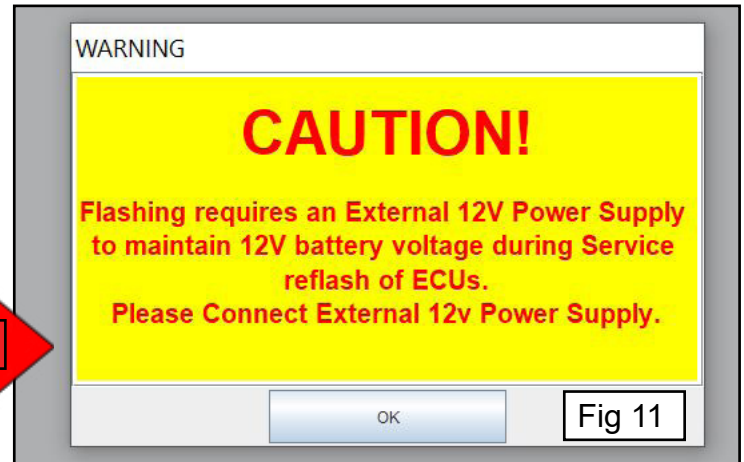
ALERT: This is a MY18 and MY19 Revero Warning only, disregard when updating a MY20 Revero GT (Fig 11).

Disregard press "OK"
