# SERVICE BULLETIN

Classification: EL20-019	Reference: NTB20-061	Date: August 31, 2020
-----------------------------	-------------------------	--------------------------

## TRAFFIC SIGN RECOGNITION OR LANE DEPARTURE WARNING MALFUNCTION DISPLAYED AND MIL ON WITH DTC C2503-54 AND/OR C1F6B-54 STORED

**APPLIED VEHICLES:** 2020 Sentra (B18)  
**APPLIED DATE:** Built before May 29, 2020

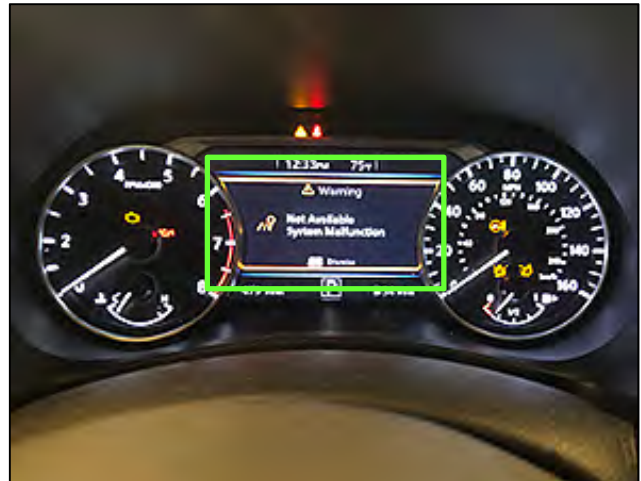
Figure 1

The customer states that one of the following warnings is displayed on the vehicle information display along with the AEB Warning Light:

- Traffic Sign Recognition Malfunction Displayed
- Lane Departure Warning Malfunction Displayed

- The MIL is ON with DTC C2503-54 (CAMERA AIMING INCOMP) and/or C1F6B-54 (CAMERA UNIT MALF) stored.

- If the vehicle was built on or before 1/31/2020, remove material from the lane camera and then reprogram the lane camera control unit.
- If the vehicle was built after 1/31/2020 but before 5/29/2020, skip to step 6 and reprogram only the lane camera control unit.

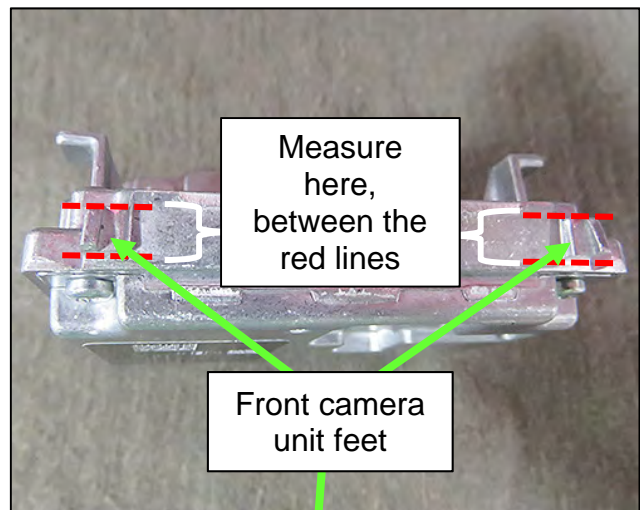
Figure 2

2. Measure the feet of the front camera unit with an appropriate tool and write the measurements on the repair order.
  - This will provide a starting measurement to compare to as material is removed.
