### PIT5759B Service Safety Restraints System With DTC B14DC SYM 1B and/or 13

Product Investigation Review Required

Brand:	Model:	Model Years:	VIN:		Engine:	Transmissions:
			from	to		
Chevrolet	Tahoe	2021	All	All	All	All
GMC	Yukon	2021	All	All	All	All

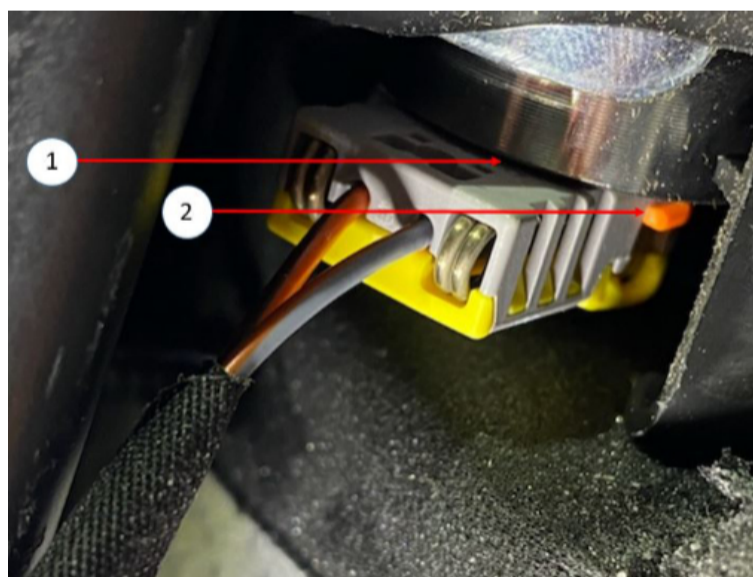
- It has been found that the F106DA Driver's front seat inboard air bag connector could be the cause of the high resistance. Inspect the F106DA Driver's front seat inboard air bag connector (shown below) to make sure it is fully seated tightly up against the airbag (1). Also, make sure the orange CPA is fully seated (2).

Note: The driver's seat does NOT need to be removed to complete this PI. Disengage the front seat back cover lower J-channel retainers and unzip the seat back cover zippers.
