Bulletin No.: PIT5763
Published date: 08/10/2020

Preliminary Information

PIT5763 Spots / Bug Or Insect Residue / Grease Substance / On Paint Surface

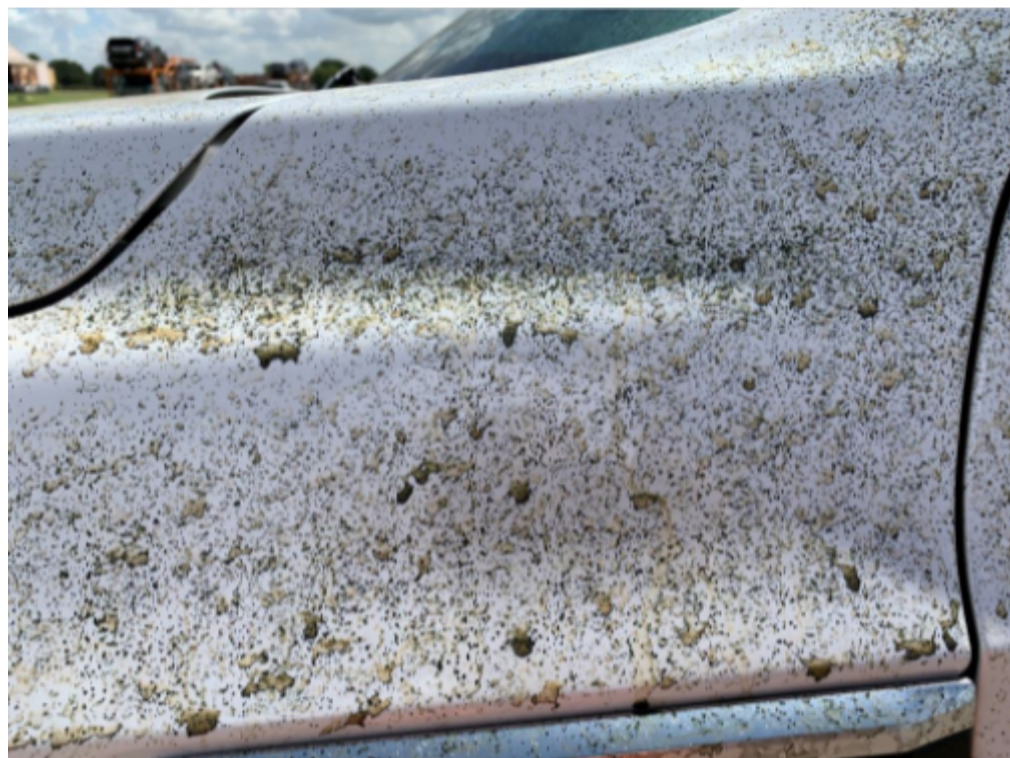
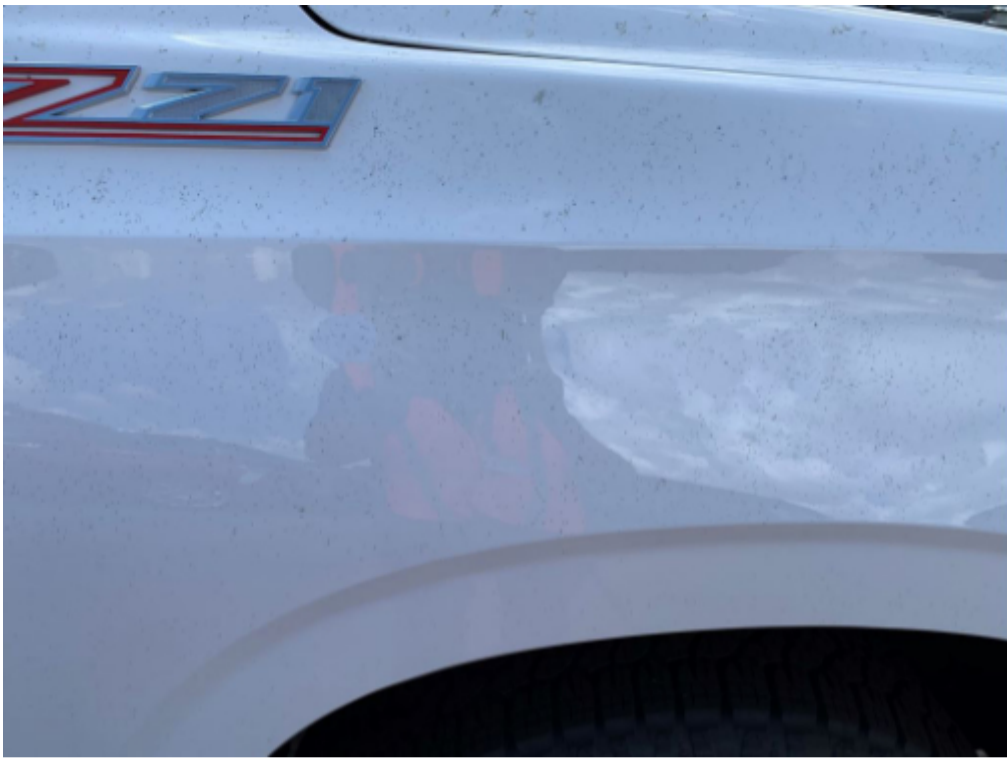
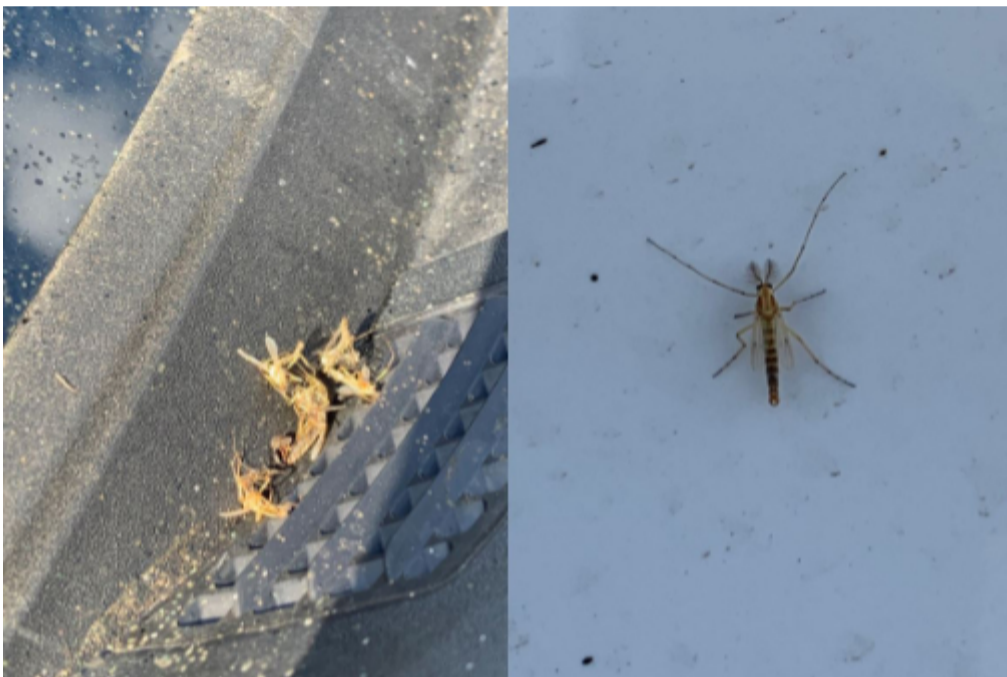
Involved Region or Country	North America
Condition	Some dealerships may comment that when they received a new vehicle from the transporter, there is some type of bug/insect residue, grease substance and/or spots on the paint surface, as shown below.
Cause	This substance on the paint may be caused by bugs/insects when the vehicle was parked at a storage lot before transportation.

Since the severity of the condition can vary due to the quantity of matter on the vehicle, proper diagnosis of the contamination is critical to the success of the repairs.

1. Thoroughly wash and dry the vehicle.
2. Clean the vehicle using a bug remover. After applying the bug remover per the manufacturer's instructions, allow it to soak for 3 minutes and then wash the vehicle in a brushless car wash system or using a hand held pressure washer. Suggested bug removal products are: 3D Bug Remover, Nanoskin Happy Bug, Wizards Bug & Tar Remover and Armour All Tar and Bug remover or equivalent.
NOTE: Avoid direct sunlight while performing bug removal procedure.

3. Apply finesse-type polish with a foam pad and then inspect the paint under high intensity fluorescent lighting.
 - If damage has been repaired, remove any swirl marks with a dual action orbital polisher and foam pad. Refer to "Clearcoat Repair Specifications - 3M Products".

- If some damage remains, continue with the following next steps for wet sanding and finesse polishing.
4. Select a small contaminated test area.
5. Measure film thickness prior to the sanding and polishing, see NOTE below. Refer to Paint Gauges

NOTE: The clearcoat on the vehicle is typically 0.059-0.078 mm (1.5-2 mils [0.0015-0.0020 in]) thick. The clearcoat contains ultraviolet screeners. Removing more than 0.5 mils (0.019 in) of the clearcoat may result in early paint failure.

6. Wet sand and finesse polish the contaminated test area. Refer to "Clearcoat Repair Specifications - 3M Products".

- During the polishing procedure, if you suspect or observe that etching has penetrated into the basecoat, too much clearcoat has been removed during sanding, or base color is transferred to the polishing pad during polishing, then the affected areas will require refinishing. Refer to Basecoat/Clearcoat Paint Systems.

- If damage has been repaired, remove any swirl marks with a dual action orbital polisher and foam pad. Refer to Clearcoat Repair Specifications - 3M Products.
