# Preliminary Information

## PIT5666A Squeak/Creak/Squawk/Itch Type Noise Heard From The I/P or Center Console Area

Brand:	Model:	Model Years:	VIN:		Engine:	Transmissions:
			from	to		
Chevrolet	Silverado 1500 (New Model)	2019	SOP	EOP	All	All
Chevrolet	Silverado 1500)	2020	SOP	5/1/2020	All	All
GMC	Sierra 1500 (New Model)	2019	SOP	EOP	All	All
GMC	Sierra 1500	2020	SOP	5/1/2020	All	All

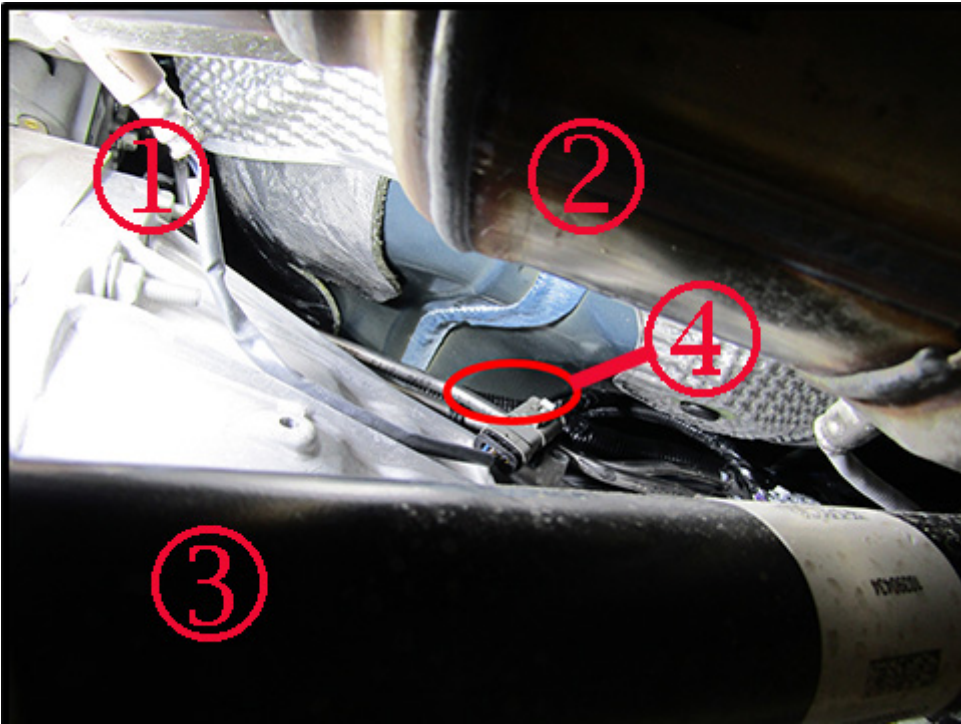
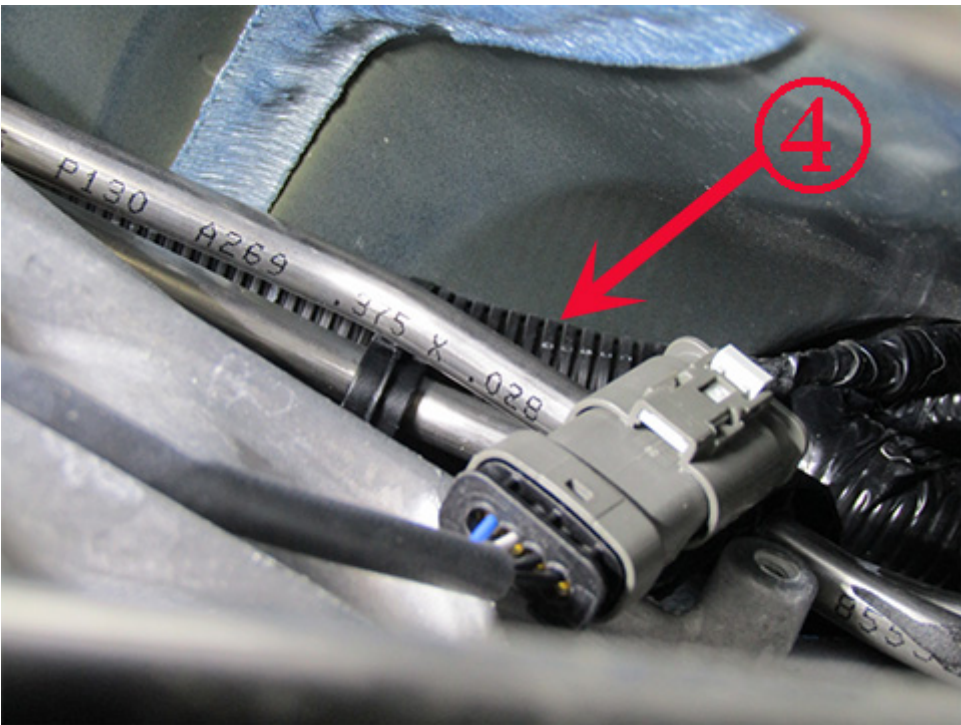
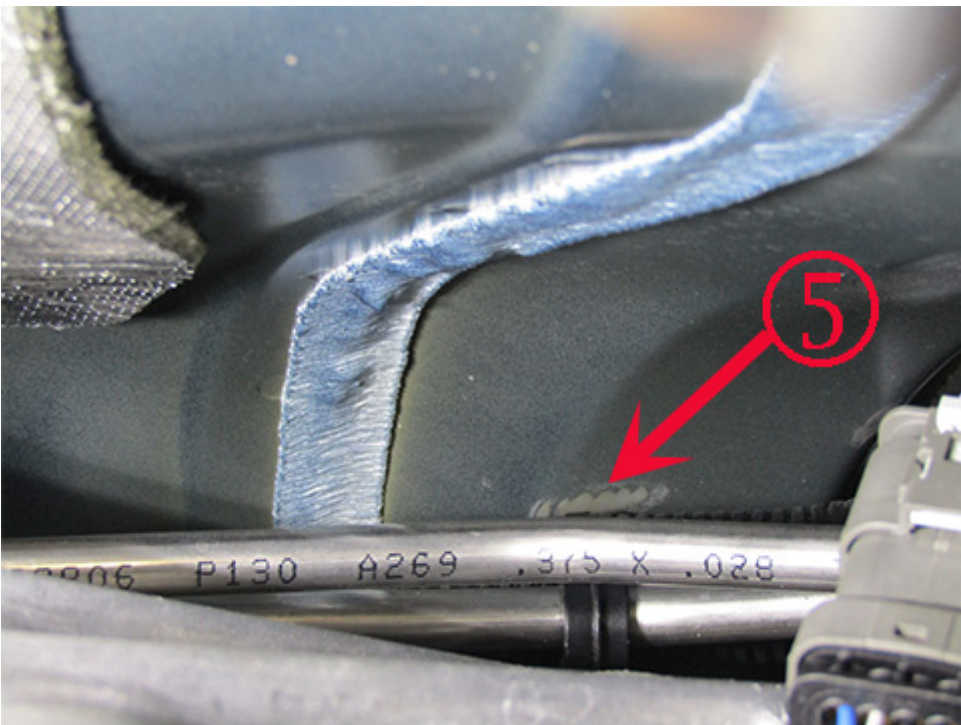
Involved Region or Country	North America
Condition	<p>Some customers may comment of a squeak, creak, itch, or rubber type noise heard from the IP dash or center console area. The noise may be duplicated by the following:</p> <ul style="list-style-type: none"><li>- Driving over bumps (noise may go away if coasting or if transmission is shifted into "N")</li><li>- During acceleration</li><li>- Brake torqueing in drive (noise may not occur when brake torqueing in reverse)</li></ul>
Cause	<p>This noise could be caused by the engine harness rubbing on the floor pan above the transmission (item numbers 4 and 5), as shown below. The photos below were taken from under the vehicle looking up along the driver's side of the transmission bell housing.</p> <p>Callout 1 - Bank 1 Sensor 1 O2 sensor Callout 2 - Bank 1 Catalytic Converter Callout 3 - Front Driveshaft (on 4WD vehicles) Callout 4 - Engine Harness rubbing on floor pan Callout 5 - Engine Harness pushed aside to show the contact on the floor pan</p>

Reposition and secure the engine harness down beside the fuel/evap lines so it no longer contacts the floor pan, as shown below. The rear transmission crossmember may need to be removed so that the transmission can be slightly lowered to gain access to the area. To allow enough slack in the engine harness to reposition it down

beside the fuel/evap lines, it needs to be moved/repositioned forward in the clips at the rear of the harness above the rear of the transmission/transfer case. First, release the rear harness clips and move/reposition the harness forward in the clips, then lock the clips closed. This will create enough slack in the harness to reposition and secure the harness down beside the fuel/evap lines, as shown below.
