PIT5765 Rattle Flutter Flapping Wind Noise Coming From The Left Or Right Front Of The Vehicle

Brand:	Model:	Model Years:	VIN:		Engine:	Transmissions:
			from	to		
Chevrolet	Tahoe	2021	All	All	All	All
GMC	Yukon Models	2021	All	All	All	All

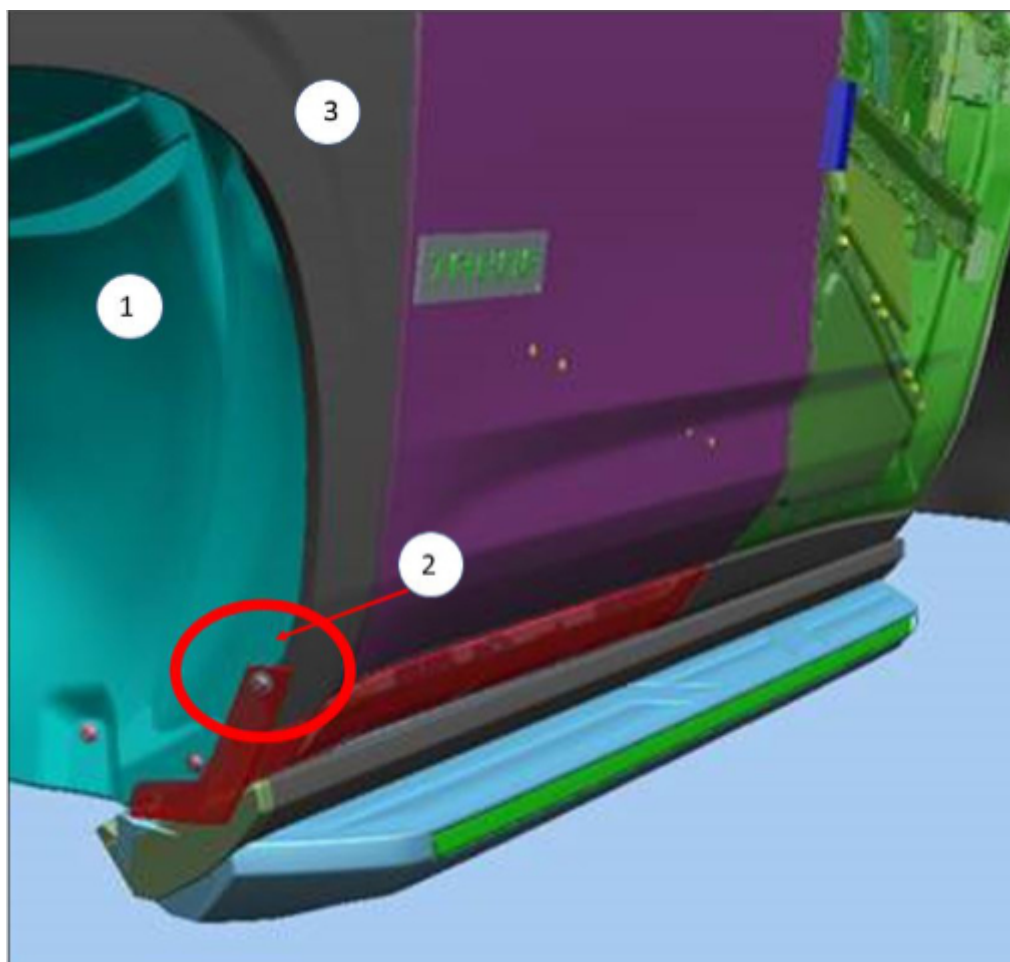
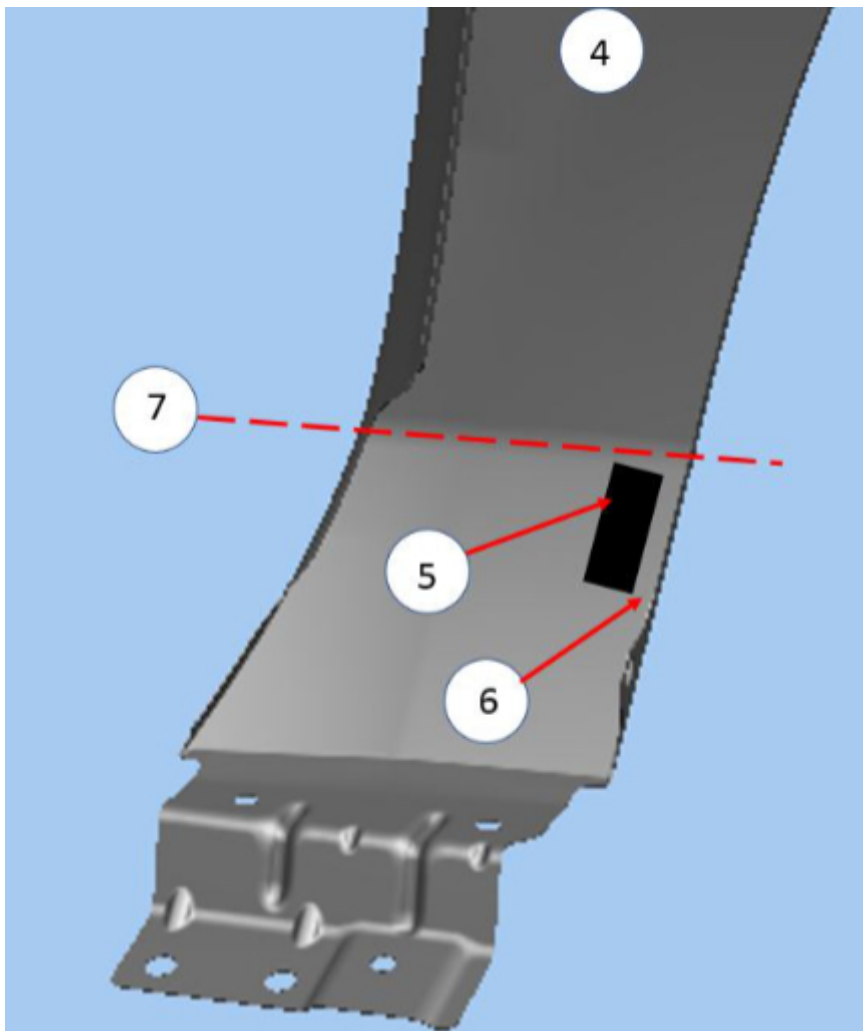
Involved Region or Country	North America
Condition	Some customers may comment on a rattle, flutter, flapping, and/or wind type noise from the front end. The noise could be heard from either the left, right or both sides of the vehicle and may occur at higher speeds. In some cases, the noise may sound like it is coming from the windshield area.
Cause	The cause of the noise could be either the left or right front inner wheel well liner having excessive movement in the area shown below (2).

- 1 - Driver's wheel well liner
- 2 - Area where the wheel well liner is loose and making noise
- 3 - Driver's front fender
- 4 - Inboard side of the driver's front fender
- 5 - Foam/Butyl tape to be installed
- 6 - 10 mm gap between foam/butyl tape and flange on the fender
- 7 - Fender feature/body line

To correct this concern apply a 1"x3"x1/4" thick piece of foam, or a couple layers of butyl tape to the inside of the fender as follows:

1. Partially remove the front wheel well liner to obtain access to the back/inboard side of the front fender (4).
2. If necessary, clean the back/inboard side of the fender to remove any dirt, mud, etc.
3. On the back/inboard side of the fender, start at the fender feature line (7) and 10mm from the fender flange (6), and place the 1"x3"x1/4" thick piece of foam or layers of butyl tape (5), as shown above.
Note: The foam/butyl needs to create a cross car interference with the fender liner return flange.
4. Reinstall the front wheel well liner. With the foam/butyl installed it may be necessary to use a trim pick or similar tool to pull the wheel house liner to the full forward position.
5. Once the wheel well liner is installed there should be no fore/aft movement when the wheel well liner is tapped or lightly pushed on.
