Preliminary Information

PIT5759C Service Safety Restraints System With DTC B14DC SYM 1B and/or 13

Brand:	Model:	Model Years:	VIN:		Engine	Transmissions:
			from	to	Engine:	Transmissions.
Chevrolet	Tahoe	2021	All	All	All	All
GMC	Yukon	2021	All	All	All	All

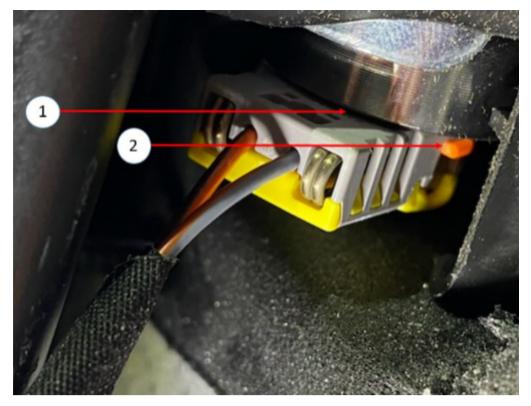
Involved Region or Country	North America
Additional Options (RPO)	AYQ
Condition	Some customers may comment on a "Service Safety Restraints System" message displayed on the DIC. When checking for DTCs, a B14DC symptom 1B and/or 13 will be set in the K36 Restraints Control Module. This DTC is for an open or high resistance in the F106DA Driver's front seat inboard airbag deployment loop.
Cause	Under investigation.

- It has been found that the F106DA Driver's front seat inboard air bag connector could be the cause of the high resistance. Inspect the F106DA Driver's front seat inboard air bag connector (shown below) to make sure it is fully seated tightly up against the airbag (1). Also, make sure the orange CPA if fully seated (2).

Note: The driver's seat does NOT need to be removed to complete this PI. Disengage the front seat back cover lower J-channel retainers and unzip the seat back cover zippers.
