PIP5498M SES Lamp P050D P0300 Setting On A Cold Start And/Or a Run Rough Warm with No codes

Models

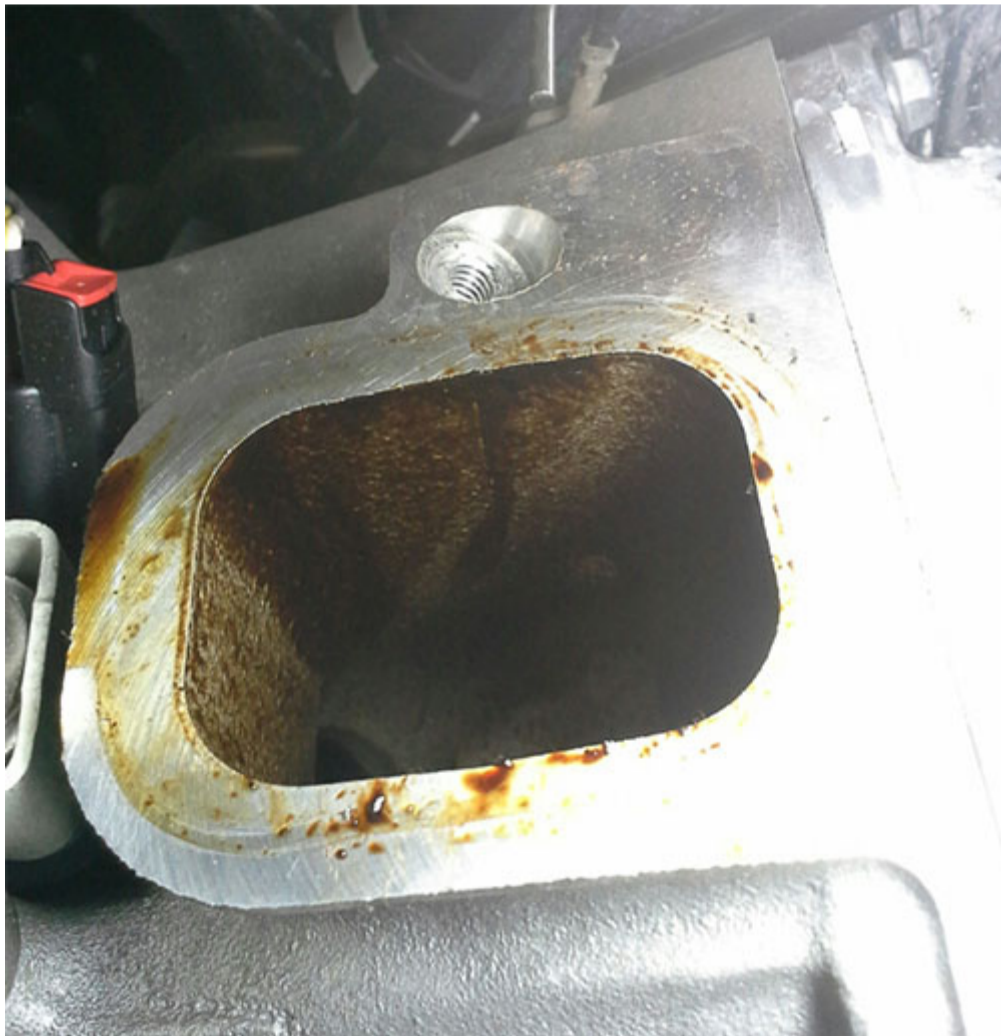
If the head casting line is the concern the intake port will be wet with a coolant oil mix.

This could be the cause of a running rough warm concern with or without codes.

The location of where the coolant is running down in the port will also look washed down.

If this is found the cylinder head will need to be replaced.
