Preliminary Information

PIP5680B Excessive Oil Smoke From the Exhaust On Cold Start

Brand:	Model:	Model Years:	VIN:		Engine:	Transmissions:
			from	to		
Cadillac	ATS	2016	All	All	3.6L LF4	All

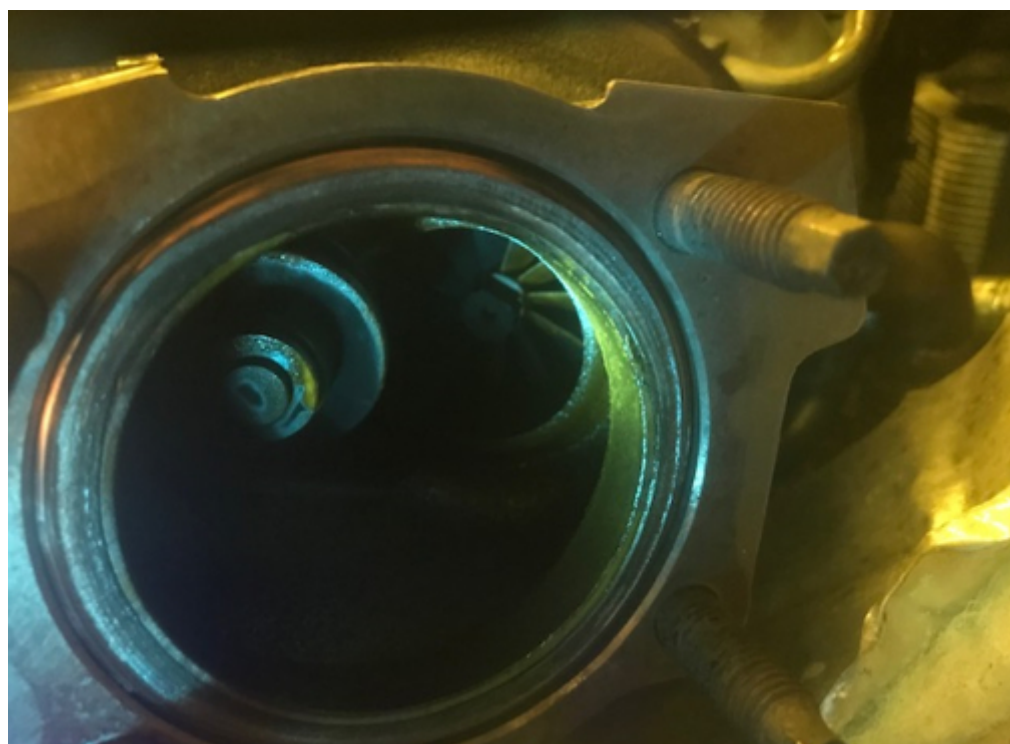
To check for this concern first inspect the outlet of the turbochargers for the presence of oil with dye in the system. (See below)

If oil is found at the outlet of the turbocharger on either side, then replace the turbocharger, drive to clean out the exhaust and then let sit to get cold and reevaluate.
