Preliminary Information

PIP5653J Squeak Chirp Noise From Front Axle In 2wd

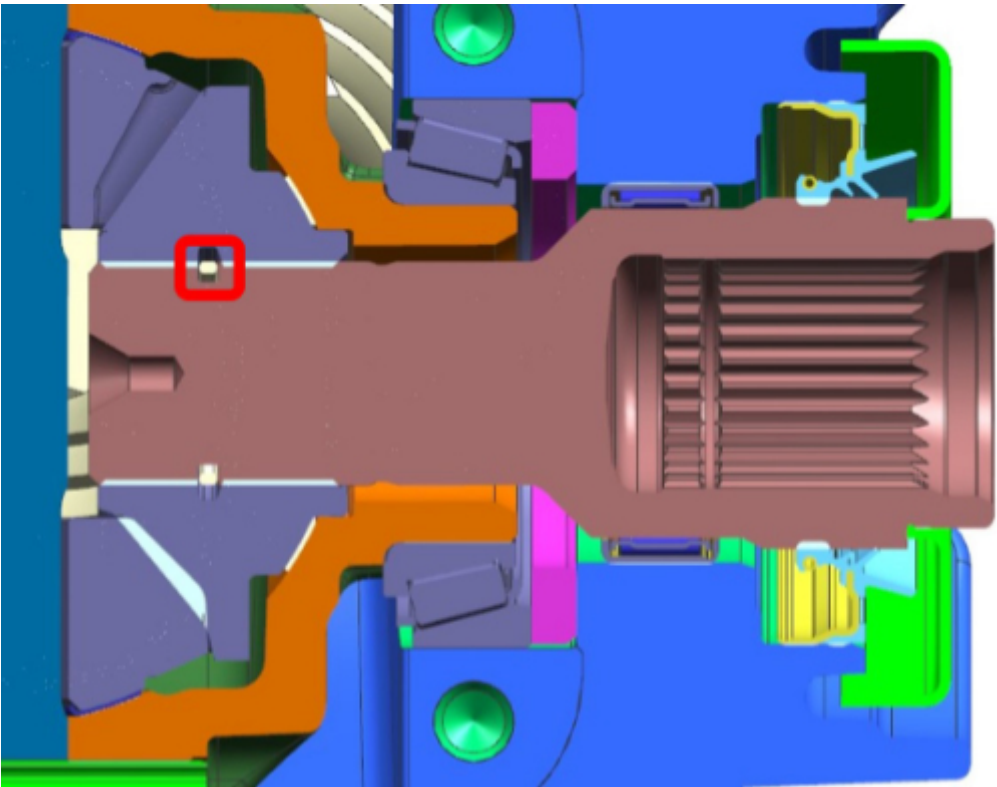
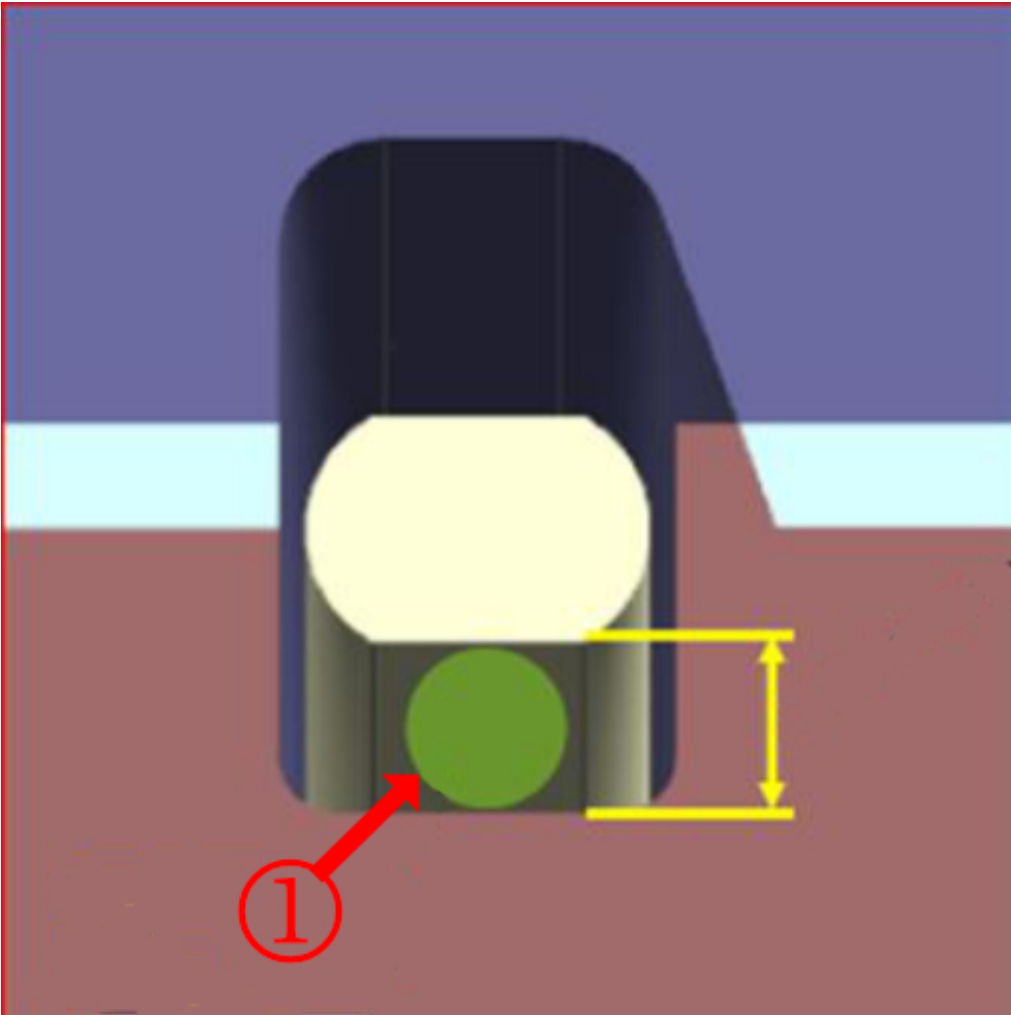
The condition seems to originate from contact between the left stub shaft and the cross pin along with the retainer ring fitting loose in the groove in the front differential assembly.

**Once all the parts are on hand to perform this repair and the stub shaft has been removed from the differential assembly. Slide o-ring (WPC855) onto stub shaft and into the groove, place the retainer ring into the groove ensuring that the o-ring stays under the snap ring as pictured below. Follow published repair procedures in Service information to reassemble the vehicle. The seal may not need replacement if it is not damaged during removal of the stub shaft.**
