MAS002224

MCL 20-04

Levante M161 Sunroof Anomalies

Section: Body/Sunroof

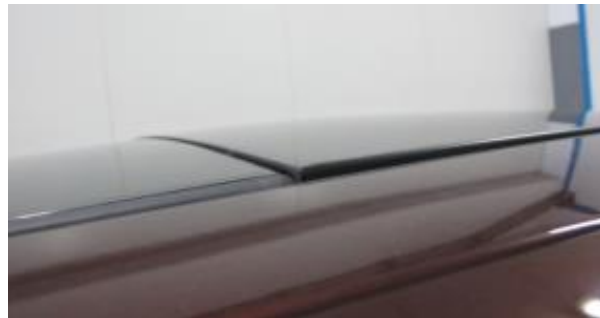
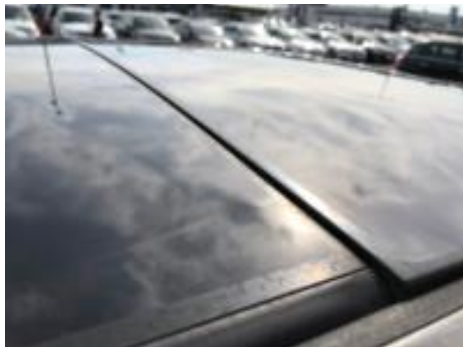
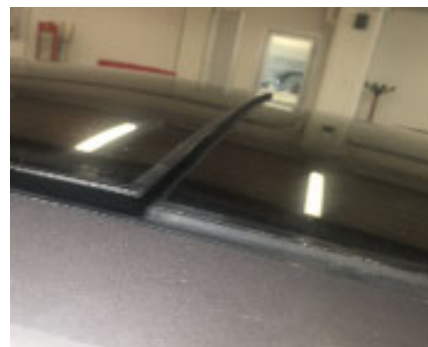
- Water infiltration from central area of sunroof
- Excessive Wind noise from the sunroof
- Complaints about excessive gap between the front and rear sunroof glass panels

Visual appearance of the sunroof as shown in the pictures below:

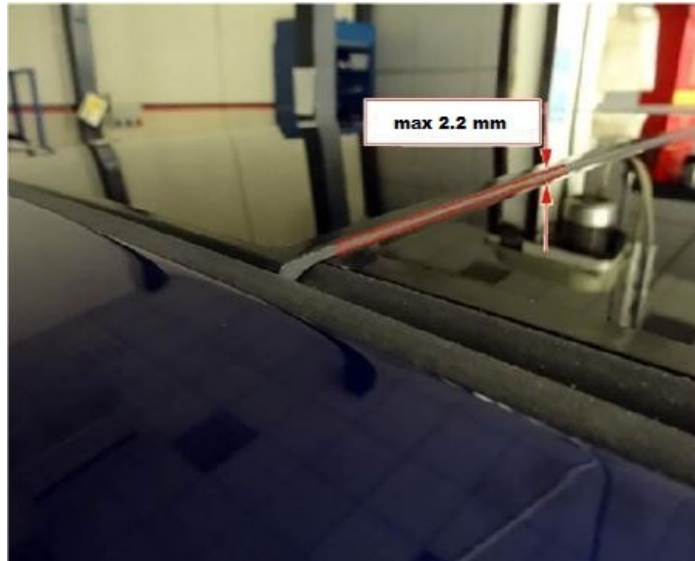
- A) Measure the gap between front and rear panels then follow the Workshop Manual procedures for the Sunroof settings (procedure: 09.71.012 - 40 SUNROOF GLASS - Adjustments).

- B) If the gap is 2.2 mm or less, (the project specification), it cannot be considered an issue mechanically or aesthetically. In addition, it will not be the cause of water infiltration or wind noise. Investigate other areas of the roof if there is a complaint of water/wind infiltration

Report the value measured and a clear image showing the measurement.

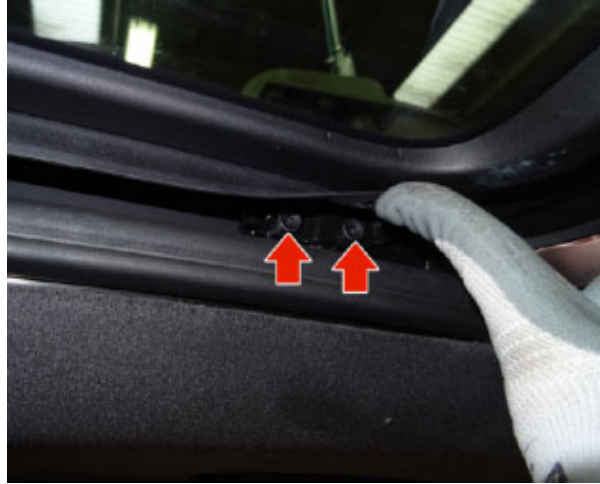
6. Check that the screws that keep the front glass fixed to the mechanism are correctly installed (correct tightening torque is 7 Nm +/- 10%). Refer to the workshop manual procedure for the number of screws to be checked.

Please report the results of the inspection and the torque values for all of the screws.

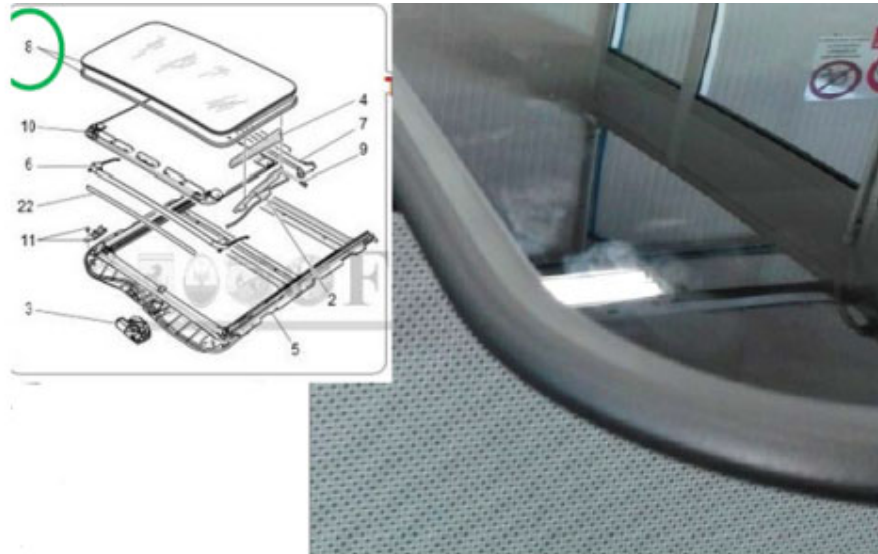
- 1.1 If water is leaking inside the vehicle (ie, dripping from the front dome light over the central console) the first check to perform is to ensure the sunroof gasket (see picture below) is installed correctly and has no cuts, wrinkles, etc. and that it is air-tight (sealed) all around.

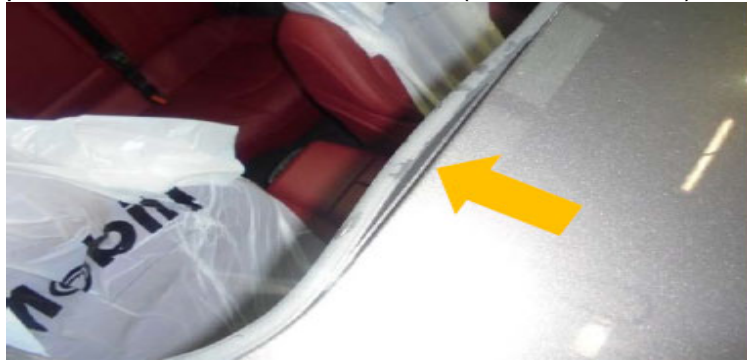
If the gasket is compromised in one or more sections (as shown below), it must be replaced.

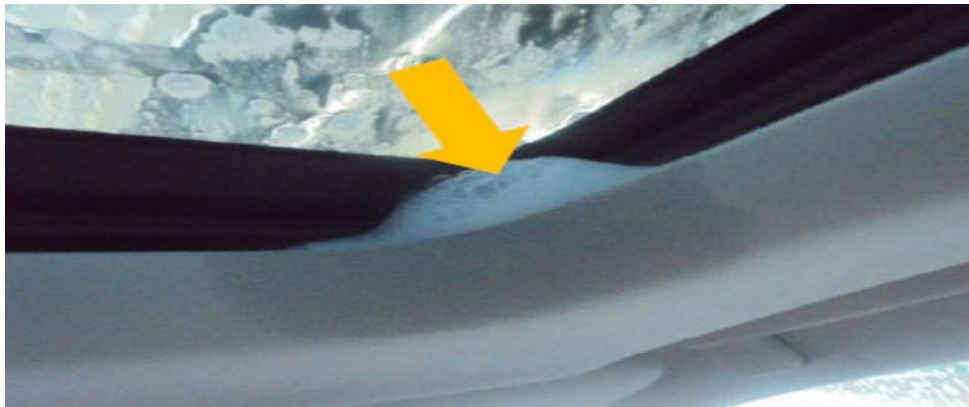
If the gasket looks ok, proceed with a functional test of spraying water over the sunroof. If the gasket is not adhering completely, water drops will appear along the inner perimeter of the sunroof (for ex. on a corner as shown below). In this case the gasket needs replacing.

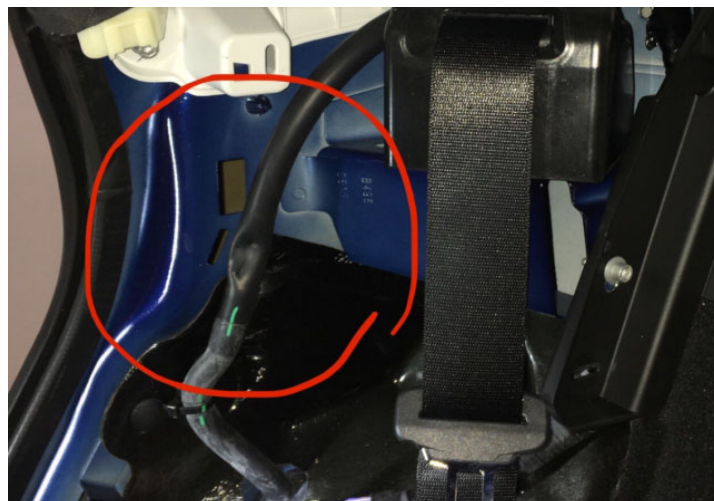
1.2 If the gasket proves to be functionally and aesthetically compliant, remove the covers from the A and C pillars for a closer inspection of the four sunroof drain pipes,. Look for any pinched, cut or clogged sections, as in the example below. Replace any damaged pipes.

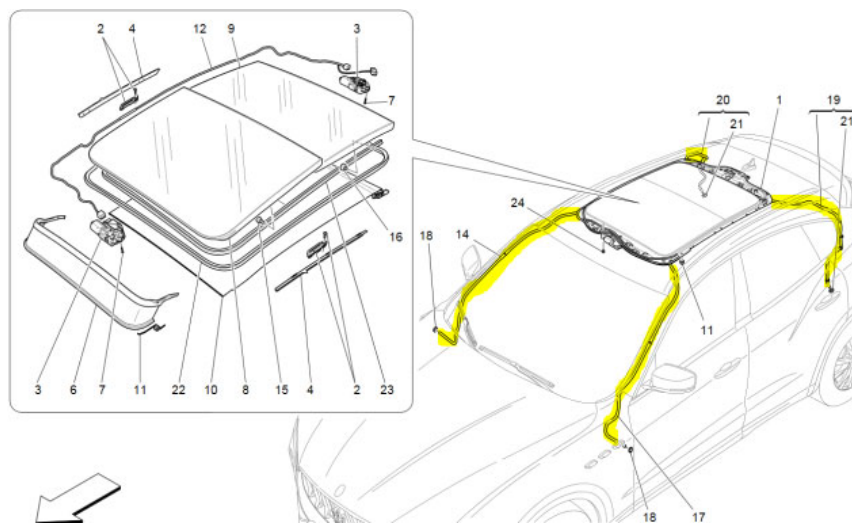
1.3 There are four junctions connecting the sunroof assembly to the car body. At each of these junctions, a path is used to let the water flow out of the vehicle through four drain pipes (two on the front, two on the rear sides of the vehicle) .

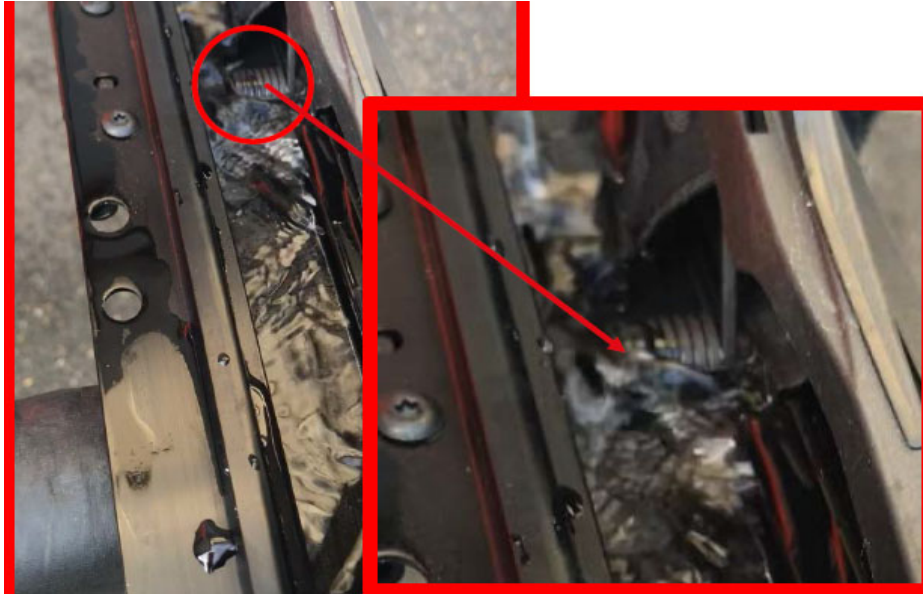
Make sure the pipes are not obstructed by dirt or debris and that water is flowing freely out of all four pipes. A 20/30 minute water-test is enough for this examination. If one or more pipes is obstructed or clogged, the water level will rise over the deflector spring (picture below) and leak inside to the cabin.
