# AfterSales Diagnostic sheet

**MAS002246**

**BOL 20-05**

## Vehicle vibration during acceleration

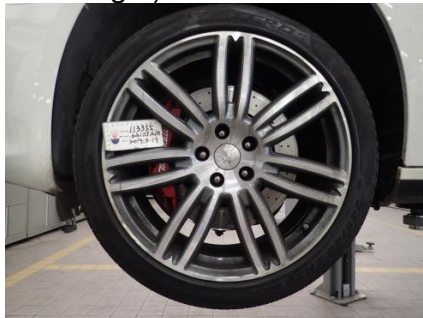
Figure 1: Sample picture of the sidewall of the tire. It is very important to clearly make the tires size visible.

- 1) Save a scan report of DTCs and Parameters for ECM, TCM and AWD modules.
- 2) Take pictures (as shown in Fig.1) of the sidewalls of all 4 tires.

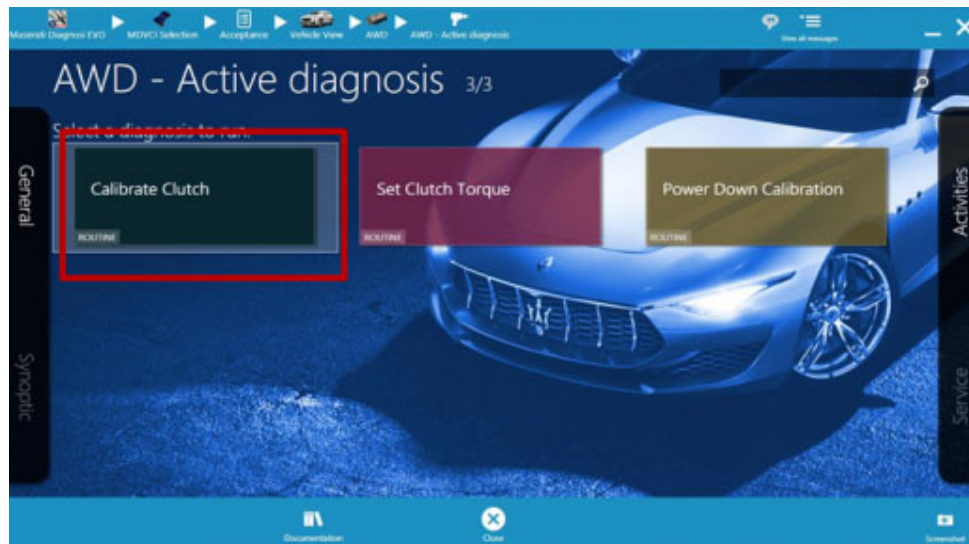
Figure 2: Active diagnosis of the AWD module.

- 3) Verify the level and the quality of the AWD Transfer Case oil by taking a sample of the oil from the Transfer Case.  
Specify whether abnormalities can be found, namely whether:
  - a. There is contamination of metal debris.
  - b. The oil color is normal.
  - c. The oil smell is normal or burnt.
- 4) Perform the Active Diagnosis Calibrate Clutch of the AWD (All-Wheel Drive) Module as shown in **Error! Reference source not found..**

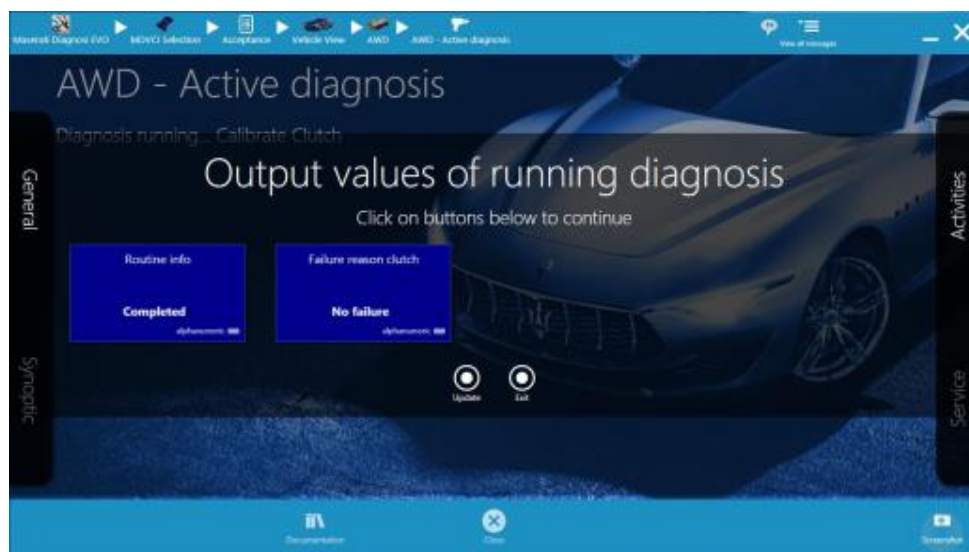
Figure 3: settings of the Active diagnosis *Calibrate Clutch*.

- 5) In the following screen, please select the settings below and shown in **Error! Reference source not found.:**

- d. Routine info: *Completed*
- e. Failure reason clutch: *No failure*

After that, please repeat the road test in order to attempt to replicate the Customer's complaint. Report whether the issue continues to exist or not.

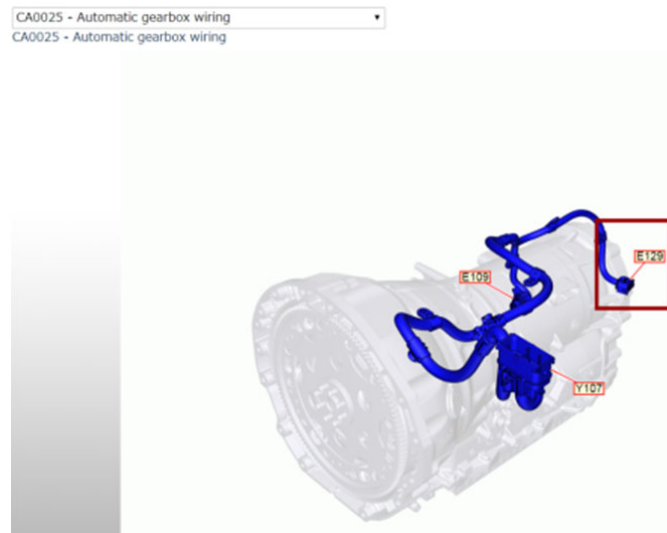
Figure 4: connector E129-B is the electrical connector of AWD (All-Wheel Drive) control module in case of Levante. TechDoc Version 209.

- 6) Disconnect the electrical connector for the AWD Module, as shown in Figure 4 (case of Levante).

Test drive the Vehicle again to check whether, in the same condition of the Customer's complaint, the issue has been resolved or not and report findings in the BOL report.

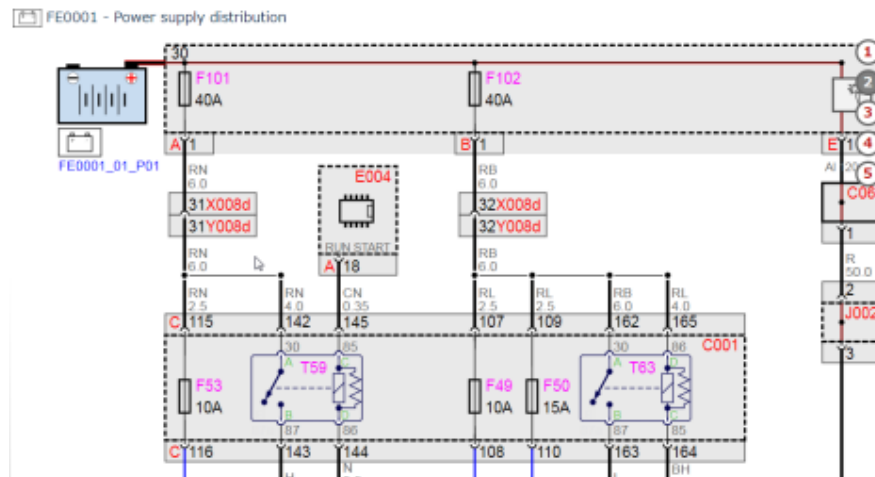
Figure 5: wiring diagram for the power supply fuse of the AWD (All-Wheel Drive) control module. TechDoc version 194.

As an alternative, the same result can be obtained by removing the Fuse F53 in the FDU (Front Distribution Unit) as per Wiring Diagram FE0001 – Power supply distribution, page 2. The wiring diagram is shown in Figure 1.

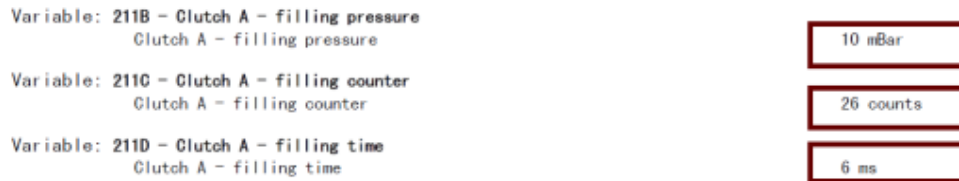
Figure 6: Clutch Filling Counters in the ENGINEERING PARAMETERS in the TCM module.

- 7) Perform the Active Diagnosis Reset Adaption Parameters of the TCM module.  
This Active Diagnosis resets the Clutch Filling Counters and the Clutch Filling Pressure in the TCM, as shown in the Group ENGINEERING PARAMETERS of TCM Base Diagnosis Parameters, as shown, for Clutch A, in Fig. 6.

After the Active Diagnosis Reset Adaption Parameters, the parameters listed in **Error! Reference source not found.** will reset to 0 mBar, 0 counts and 0 ms respectively.
