AfterSales Diagnostic Sheet

MAS002249
(BOL 20-07)

Diagnostic Guide for Electric Steering Rack Complaints (EPS)

Models: M157/M156/M161 from MY 18 and later

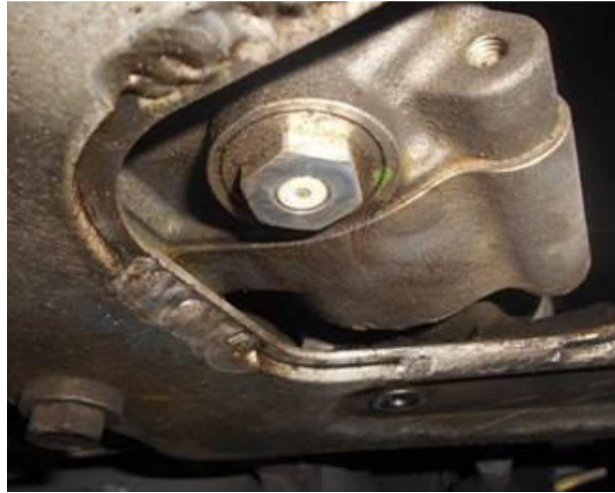
Figure 1: Drain valve

- 5) Check the status of the drain valve: is the white section level with the outside face of the nut (as Figure 1)? Attach a photo to the BOL. (In cases of water inside the housing, the white section will move inwards)

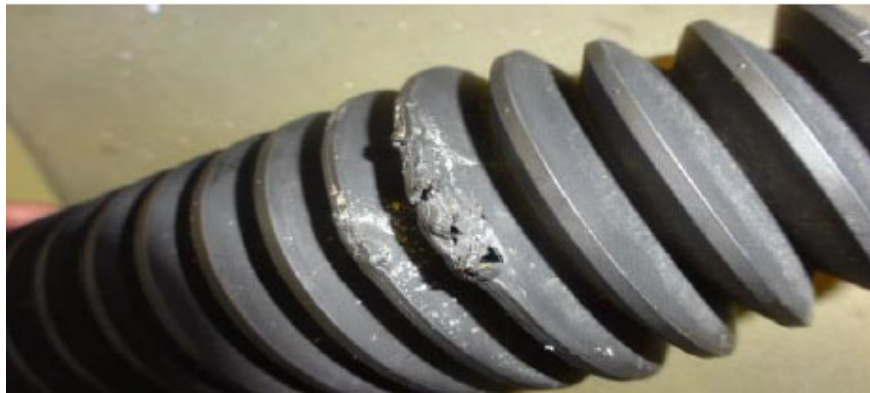
Figure 2: steering tensioners bellows

- 6) Check for the presence of cuts/damages on the steering rack bellows (figure 2) and attach photo's to the BOL.

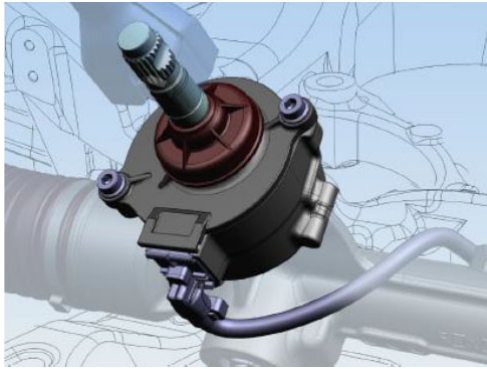
Figure 3: SWAS connection

- EPS Power Supply
- CAN network interface
- Wirings between ECU and SWAS (module of the Steering Wheel Angle Sensor, see figure 3)

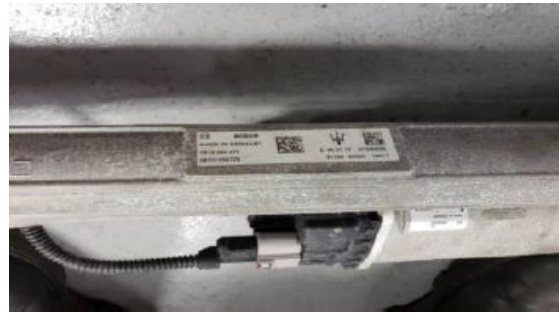
Figure 4: EPS connector

2) Are the following cables/connectors intact and correctly connected ? (do not unplug the connectors) follow wiring diagram FE0507 - Electric driving system.
