Technical Service Bulletin

SUBJECT:		No: TSB-20-14-002	
COOLANT LEAK AT HOSE CONNECTION		DATE: August 2020	
		MODEL: See Below	
CIRCULATE TO:	<input type="checkbox"/> GENERAL MANAGER	<input checked="" type="checkbox"/> PARTS MANAGER	<input checked="" type="checkbox"/> TECHNICIAN
<input checked="" type="checkbox"/> SERVICE ADVISOR	<input checked="" type="checkbox"/> SERVICE MANAGER	<input checked="" type="checkbox"/> WARRANTY PROCESSOR	<input type="checkbox"/> SALES MANAGER

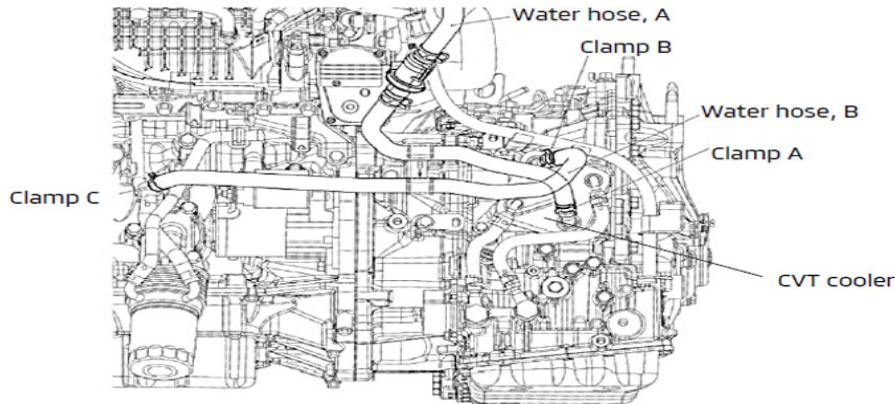
A customer may report a condition where the coolant temperature warning light illuminates and a coolant leak is found at the hose connection. Thermal effects may cause deterioration of the CVT water hose, due to the force at fastener. Eventually, the water tight sealing portion of the hose becomes weaker than the coolant pressure, allowing the coolant to leak.

Hose layout for reference using 4B40/GK0W as an example:

Replace the hose clamp with a countermeasure hose clamp and replace the water hose with a brand new water hose.
