Technical Journal

No steering assistance during workshop visit

REF NO: TJ 34507.2.0	ISSUING DEPARTMENT: Technical Service	CAR MARKET: United States and Canada	
PARTNER: 3 US 7510 Volvo Car USA		ISSUE DATE: 2020-04-21	STATUS DATE: 2020-08-07
FUNC GROUP: 6422	FUNC DESC: Steering gear, servo complete	Page 1 of 3

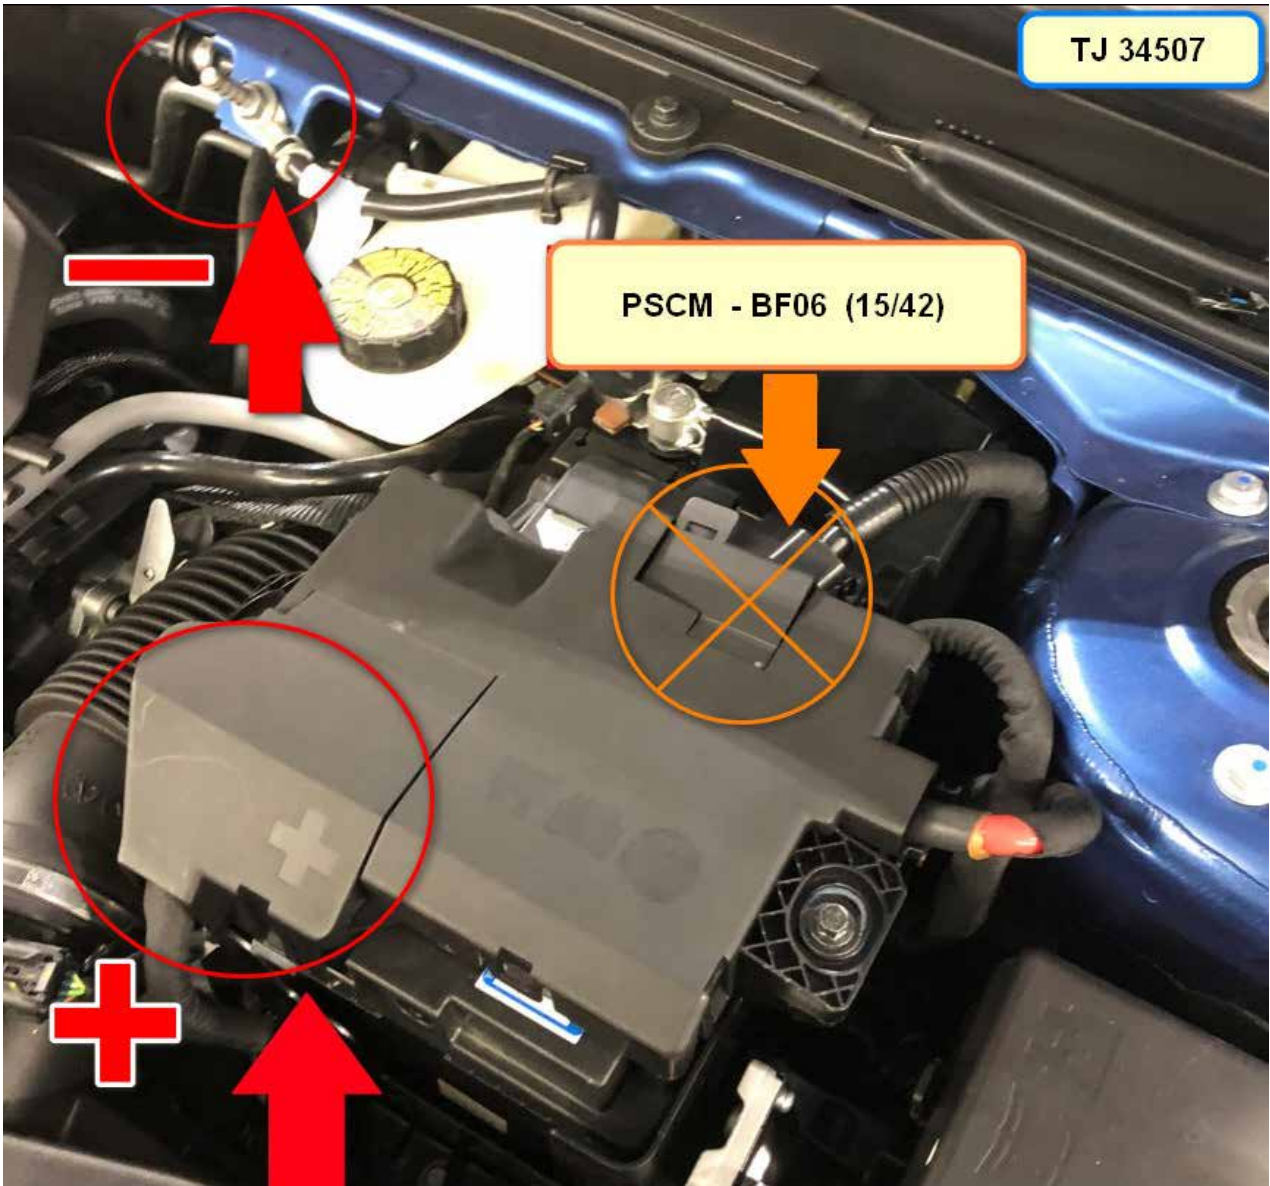
The concern could occur in the workshop if the technician connected the battery charger clamp directly on the stud for the steering fuse instead of the normal battery charging post, please see attachment. Red arrows in the photos show the correct B+ and B- positions for charging / jumpstarting.

If the power steering system is not responding, or if there is an error message in VIDA that it is not possible to download software to the power steering control module (PSCM), then check the fuse for the power steering system, Volvo electrical component BF06 (15/42 in wiring diagram).

In case the 100A fuse is defective, then replace only the fuse, there is **no** need to replace the steering gear or any other steering equipment.

Parts: 100A Fuse P/N 31654002. Note: do not use any other 100A fuses since these have different dimensions.
