Technical Journal

**12V battery message, Start/Stop unavailable, DTCs CEM-B129F96,
CEM-B10A613**REF NO:
TJ 34241.2.1ISSUING DEPARTMENT:
Technical ServiceCAR MARKET:
United States and CanadaPARTNER:
3 US 7510 Volvo Car USAISSUE DATE:
2020-08-13STATUS DATE:
2020-08-27FUNC GROUP:
3300FUNC DESC:
Starting system

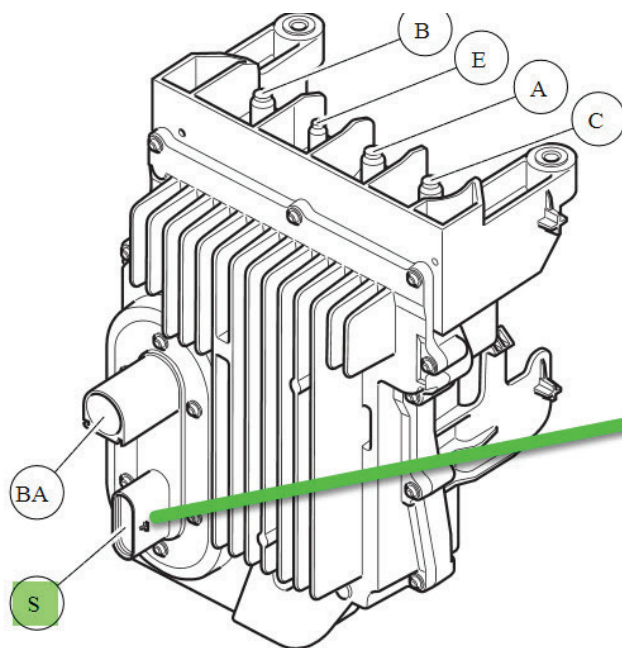
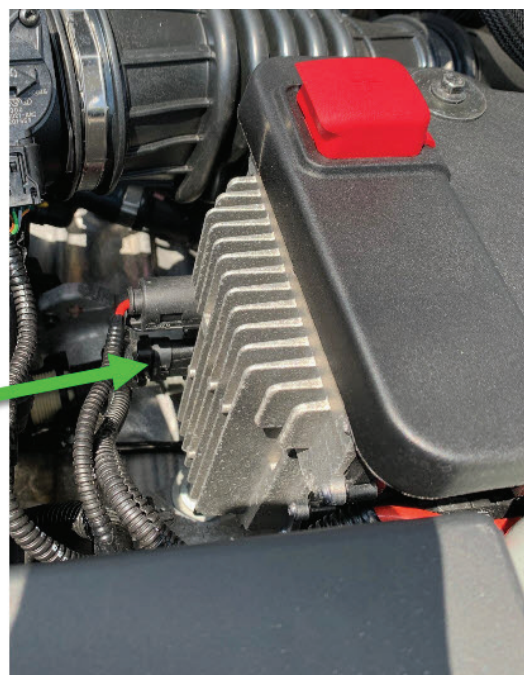
TJ 34241

Customer concern: DIM message “12V battery charge fault” with permanent DTC *CEM - B129F96*

Auto Start/Stop may also be unavailable along with DTC *CEM - B10A613* that will not clear

- Disconnect the negative cable on the main battery
- Remove the lower connector (“S”) on the BCSM (See attachment).
- Wait at least 15 minutes
- Reconnect the BCSM and main battery
- Erase all DTC’s.

This will reset the BCSM and the internal flash memory.
