Subject		Market
<b>Panasonic Navigation MEU or DCU Replacement Precautions</b>		USA
Service Category	Section	
Audio/Visual/Telematics	Navigation/Multi Info Display	
Applicability		
17CY NAV Equipped Vehicles w/o CarPlay

APPLICABLE VEHICLES			
2019	LS500	2018-2019	NX300
2018-2019	NX300H	2018	LC500
2018	RC300	2018	LS500H
2018	RC350	2018	LC500H
2018-2019	RC F

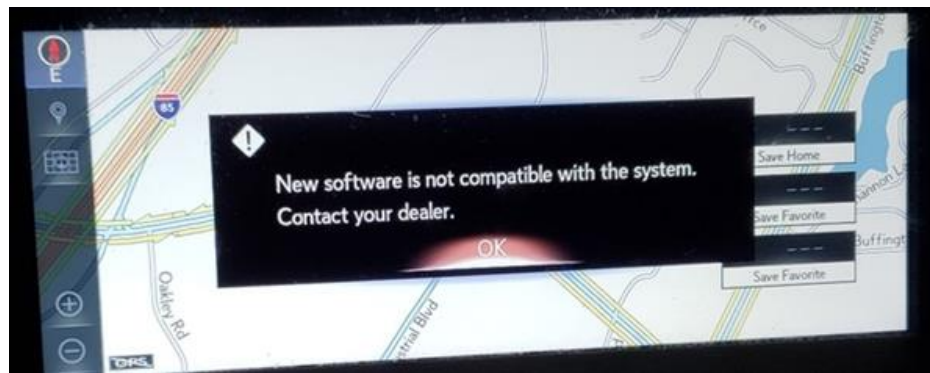
If the updated MEU (Navigation) or DCU (Radio) exchange part is installed on a vehicle that has never been updated, a software mismatch can occur, and an error message may be displayed.

1. Confirm if the vehicle has Apple CarPlay
  - a. Yes - Install the MEU/DCU exchange parts
  - b. No - Perform L-SB-0028-19 Rev1: Multimedia System Enhancements Phase 3 (Panasonic)
2. Confirm normal operation (without error messages) prior to releasing vehicles to the customer
