TECHNICAL INSTRUCTIONS
FOR
LIMITED SERVICE CAMPAIGN KLG
CUSTOMER SUPPORT PROGRAM 19LE05

SAFETY CONNECT SYSTEM – VEHICLE LOCATION INACCURATE
CERTAIN

**2011 – 2017 MODEL YEAR LS, 2013 – 2016 MODEL YEAR LS Hybrid,
2011 – 2017 MODEL YEAR GS, 2016 – 2017 MODEL YEAR GS-F,
2013 – 2017 MODEL YEAR GS Hybrid, 2010 – 2017 MODEL YEAR IS,
2011 – 2015 MODEL YEAR IS-C, 2013 – 2014 MODEL YEAR IS-F,
2015 – 2017 MODEL YEAR RC, 2015 – 2017 MODEL YEAR RC-F,
2011 – 2017 MODEL YEAR CT, 2010 – 2017 MODEL YEAR RX,
2010 – 2017 MODEL YEAR RX Hybrid, 2015 – 2017 MODEL YEAR NX,
2015 – 2017 MODEL YEAR NX Hybrid, 2013 – 2017 MODEL YEAR LX,
2013 – 2018 MODEL YEAR GX, 2010 – 2017 MODEL YEAR ES,
2013 – 2017 MODEL YEAR ES Hybrid**

Updated 08/24/2020

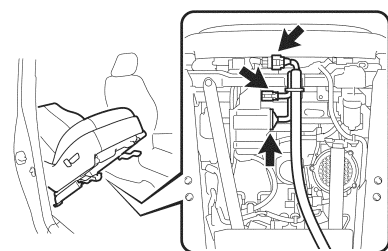
Be sure to disconnect each connector after disconnect the negative battery terminal

- b) DISCONNECT THE FRONT PASSENGER SEAT CONNECTORS (Only GS, GS HV, IS (Not included IS-C, IS-F), RC, RC-F, CT, NX, NX HV, GX, ES, ES HV)

- (1) Separate the front passenger seat, and then disconnect each connector of the front passenger seat.
