May 28, 2020

# Customer Service Notice

Units Affected: DB41B digger derricks built before January 2020 (see attached list)

## HOP System Update

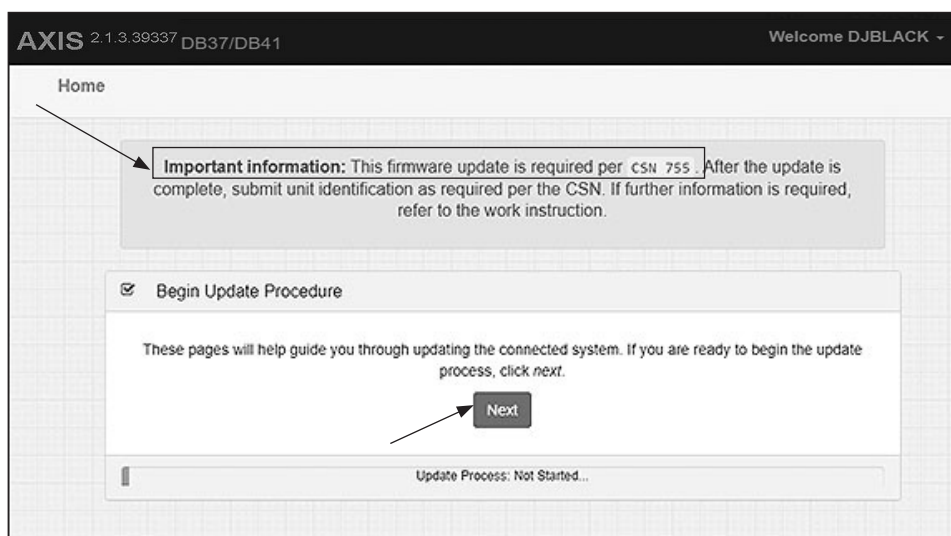
**Figure 3 – AXIS Home Page Indicating Derrick Firmware Update Is Required**

5. Navigate to the DB37/DB41 AXIS home page.
  - If the home page displays the screen stating, “Important information: This firmware update is required per CSN 755.” as shown in Figure 3, proceed to step 6.
  - If the home page displays the DB41 Welcome screen as shown in Figure 4, the derrick firmware is up to date. Proceed to step 15.
  - If the home page appears as shown in Figure 5 or a popup appears as shown in Figure 6, there is a problem with the AXIS system or connection. Email [axis.support@altec.com](mailto:axis.support@altec.com) for assistance before proceeding.

6. On the AXIS DB37/DB41 home page, click Next under Begin Update Procedure (refer to Figure 3).
7. On the Step One screen, select CORRECTIVE SETTING: START UPDATE PROCESS on the drop-down menu (refer to Figure 7). Then click Next.
