## Thor Motor Coach Technical Service Bulletin

| TSB # | <b>TSB 20-05</b> | | |
| Description/Title: | Fog Light Relay | | |
| Affected Product Line(s): | Certain Model Year 2021<br>Hurricane & Windsport Motorhomes | | |

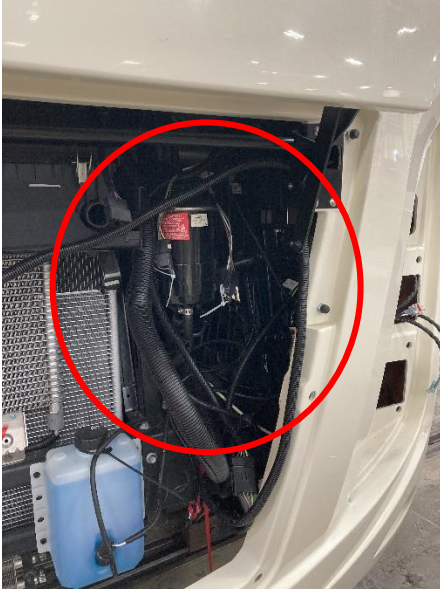
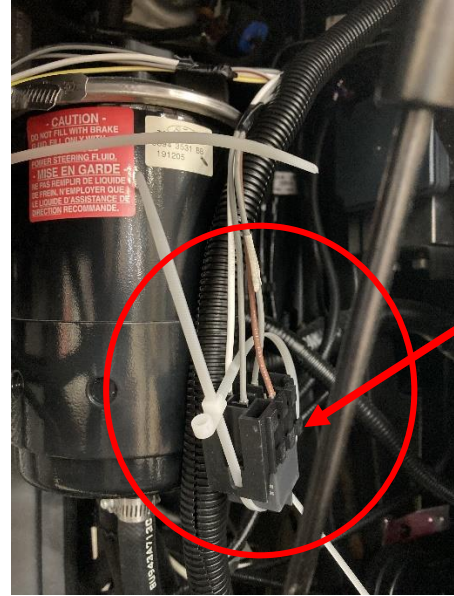
On certain model year 2021 Hurricane & Windsport Motorhomes built on a 2020 Ford F53 Chassis, the fog light relay will buzz at a certain voltage range. The fix will be to install a harness to the fog light relay.

1. Open hood of the motorhome to locate the fog light relay with white and brown wires near the firewall.
