SIB 12 22 19

2020-08-03

EME GROUND CONNECTION MONITORING FAULTS

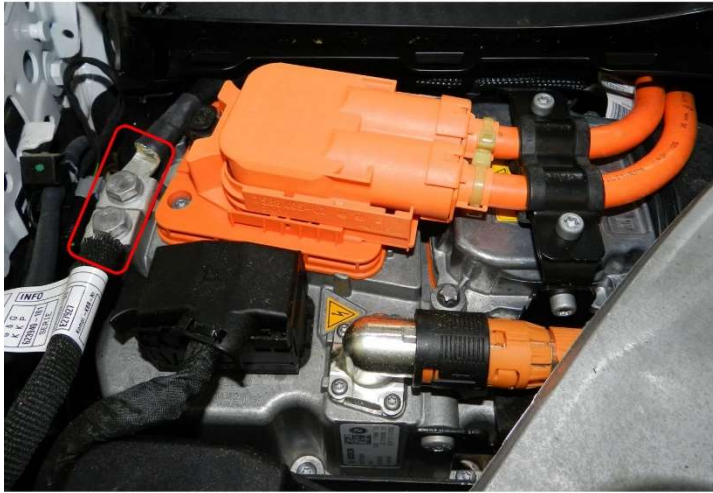
GRUSB1219-09

Increased ground cable contact resistance at Electrical Machine Electronics (EME) due to corrosion/oxidation.

1. Remove both grounding cables at the EME. (G30 shown)
