SIB 41 02 20

TRUNK LID RUBS ON BUMPER COVER

E-Series	Model Description
F44	2 Series Gran Coupe

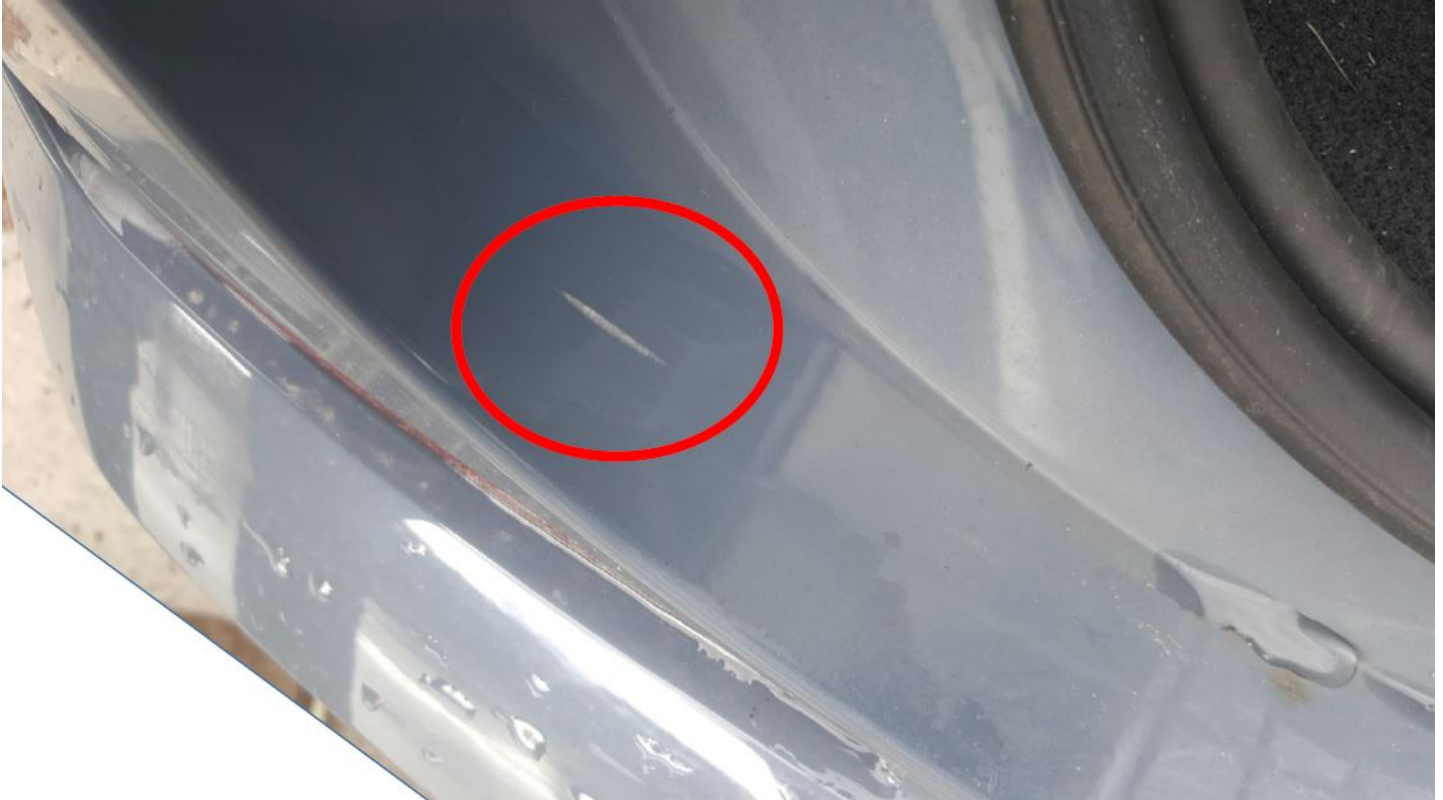
The trunk lid may slightly rub on the top of the rear bumper cover, causing scuff or scratch marks.

The rear bumper cover is adjusted too close to the trunk lid.

Adjust the rear bumper cover away from the trunk lid.
