SIB 54 13 19

2020-08-11

FRONT ROLLER SUNSHADE LOOSE

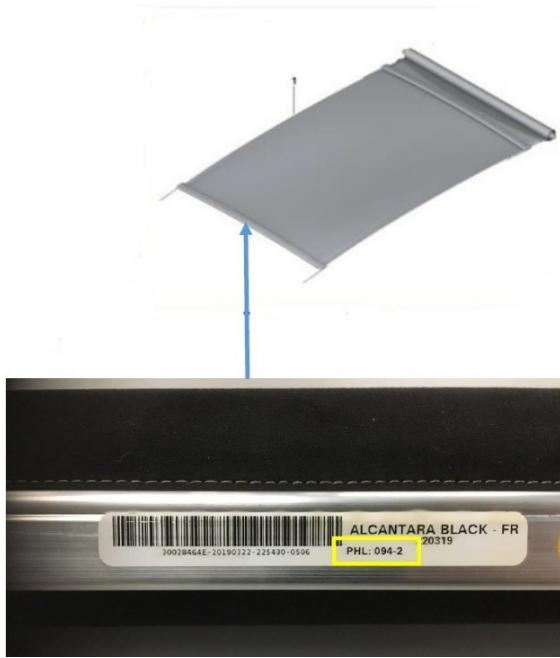
**** Special notes on sunshade****

Before installing a replacement sunshade, ensure that the “PHL” number printed on the ID sticker for the sunshade is 095-2 or higher.

Note: Reference photo for location of ID sticker. Unrolling the sunshade is not required to perform the inspection.

Do not install a sunshade that is below PHL 095-2.
