SIB 62 08 18

2020-08-24

## INSTRUMENT CLUSTER DISPLAY SHAKES-SHIFTS TO THE LEFT

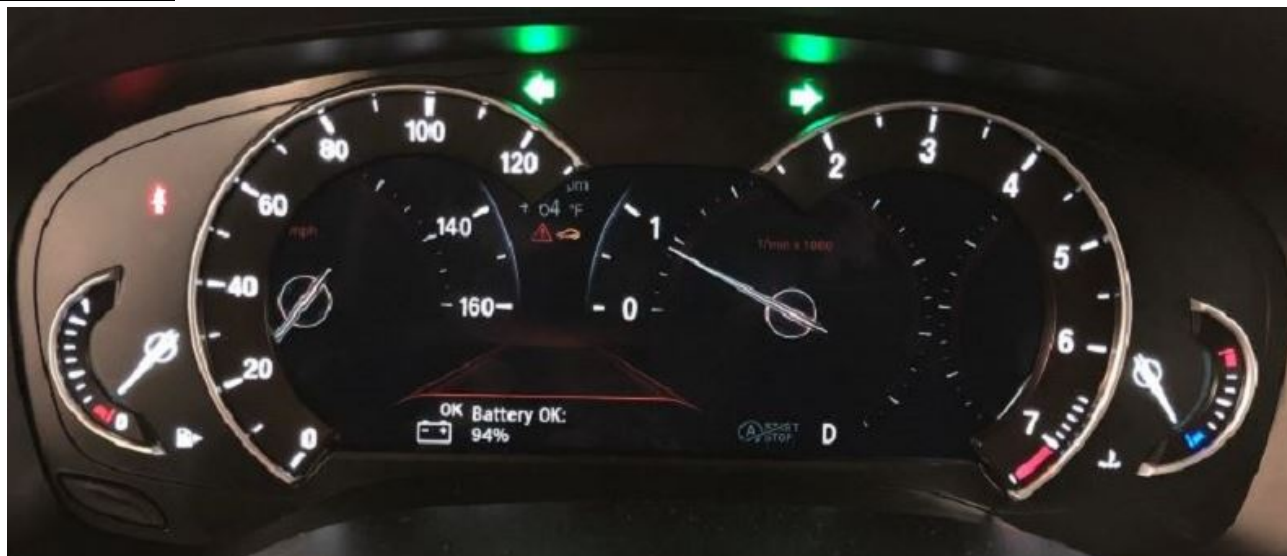
The  
Instru  
ment

cluster intermittently flickers, shakes and has shifted to the left.

The fault is resolved once the vehicle goes into sleep mode.

The fault can reoccur at any point.

Problem with the contact at the Automotive Pixel Link connection plug on the instrument cluster.

Software error in the Instrument cluster (Kombi)

Replace the instrument cluster (Kombi).

Program vehicle and perform ABL Dashboard: "Display jitters/shifts to the left"
