SIM 41 01 20

## CRACKING NOISE FROM A-PILLAR

| E-Series | Model Description | Production Date |
|---|---|---|
| F60 | MINI Countryman | Up to February 7, 2020 |

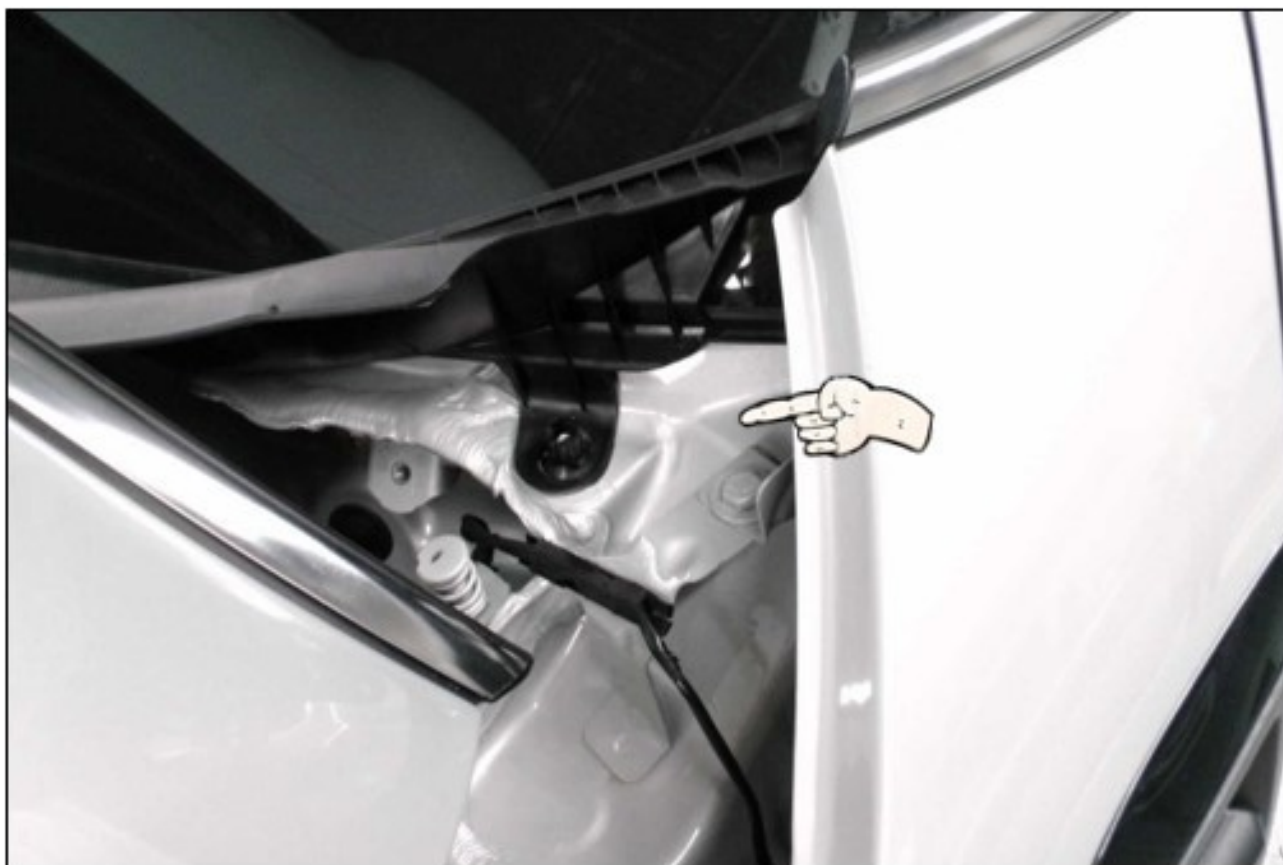
1. Completely open the hood to gain access to the area shown below (driver's side shown):

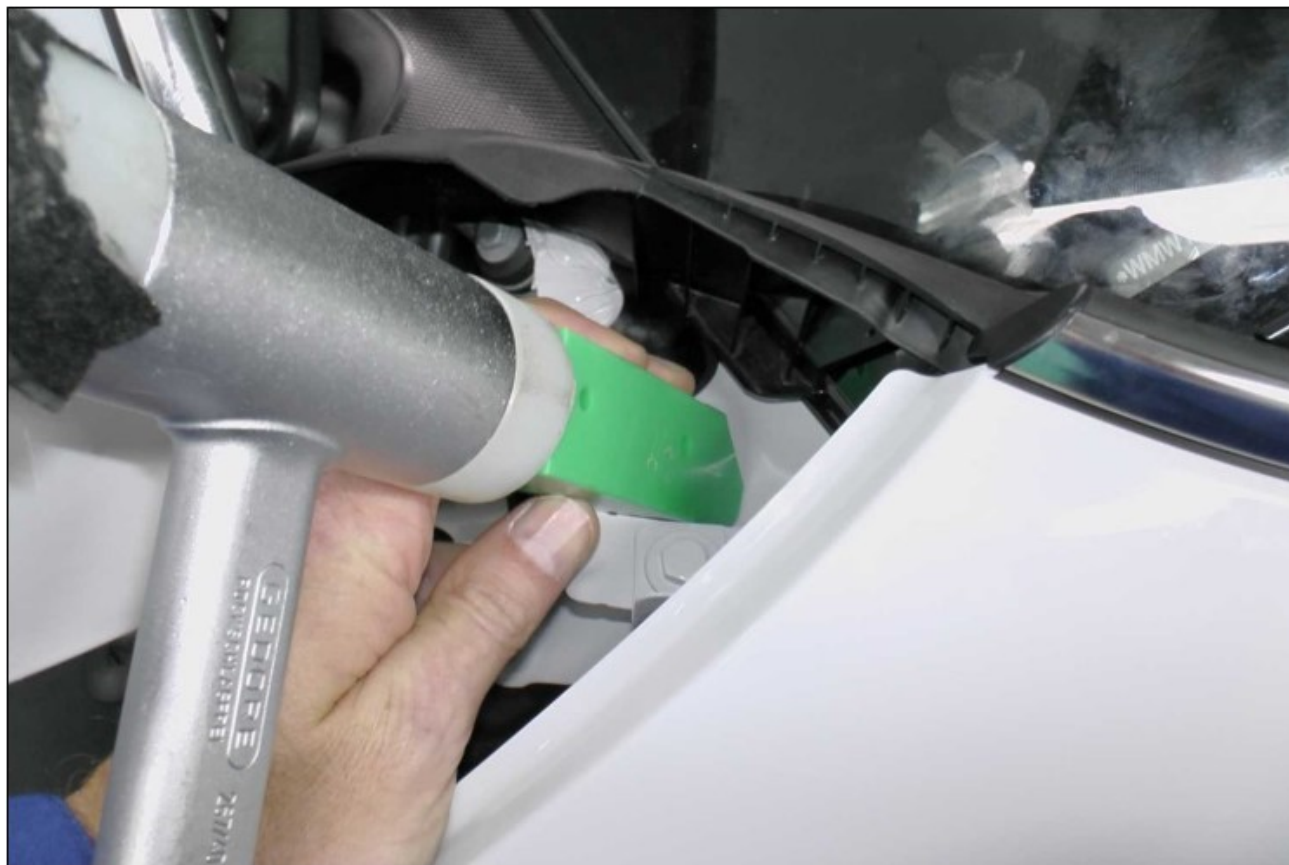
When driving over rough road surfaces, a cracking noise can be heard from either or both lower A-Pillars near the bottom corners of the windshield.

Interference between 2 sheet metal panels.

2. On the affected side or sides, reference the photo below for the exact location of work to be performed. Using a mallet and suitable tool, rework the face of the sheet metal with 3 strikes, using moderate force. This will separate the interfering panels below.

**Note: A plastic tool is preferred, but if metal must be used, the metal tool must be wrapped in felt or cloth to prevent scratching the paint.**
