**Polestar: Changed Wi-Fi Hotspot Name, “MyPolestar”**

REF NO:  
**TJ 35407.2.0**

ISSUE DATE:  
**2020-08-04**

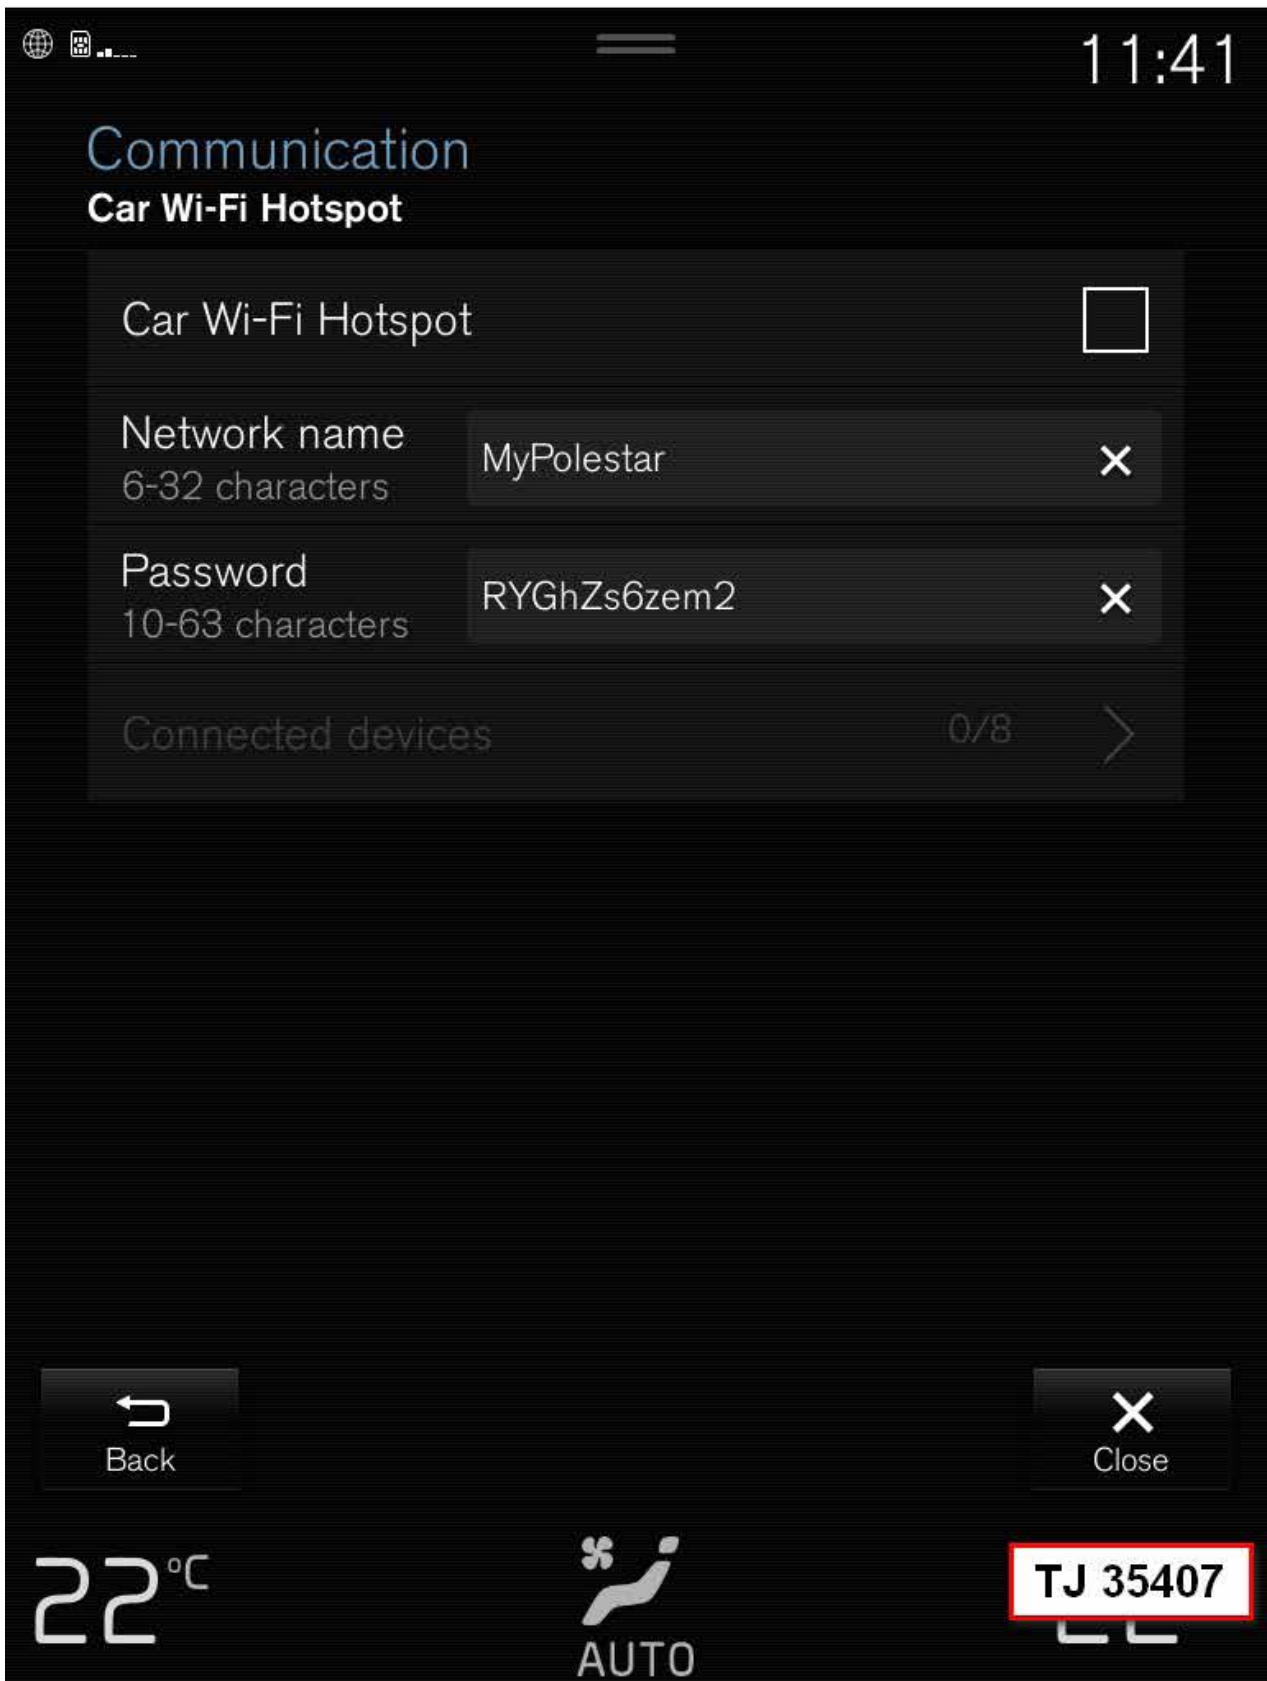
See image in attachment "TJ 35407.jpg"

After a software download or after performing a factory reset of the IHU, the in-car wifi hotspot name (SSID) may change from the pre-set “MyPolestar.”

In the infotainment menus go to Settings-> Communication -> Car Wi-Fi hotspot -> Network name and change the name of the network back to "MyPolestar".
