September 10, 2020

Version 3

Popping or Crackling from the Speakers; No Sound from the Audio System; Network Loss Message and/or Display Issues

AFFECTED VEHICLES

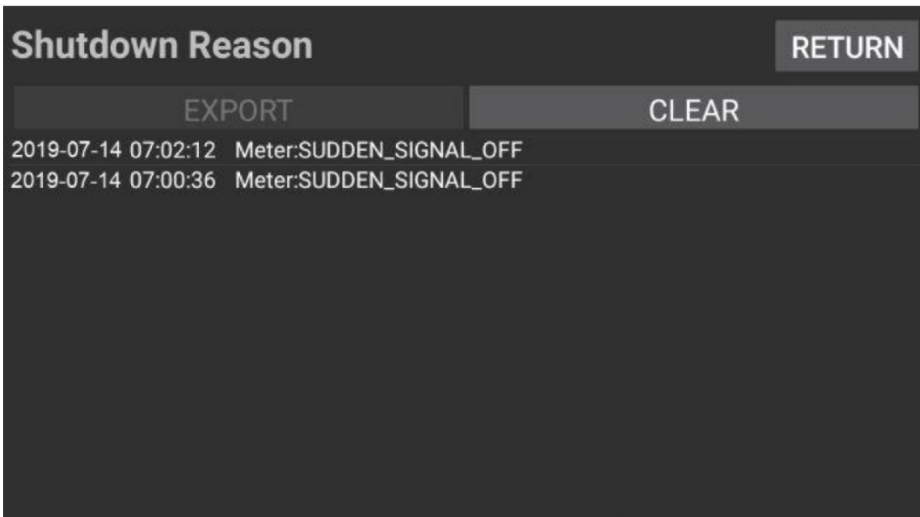
In this example, the cause of the failure can be identified as **Meter:SUDDEN_SIGNAL_OFF**.

Write down any failures; they will be collected on the warranty claim. Then, clear the data.
