Business Class M2  
Cascadia  
108SD/114SD  
> New Cascadia

**Freightliner  
Service Bulletin**

**Description of revisions:** *This bulletin replaces the version dated July 30, 2020. Information about a reman part has been added.*

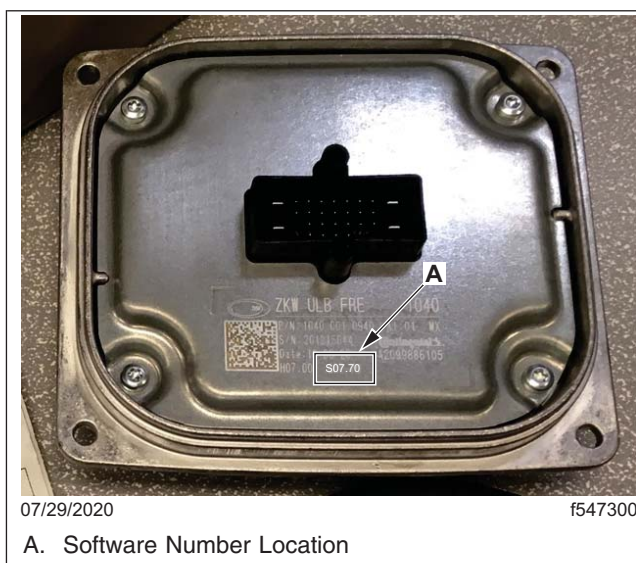
**Fig. 1, Inner ULB Cover With Software Number**

New Cascadia vehicles with light emitting diode (LED) headlamps built from January 1, 2017 through February 17, 2020 may experience intermittent disabled headlamps due to an issue with the universal light ballast (ULB).

The LED headlamps can turn off if the supply voltage drops below approximately 9V. This low voltage commonly and momentarily occurs when cranking the engine on a vehicle with batteries that are not fully charged. The momentary low voltage may cause the electronic ULB control unit to malfunction. The ULB may not resume normal function until the power supply to the headlamp is disconnected.

If this malfunction occurs, the entire headlamp does not need to be replaced. Replace the ULB control unit. Before installing, validate the software number of the ULB is S07.70 or later. **Do not** replace the ULB with with a ULB that has the software number S07.26 or earlier. See [Fig. 1](#) for software number location.
