SS 1034348 New Cascadia Unintended 4-way Flashers Activation

This solution applies to all New Cascadia (P4) vehicles.

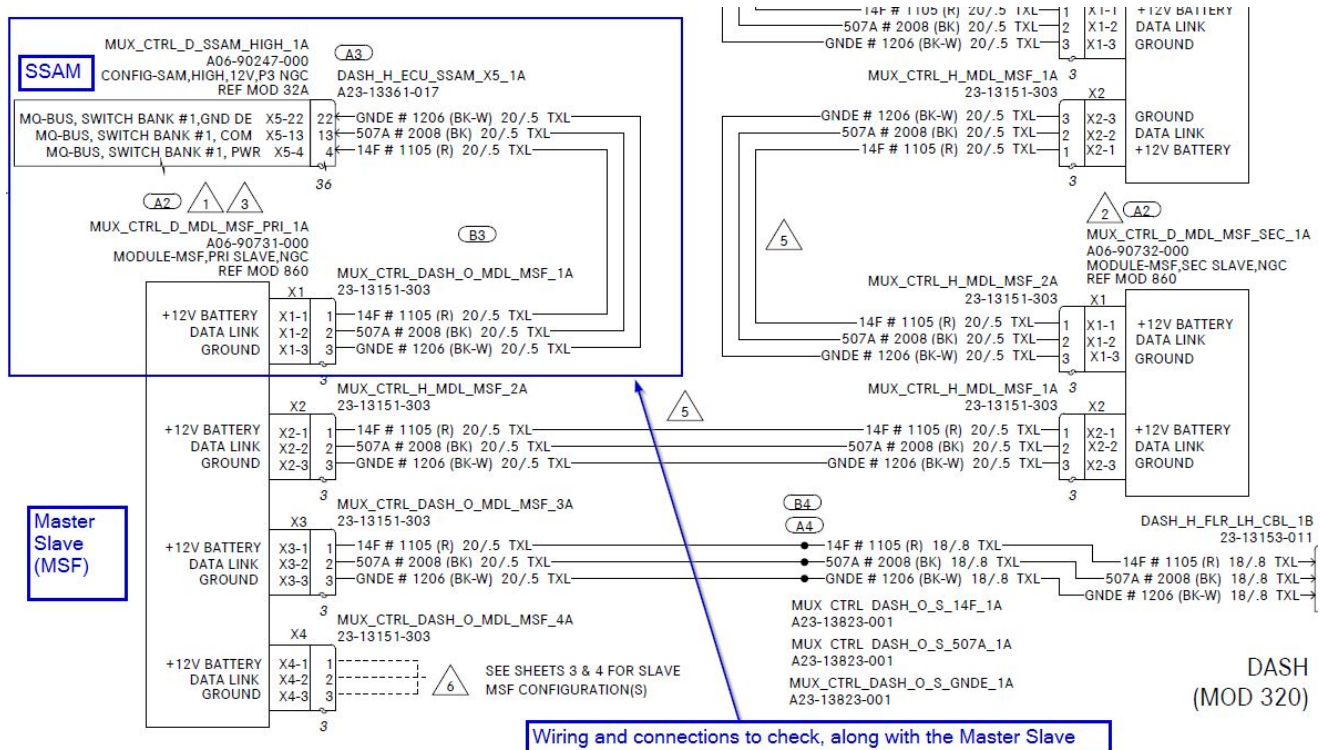
If the condition can be duplicated, then once the 4-ways are activated, connect DiagnosticLink to the vehicle and monitor the four way switch to see if the switch is depressed. If the switch is showing depressed, then check the wiring to the Master Slave from the SSAM for any connection issues or switch problems, reference the print below.

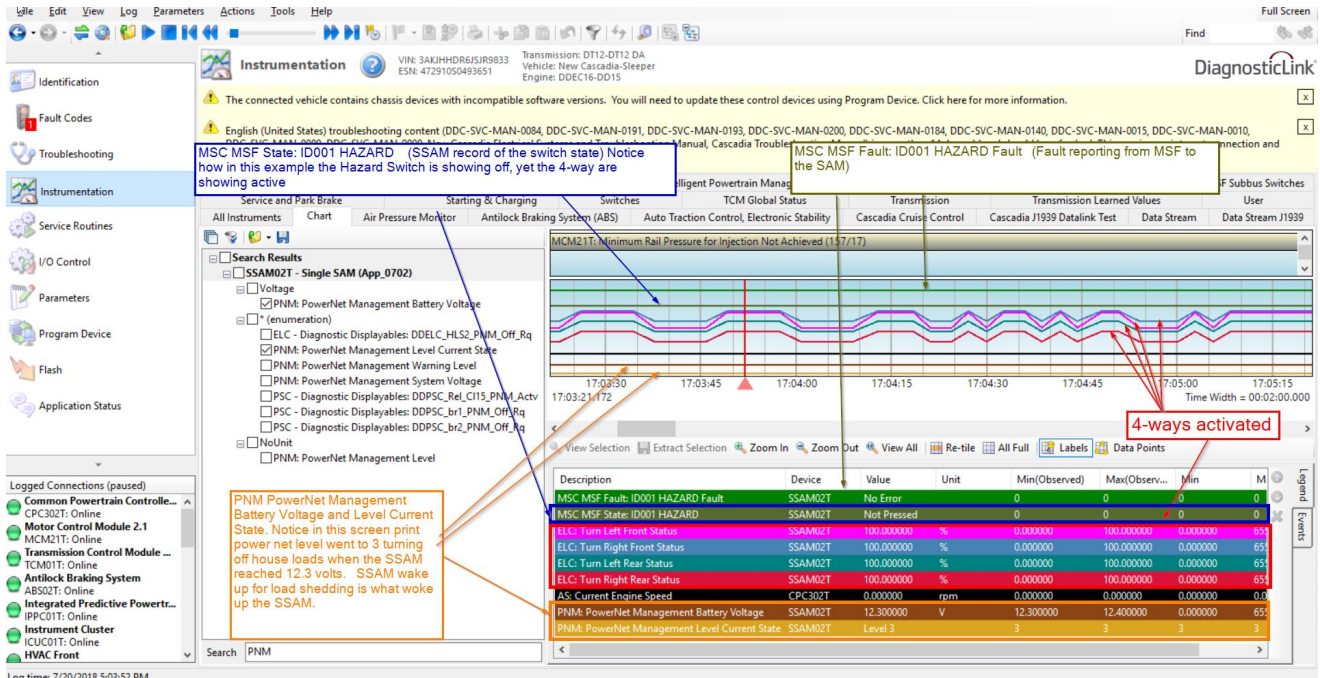
If the 4-way (hazard) switch is not activated and the 4-way flashers are showing activated as pictured in the screen print below, then proceed to the next step in this solution for voltage drop tests to the SSAM.

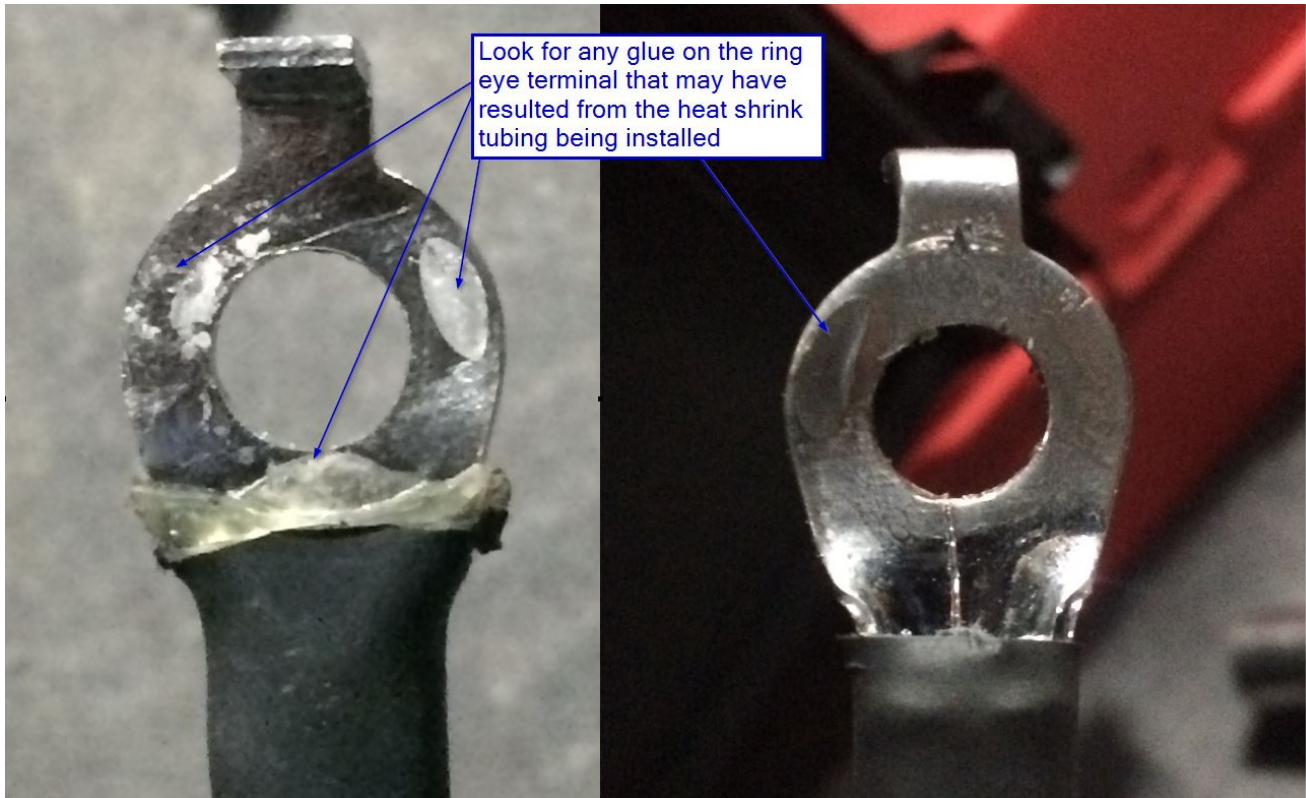
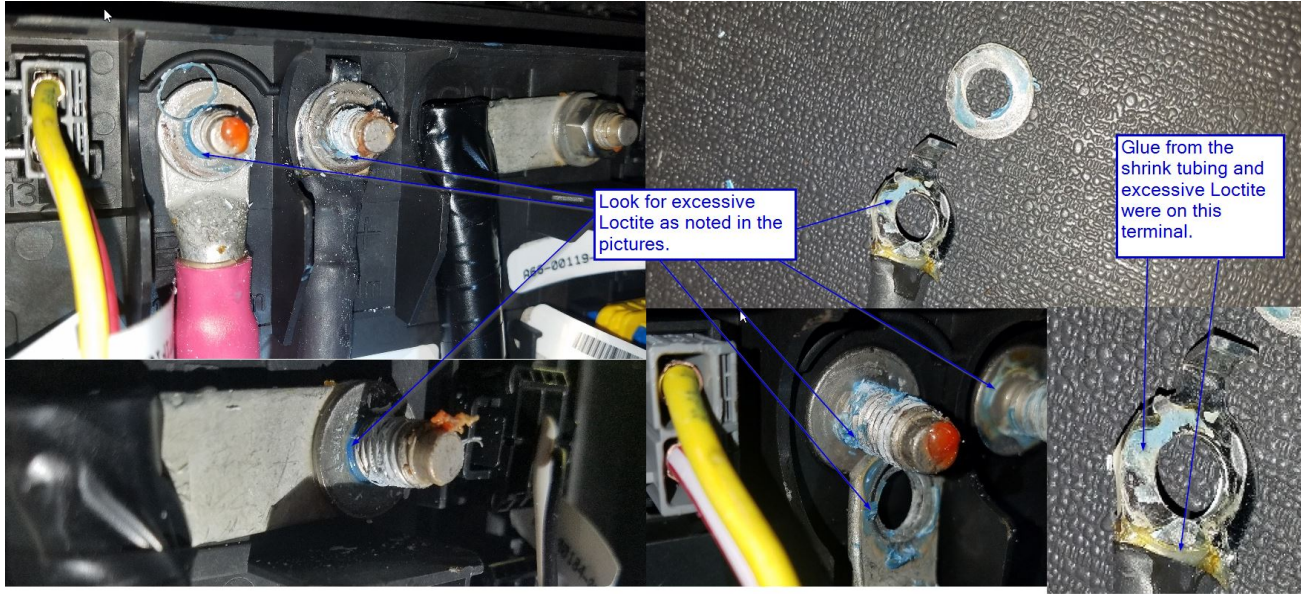
- Remove the Bat 1, Bat 2 and the ground cable from the SSAM. When removing the cables from the SSAM studs, make sure to inspect the cables for any excessive Loctite or glue that may be present on the ring eye terminals (See photos below). Make sure to document any material that is found on these connections.
- Clean the SSAM studs, cable ring eye connections and all of the mounting hardware, so that all connection surfaces are clean and free of foreign material.
- The reason for this inspection and cleaning of the connections, is to ensure that no voltage drop occurs between the cable ring eyes and the studs located on the SSAM. Note: Locking nuts for the power and ground connections were installed starting 5/20/2019, eliminating the need for any Loctite. The new locking nut P/N is 23-14592-008 - NUT-HEX,SST,8M,W/ PATCH LOCK.

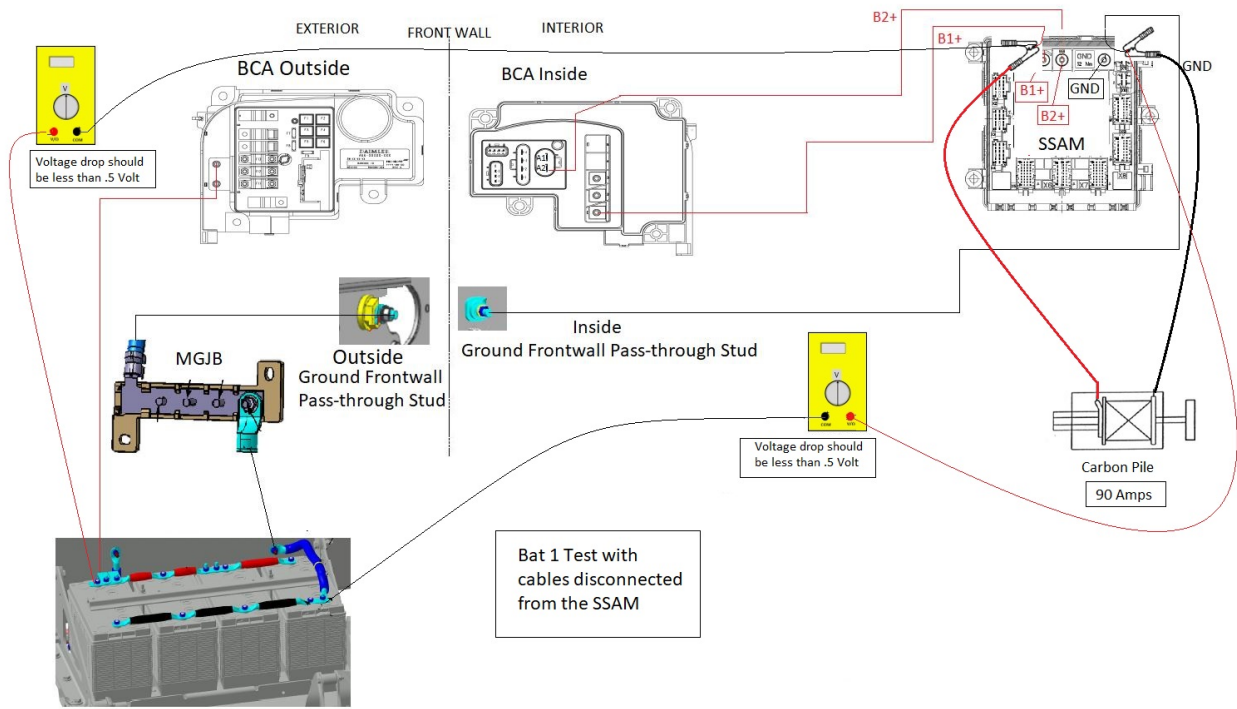
Bat1 voltage drop test. For this test, the load will be placed between the ground terminal and Bat 1.

- Bat1 test can be run by loading the GND and BAT1 cables to 90 amps and checking for voltage drops on the cables (should be less than .5 volt). Bat 2 cable should be removed from the SSAM and taped up so not to come in any contact with ground during the test. Also make sure the Bat1 and Ground are not contacting any conductive surfaces prior to reconnecting the battery ground cable to run the test.
- Reference the figure below when hooking up the connections to the SSAM. Again, for this test, the Bat 1 and GND are not connected to the SSAM when running the test. Once all of the connections are secure and in place you will need to connect the ground cable back to the batteries in order to apply the 90 amp load to the cables.

If a voltage drop of greater than .5 volts is recorded, then reference the figure above and locate where the voltage drop is occurring. Make sure to unhook the ground cable to the batteries prior to tracing out the voltage drop.

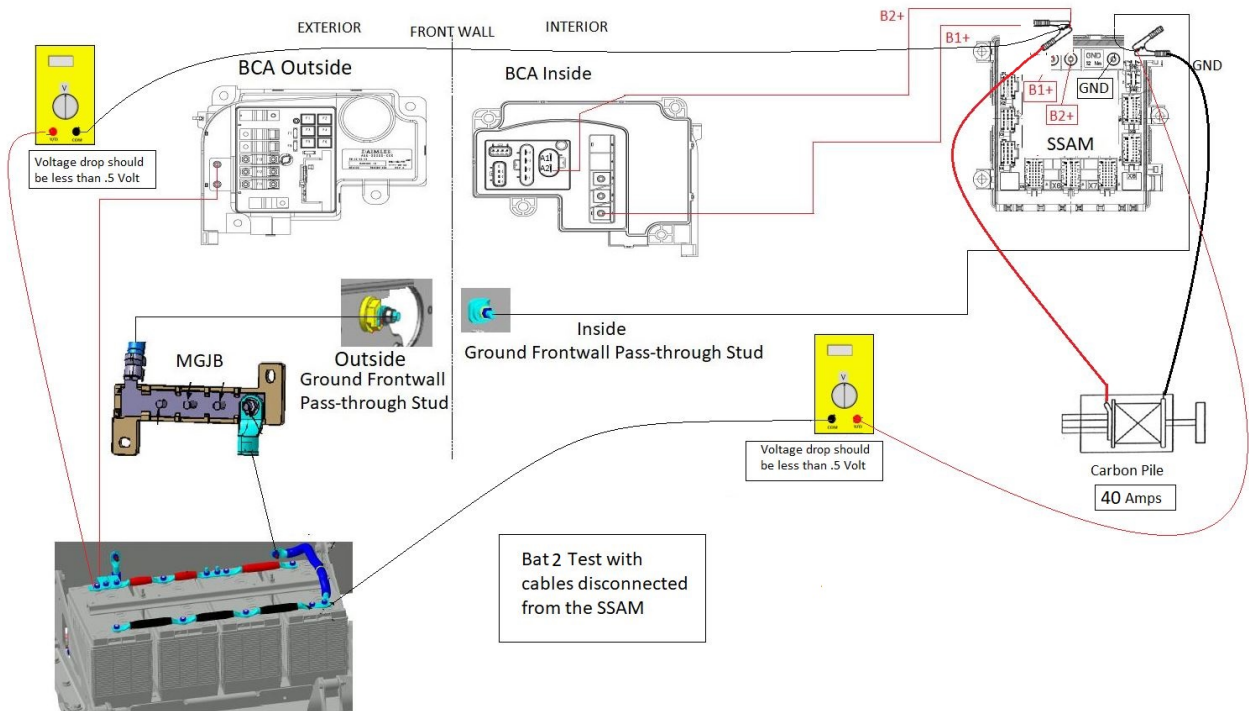
Bat2 voltage drop test. For this test, the load will be placed between the ground terminal and Bat 2. Make sure the batteries are disconnected from the vehicle prior to hooking up testing connections.

- Bat2 test can be run by loading the GND and BAT2 cables to 40 amps and checking for voltage drops on the cables (should be less than .5 volt). Bat 1 cable should be removed from the SSAM and taped up, so not to come in any contact with ground during the test. Also make sure the Bat2 and Ground are not contacting any conductive surfaces prior to reconnecting the battery ground cable to run the test.

- Referencing the figure below when hooking up the connections to the SSAM. Again, for this test, the Bat 2 and GND are not connected to the SSAM when running the test. Once all of the connections are secure and in place you will need to connect the ground cable back to the batteries in order to apply the 40 amp load to the cables.

If a voltage drop of greater than .5 volts is recorded, then reference the figure above and locate where the voltage drop is occurring. Make sure to unhook the ground cable to the batteries prior to tracing out the voltage drop.

Once all of the voltage drops (if Present) have been addressed and the cables have less than a .5 volt drop when loaded, the reconnect the SSAM connections making sure to torque the fastening nuts to 12 NM. Make sure to properly attach the ground cable back to the battery. Since the complaint is hard to duplicate, testing to see if the problem reoccurs
