9/11/2020
CAL FTL 35001

Subject: Inspection of ConMet Disc Brake Rotor to Hub Fastener

Models Affected: All Business Class M2, New Cascadia, and Coronado vehicles built from June 1, 2020 through August 24, 2020

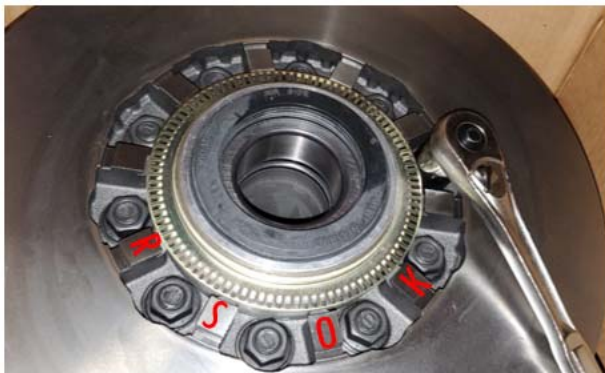
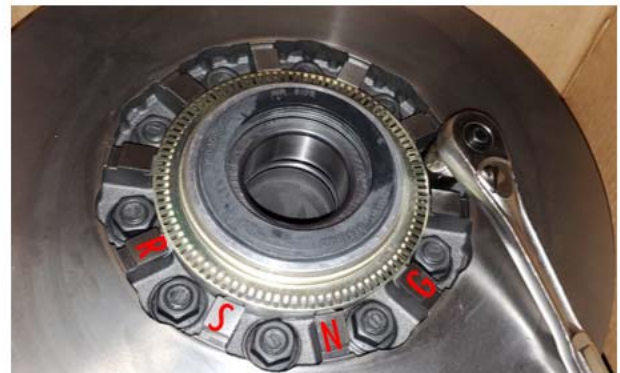
1. Support the hub in a way that allows up to **40 ft-lb** of torque to be applied to the rotor mounting nuts. Potential methods include setting in an upside down drum or wheel or other fixture or held by a second person.
2. Torque all ten (10) rotor attachment nuts in the tightening direction to **40 ft-lb** (or practical equivalent). If the nut turns, continue to tighten the nut to verify that the stud is being pulled out of the hub. **This is a reject condition.** Note: due to the length of the stud shank and friction between the stud shank and the hub it may not be easy to remove the stud by hand even after the stud rotates freely.

3. Mark rejected hubs as “RS NG” and reserve for ConMet. Replace with a new hub assembly.
4. Mark certified hubs with a “RS OK” on the top of the flat pads on the rotor.
5. If the inspected hub was removed from an axle, replace the seal before reassembling on to the axle.

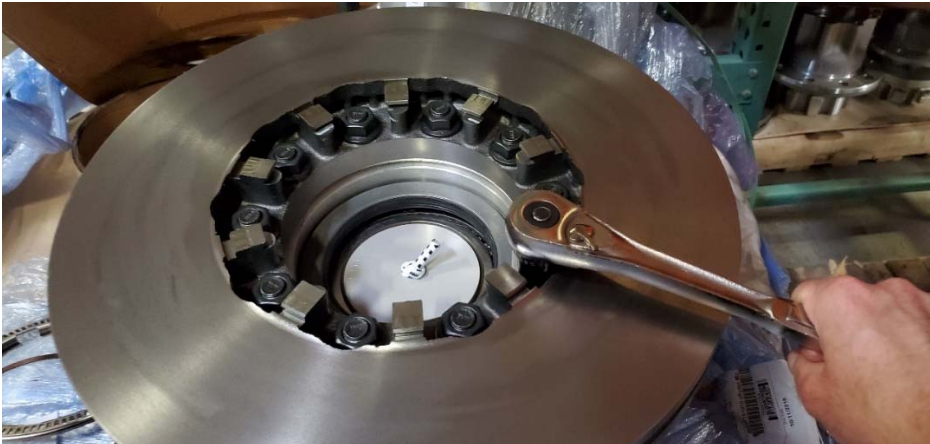
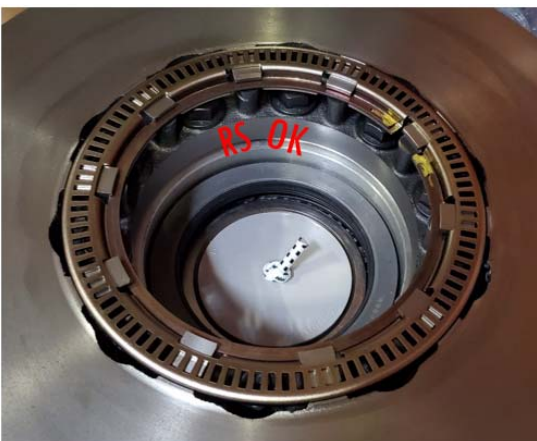
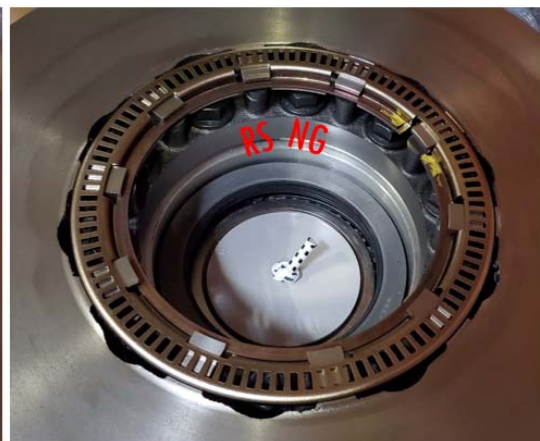
3. Remove the ABS ring from the rotor.
4. Torque all ten (10) rotor attachment nuts in the tightening direction to **40 ft-lb** (or practical equivalent). If the nut turns, continue to tighten the nut to verify that the stud is being pulled out of the hub. **This is a reject condition.** Note: due to the length of the stud shank and friction between the stud shank and the hub it may not be easy to remove the stud by hand even after the stud rotates freely.

5. Mark rejected hubs as "RS NG" and reserve for ConMet. Replace with a new hub assembly.
6. Mark certified hubs with a "RS OK".
