# DAIMLER

On August 24, 2020 DTNA identified an issue affecting Freightliner, Western Star and FCCC models equipped with ConMet flat rotor disk brakes and aluminum hubs. Rotor mounting studs installed on steer and drive hubs on vehicles with flat rotors built from May 1, 2020 through August 24, 2020 may fracture due to hydrogen embrittlement. Initial inspection data indicates approximately 1% of the mounting studs may fail. Table 1 lists the affected hub assemblies.

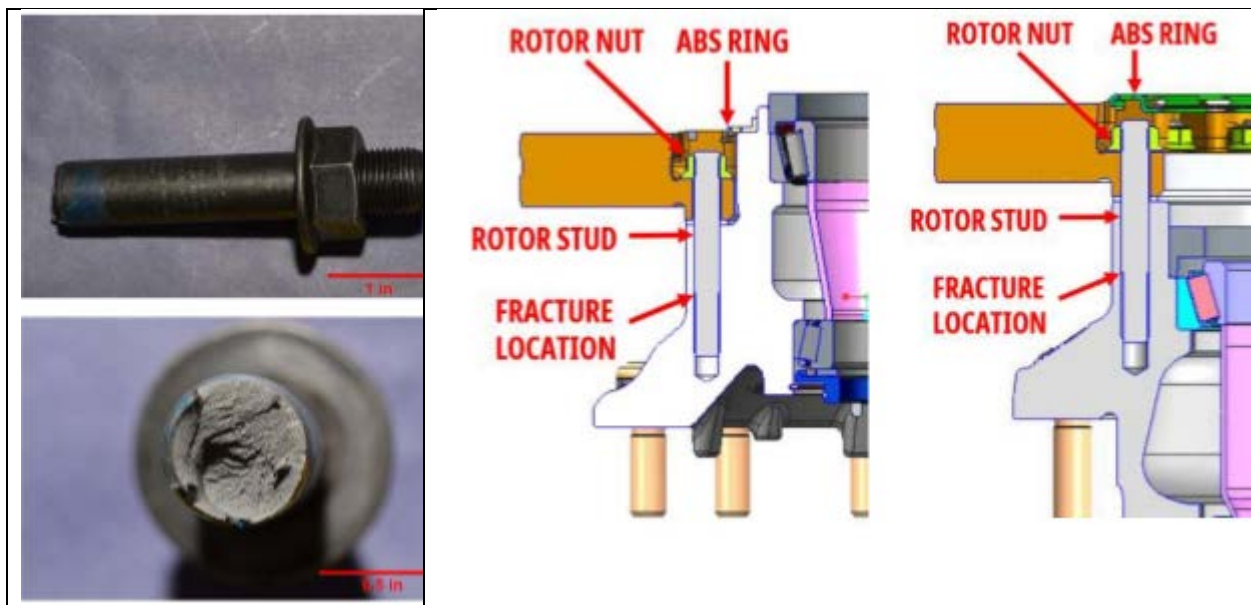
When hydrogen embrittlement affects the rotor mounting stud fracture of the stud occurs 1 to 24 hours after torqueing of the stud - see Figure 1. Fracture of the stud occurs approximately 1.7 inches (43.2 mm) below the rotor mounting surface. A fractured stud could dislodge from the hub mounting hole however the stud will be captured by the ABS tone ring - see Figure 2. As damage progresses damage to the ABS tone ring, ABS sensor, and caliper anchor plate may occur. Drivers may notice wheel end noise, vibration, or an ABS indicator light - see Figure 3. Based on engineering, test and field information vehicle safety is not compromised.

Figure 1. Rotor mounting stud fracture due to hydrogen embrittlement

possible. To check the stud a torque of 40 ft-lb (54.2 Nm) needs to be applied to the rotor mounting stud. If the rotor mounting nut or stud turn the stud has likely fractured. If a fractured rotor stud is discovered then the wheel end should be replaced. If no fractured studs are discovered then the wheel end may be reused.

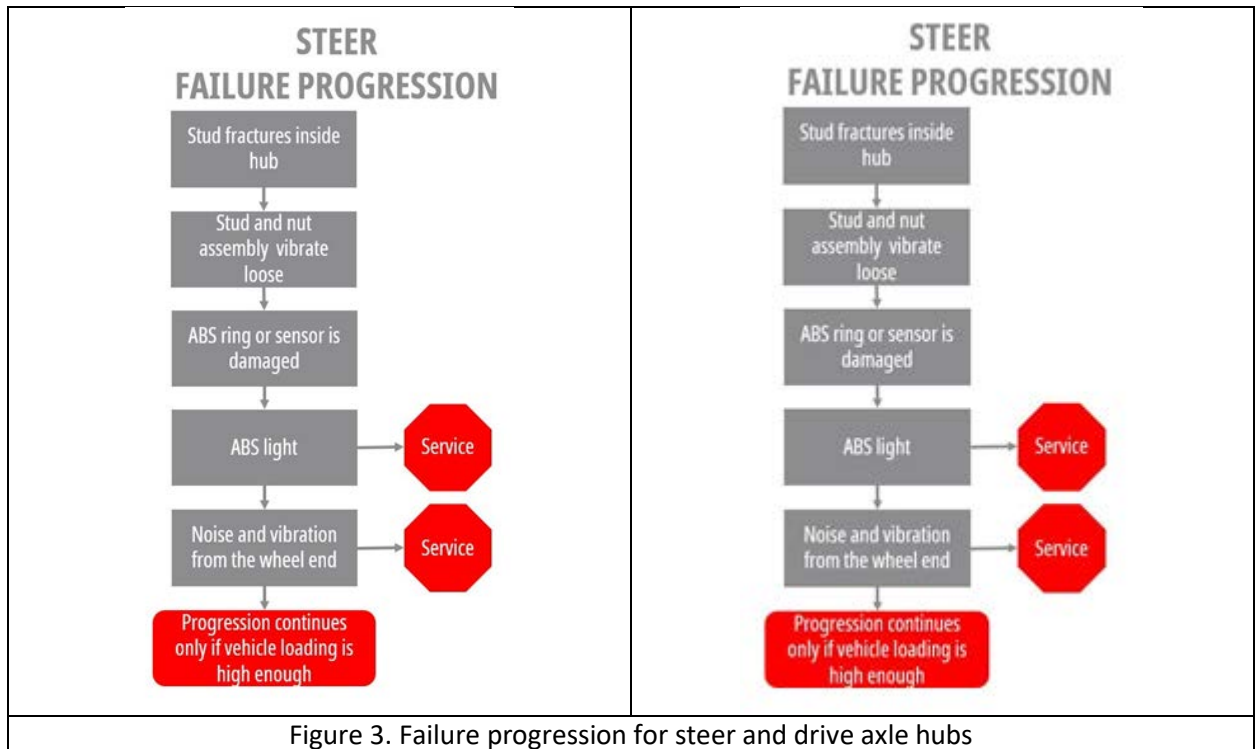
Figure 3. Failure progression for steer and drive axle hubs
