DTNA identified an issue affecting Freightliner, Western Star and FCCC models equipped with ConMet flat rotor disk brakes on aluminum hubs. Inspection data indicates approximately 1% of all rotor-mounting studs installed on steer and drive hubs on vehicles with flat rotors built from May 1, 2020 through August 24, 2020 may fracture due to hydrogen embrittlement.

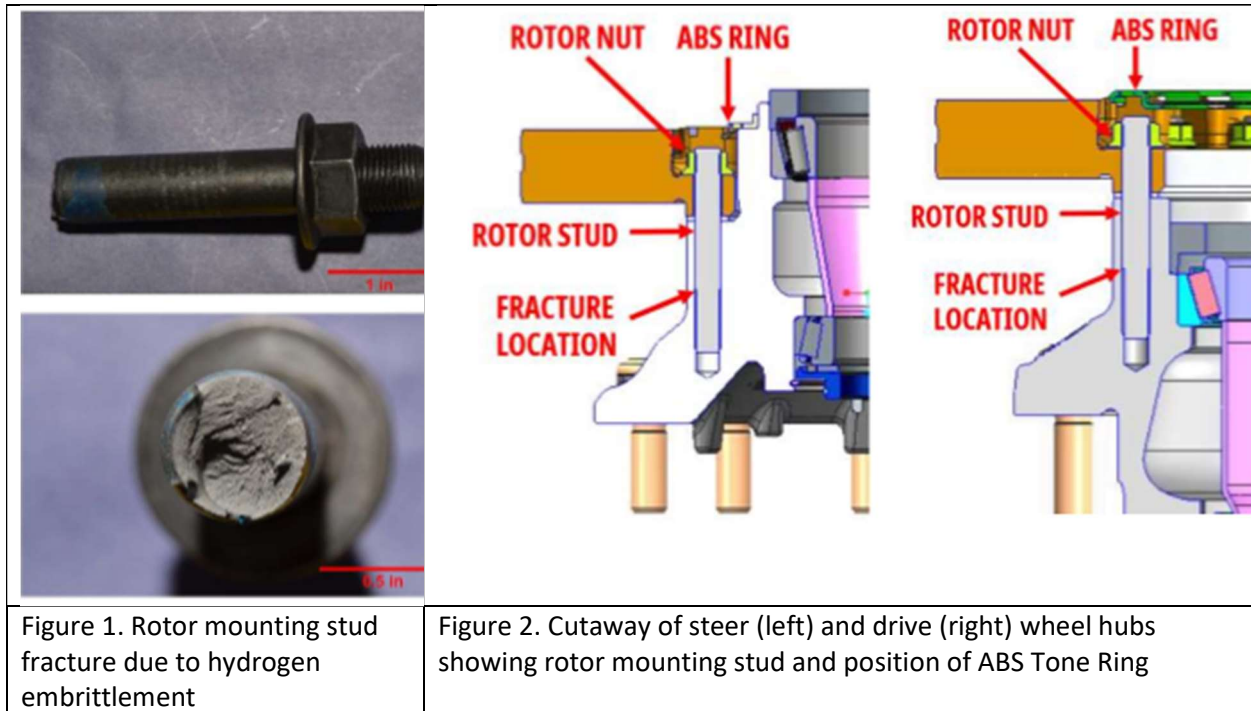
A fractured stud could dislodge from the hub mounting hole however the stud will be captured by the ABS tone ring - see Figure 2. As damage progresses damage to the ABS tone ring, ABS sensor, and caliper anchor plate may occur. Drivers may notice wheel end noise, vibration, or an ABS indicator light - see Figure 3. Based on engineering, test and field information, vehicle safety is not compromised.

DTNA initiated a hold on all vehicles at our plants and facilities to inspect and replace faulty rotor mounting studs with validated stock before releasing the vehicle from the plants. Once fully verified, the held vehicles will be released.

If a fractured rotor stud is suspected on an in service vehicle, then the vehicle should be inspected at a dealer when possible.
