Front bumper/facia fit above headlamps

Topic number	LI88.20-P-071570
Version	1
Function group	88.20 Bumpers
Date	08-12-2020
Validity	BR290 with manufacturing date up to and including 07/2019
Reason for change	
Reason for block

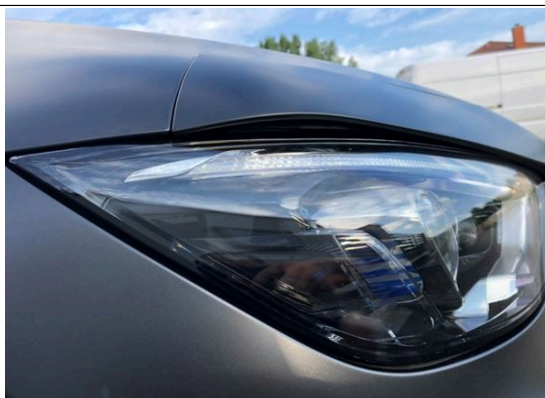
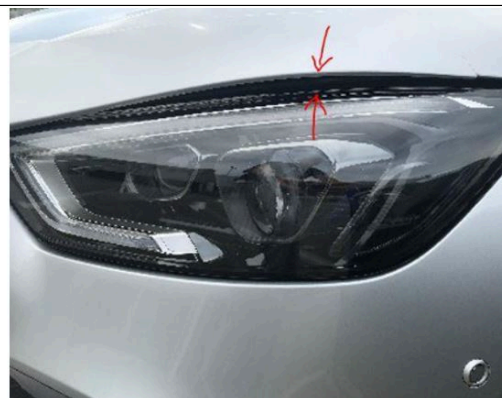
Beanstandung.JPG:

Bulging of front bumper/facia above headlamps (see attachment). Function of headlights not blocked or impaired.

Attachments	
File	Description
Beanstandung.JPG	Bulging on bumper above the headlamp

Bonding between bracket and bumper may be separating.

- If brackets can be easily removed without damaging or deforming the bumper --> Reworking instructions will be provided via the PTSS case
- If brackets cannot be removed without damaging or deforming the bumper (bond too strong --> the entire bumper incl. brackets must be replaced)
