Emissions Recall

Code: 26M4

Subject	Catalyst															
Release Date	September 05, 2020															
REVISION SUMMARY	<ul style="list-style-type: none">Updated claiming instructions and part information with Criteria M1 information.Updated claiming and work instructions to include rivet (N -038-549-4) for the noise insulation. Due to a change in the repair manual, this rivet is now a mandatory replacement part.Updated work instructions to include a caution about working with exhaust fasteners.															
Affected Vehicles

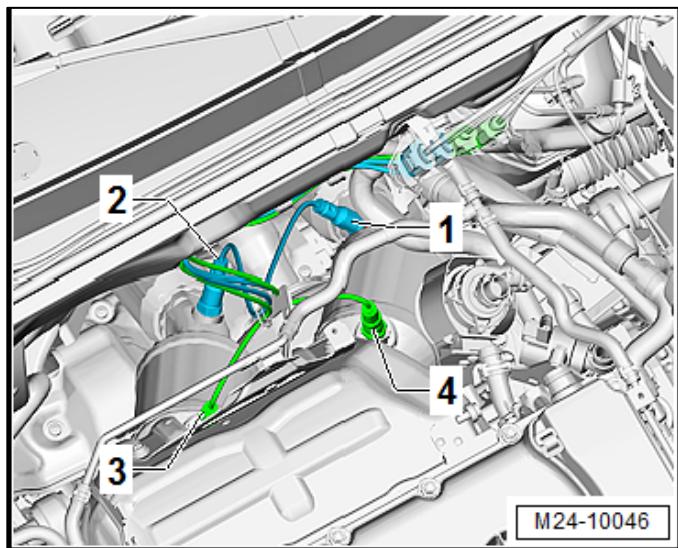
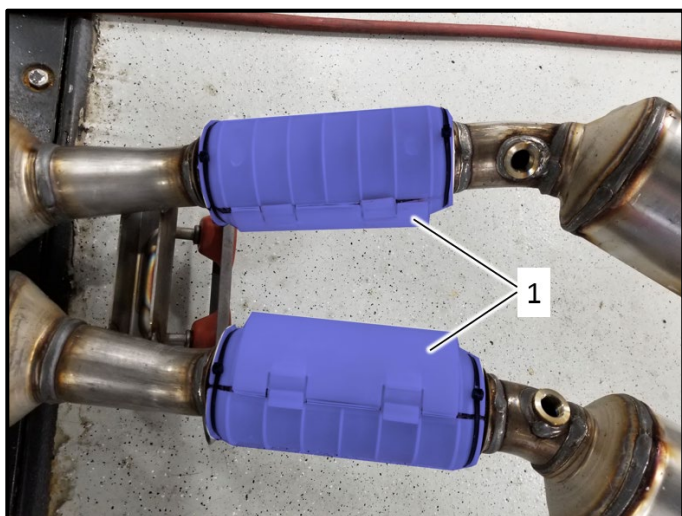
Danger of causing damage to the decoupling element!

Do not bend the decoupling element more than 10°. Do not damage the wire mesh on the decoupling element.

- Ensure the transportation protection <1> is secured on the new catalyst before installing.
- After installing and securing the catalyst to the exhaust manifold, remove the transportation protection from the catalysts.
