Emissions Recall

Code: 26N6

Subject	Catalyst															
Release Date	September 05, 2020															
REVISION SUMMARY	<ul style="list-style-type: none">Updated claiming instructions and part information with Criteria M1 information.Updated claiming and work instructions to include rivet (N -038-549-4) for the noise insulation. Due to a change in the repair manual, this rivet is now a mandatory replacement part.Updated work instructions to include a caution about working with exhaust fasteners.															
Affected Vehicles

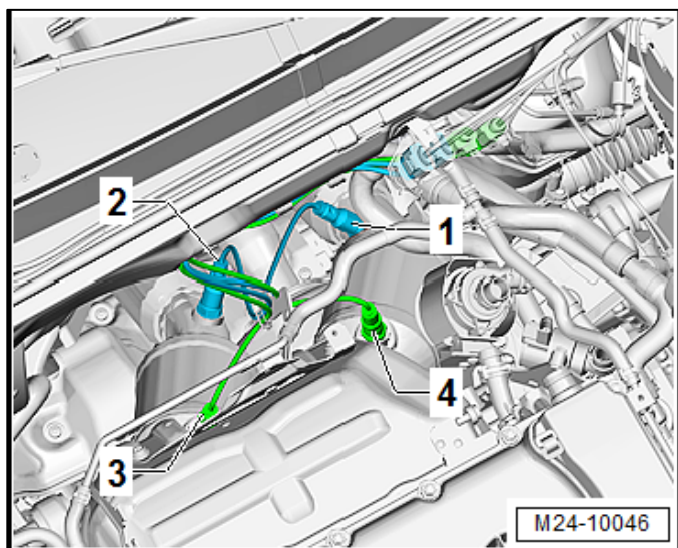
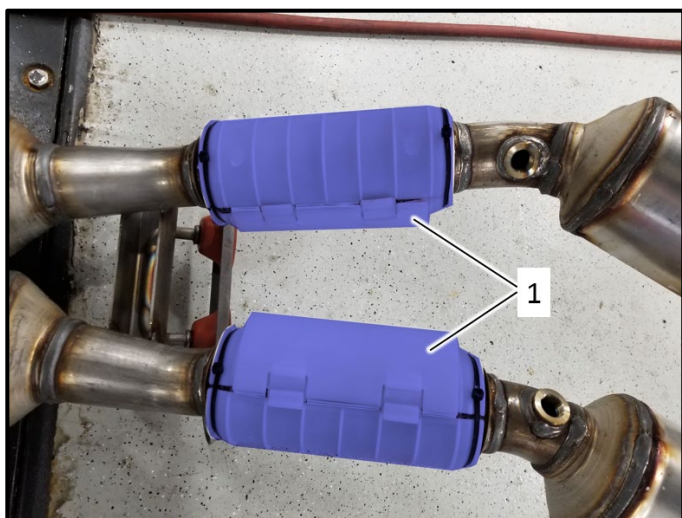
Oxygen sensors <1>, <3> and <4> can be removed with tools from the Ring Wrench 7-Piece Set -3337-.

Oxygen sensor <2> will have to be removed with a locally sourced oxygen sensor socket.

- All exhaust nuts must be soaked with penetrating oil prior to removal to avoid exhaust stud breakage.
- All exhaust nuts should be removed using hand tools and not impact tools.
- Any rusted fastener should also be soaked with penetrating oil to avoid breakage.

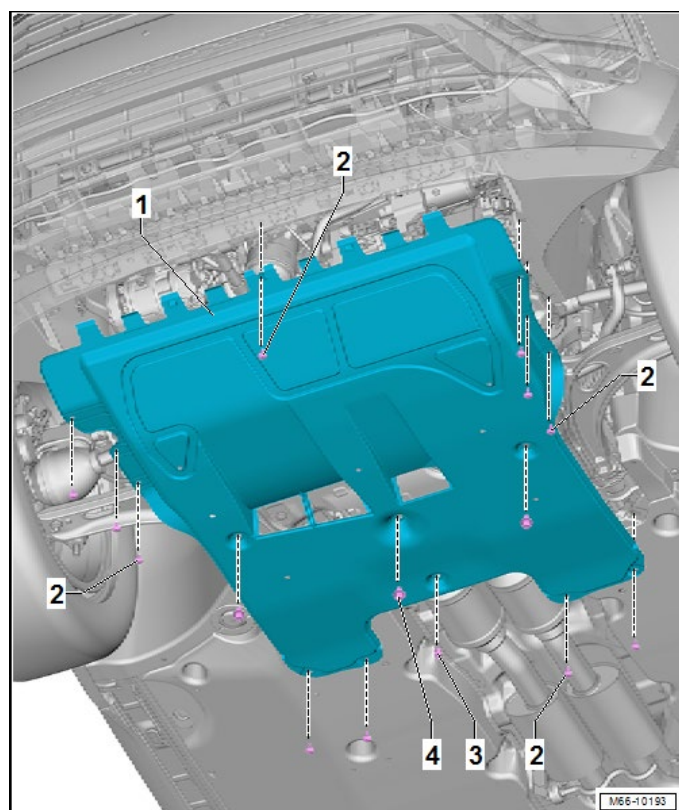
This rivet is required to prevent noise and to prevent debris from building up on the top of the noise insulation.

- A new expanding rivet <3> must be installed when reinstalling the noise insulation.
